Structural health monitoring of 52-meter wind turbine blade: Detection of damage propagation during fatigue testing

Keywords: Damage; fatigue testing; structural health monitoring; wind turbine blades

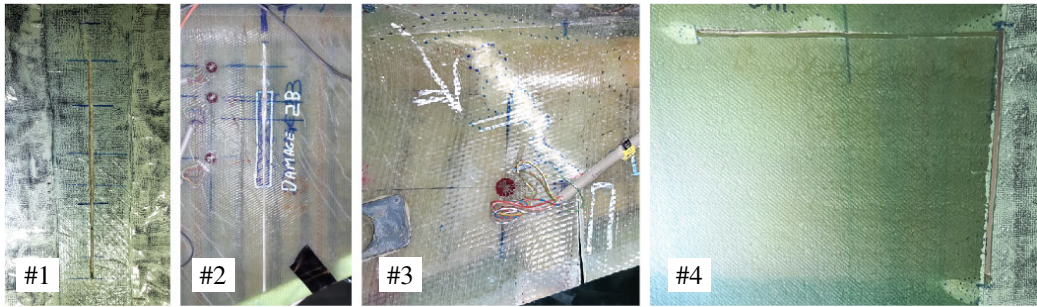
Figure 4. Investigated damage cases. #1: Transverse crack in pressure side shell. #2: Transverse crack in web start. #3: Transverse crack in web start. #4: Transverse/longitudinal crack in leading edge shell.

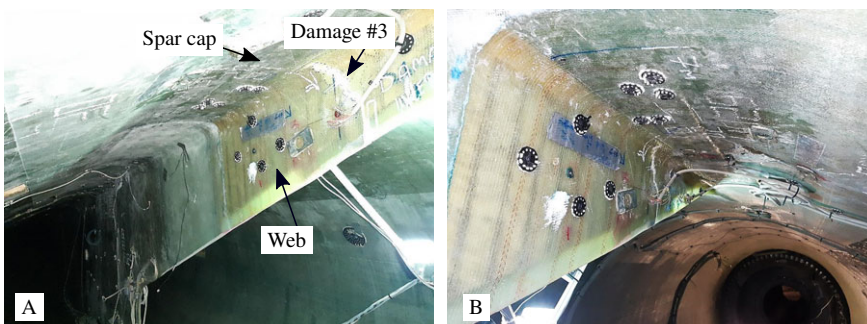
Figure 9. *Damage #3 toward the pressure side. A: Viewed toward the tip. B: Viewed toward the root.*

This section describes how damage #3 is initiated in the blade, and what observations of the damage propagation are made. To give an overview of the geometry of the blade near the damage, Figure 9 shows the area near damage #3 toward the PS.

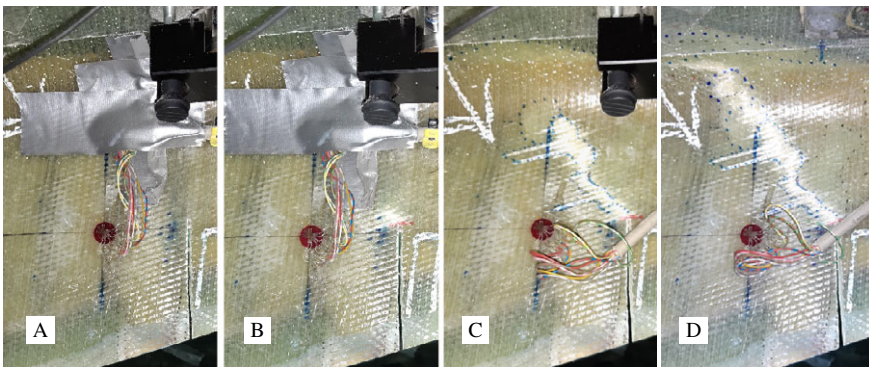
Damage #3 was desired to be crack in the laminate, transverse to the spanwise direction of the blade. A first attempt at initiating the damage was made by grinding down the laminate on both the LE and TE sides of the web start, which reduced the laminate thickness. This can be seen for the SS in Figure 8b, and a similar grinding was made toward the PS. The grindings resulted in a thinner laminate, which lead to larger strain magnitudes in the laminate, based on which the likelihood of damage initiation would increase. However, no visible damage initiated at the grinding in the laminate. Consequently, the damage was initiated by manually cutting through the laminate, which resulted in a crack, as shown in Figure 8b. Damage #3 was a transverse crack in the web laminate, placed close to the web start (see Figures 3 and 9). The damage was introduced in the web start toward both the PS and the SS. Starting from the web, the crack was initiated by cutting all the way through the web laminate. This resulted in the crack shown in Figures 8a and 10a, showing the web start toward the SS and the PS, respectively. Both artificial cracks had an initial length of approximately 100mm transverse to the spanwise direction. The width of the cracks corresponded to the width of the saw blade used to cut through the laminate. The crack toward the SS did not propagate significantly during fatigue testing, which is attributed to mean strains being of lower magnitude compared to those on the PS. Due to the loads induced by the self-weight of the blade, the SS and the PS are subjected to a negative and positive offset in mean load, respectively. Thus, the crack on the PS is loaded in tension–tension fatigue, which is more likely to propagate the crack than the compression–tension fatigue load on the SS. Since the crack in the PS web start propagated most, analysis of local sensor data in Section 4 is limited to the PS part of damage #3.

Figure 8a shows damage #3 on the SS part of the web start. No significant damage propagation occurred with the initial damage length of 100 mm, after which the damage length was increased to a total of 150 mm. A delamination formed at the crack tip after additional fatigue testing (see Figure 8b), but the delamination propagated significantly slower than the delamination in the PS web start. From the initial length of damage #3 toward the PS, as shown in Figure 10a, the crack propagated between approximately 45 and 60° toward the tip and the PS spar cap (see Figure 10c). Once the crack had propagated close to the spar cap, the damage propagated further as a delamination (see Figure 10c). With subsequent fatigue

Figure 10. Damage #3 toward pressure side: Crack in web start. A: Manual introduction of transverse crack near web start (February 22, 2021). B: Delamination starts forming at the crack tip (February 26, 2021). C: Damage propagated through delamination and laminate cracking (March 22, 2021). D: Testing stopped with this damage after the delamination propagated to the spar cap and the crack reached the spar cap (March 11, 2021).

testing, the damage propagated as both a crack and delamination through the spar cap (see Figure 10d). At this point, fatigue testing was stopped, and the damage was repaired.

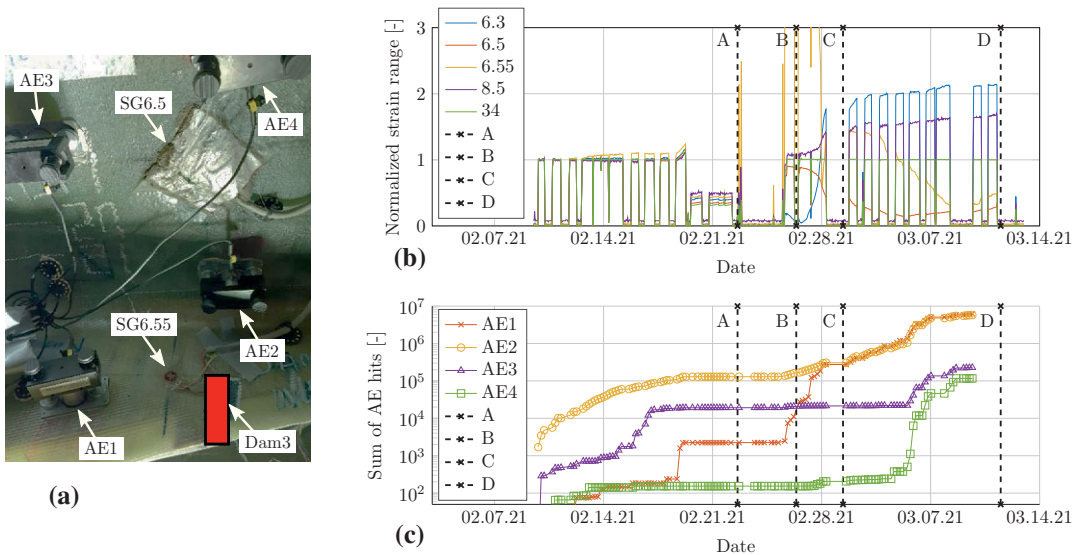
Figure 11. (a): Acoustic emission (AE) and strain gauge placement near damage #3. The location of the damage is marked with a red rectangle. (b): Normalized strain ranges $\Delta\varepsilon_{12,\text{norm}}$ (SG6.3, SG6.5, SG6.55, and SG8.5) and $\Delta\varepsilon_{11,\text{norm}}$ (SG34) for testing with damage #3. The damage was manually introduced on February 22, 2021, coinciding with the dotted line A. (c) Sum of AE hits for testing with damage #3. The four AE sensors are denominated AE1–AE4. AE measurements for the last few days of testing with this damage are not available.

As described in Section 3, damage #3 was initially introduced through grinding of the web laminate, from which a visible crack did, however, not develop during fatigue testing. The strain range of SG6.55, the yellow curve in Figure 11b, shows a slight increase in the period from February 13, 2021 to February 18, 2021, which was after introduction of the grinding, but before introduction of the laminate crack. This may indicate that some damage propagation occurred after introduction of the grinding in the web laminate. However, the damage propagation was slow and not visible during inspection. Thus, it was decided to introduce the crack manually by cutting through the laminate, which was done on February 22, 2021.

Significant changes in magnitude of all strain ranges, except for that of SG34, included in Figure 11b can be seen starting around February 27, 2021, where fatigue testing is started after manual introduction of the damage in the form of a laminate crack. SG6.55, which is placed next to the damage, shows a large increase in the strain range as a consequence of the damage being introduced. The increase in strain range is caused by the strain concentration occurring at the crack tip, which is located at approximately the same height of the web as SG6.55. The initial changes in the strain range of the other SGs in Figure 11b are minor compared to the changes from SG6.55. The large increase in strain range of SG6.55 is followed by a large drop in the strain range as the damage propagates. These changes in the magnitude of the strain range are explained by the crack tip growing past the position of the SG, and loads being redistributed around the damage. This leads to reduced strains in the laminate near the free crack faces, where SG6.55 is located. The observed changes in the strain measurements are similar to trends observed by the authors in Fremmelev et al. (2020), where numerical studies on the strain distribution near a laminate crack in a blade were studied. In the cited work, it was observed that strain magnitudes would increase as a crack grew toward the location of a strain sensor, whereas the strain magnitude would decrease once the crack tip had grown past the location of the strain sensor. This behavior was proposed to be used for the estimation of crack length and damage location.

SG6.5, which is placed on the spar cap, shows a gradual decrease in the strain range after introduction of the damage. This indicates that a reduced amount of the shear loads is transferred between the spar cap laminate and the web laminate at the spanwise position of the damage. SG6.3, which is placed on the web start, shows a large drop in the strain range after introduction of the damage. With increasing damage propagation, the strain range increases to more than twice the nominal value. For SG8.5, the strain range shows a continuous increase in magnitude after introduction of the damage and with further damage propagation. The measurement results from SG8.5 indicate that a damage in the web can be detected within a spanwise distance of at least 2 m using strain measurements.

Four AE sensors are placed between 0.2 and 0.5 m from the point of damage initiation (see [Figure 11a](#)). AE data recorded during the test period for damage #3 are shown in [Figure 11c](#), with the sum of AE hits plotted along the vertical axis with logarithmic axis scaling. Damage propagation during fatigue testing is inferred from the sensor signals starting around February 27, 2021, coinciding with the dotted vertical line B, where large changes in the magnitude of the strain range are measured, and high increases in the number of AE hits are recorded. Jumps in AE hit count prior to February 27, 2021 are mainly attributed to measurement noise captured during fatigue testing. Starting February 27, 2021, jumps in AE hit count are attributed to damage propagation, for example, sensor AE4 showing a large jump just prior to March 7, 2021. At this point, the damage has grown toward the spar cap, and the sensors placed on the spar cap measure AE hits as the damage propagates further.

From the start of the fatigue test around February 10, 2021, an increase in the AE hit count is visible in [Figure 11c](#). In general, the trends from both the AE and SG measurements in [Figure 11b,c](#), respectively, indicate damage propagation, starting from the point of manual introduction of the crack. Taking the logarithmic axis scale into account, the number of AE hits occurring before manual introduction of the crack is minor, compared to subsequent increases in hit count. After introduction of the transverse crack, fatigue testing is started on February 26, 2021. From this point in time, an increase in the AE hit count can

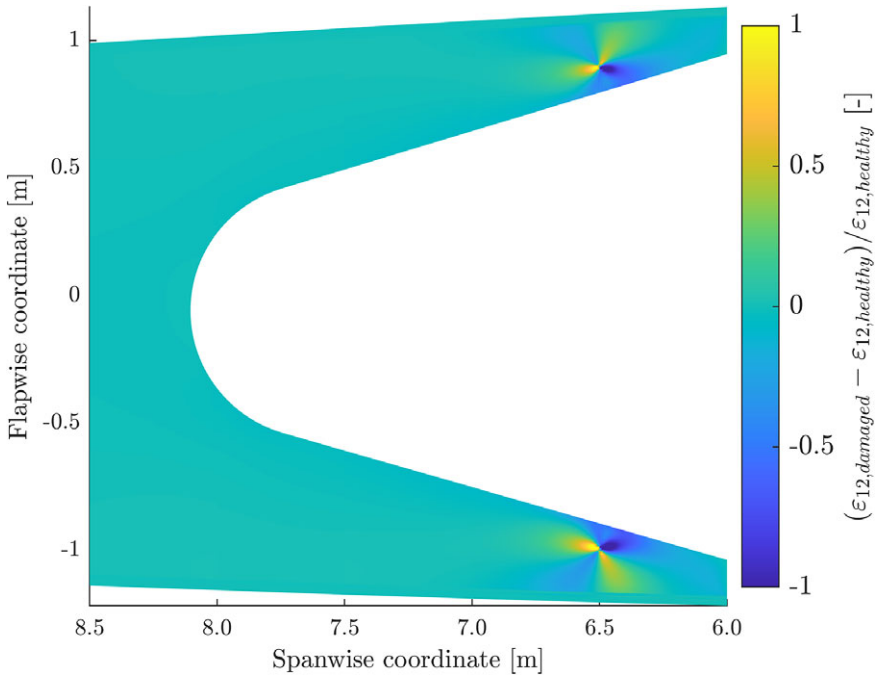
Figure 12 shows the FE geometry of the web start, overlaying the FE results for the difference in shear strain range caused by the inclusion of damage #3 with lengths of 100 mm in both the PS and SS web starts. For reference on the geometry, see Figures 9 and 10, which show photographs of the web start. The normalized shear strain range is calculated in the same manner as for the SG measurements, shown in Equation (1). Figure 12 illustrates the distance at which the strain distribution is affected by the inclusion of damage #3. The plot shows changes in the strain distribution within a distance of approximately 0.5 m with the initial length of the manually induced damage.

Figure 12. Difference in in-plane shear strain range at the web start between blade with the inclusion of damage #3 and the healthy blade. The damage is included at spanwise position 6.5 m with lengths of 100 mm on both the pressure side and the suction side. The color scale is limited between 1 and -1 to make changes in strain further away from the damage visible. Thus, changes in the strain range in the plot correspond to between 100 and -100% of the nominal strain range, whereas the strain range gradients of the peaks beyond this range are not readable from the plot.

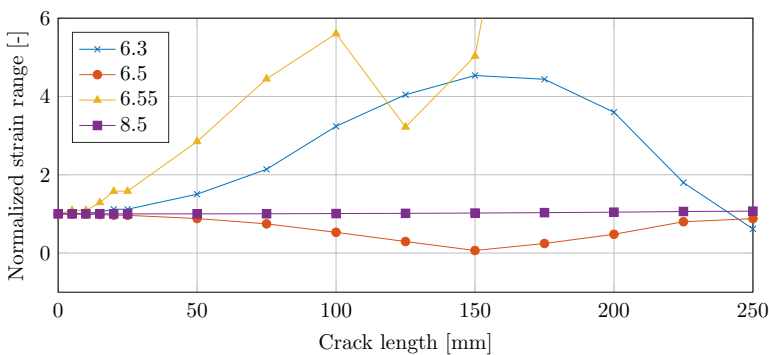
Figure 13. Normalized strain range plotted as a function of the crack length in the pressure side part of damage #3. The second axis is limited to six times the nominal strain range to cut out the peak from spanwise position 6.55 m, which is located very close to the stress concentration and will thus tend toward a nonphysically large value.

extracted at the same positions as those of the SGs presented in [Figure 11b](#), are plotted in [Figure 13](#). Only increasing damage length on the PS of the web is studied, since this is the location where the damage propagated during fatigue testing. Comparing the FE strain range in [Figure 13](#) to the SG measurements in [Figure 11b](#), the following observations are made for the four SG positions:

- **SG6.3:** The SG measurements show values of magnitudes lower than the nominal strain range after introduction of the damage with a length of 100 mm. By comparison, the FE model yields a large increase in strain range after introduction of the damage. Toward the maximum damage length, the SG measurements reach their largest value, whereas the strain range from the finite element analysis (FEA) decreases below the nominal value.

- **SG6.5:** Both SG measurements and FEA results show similar trends with a decrease in the strain range, followed by an increase in strain range.
- **SG6.55:** The large changes at SG6.55 in the FEA are due to a singularity at the crack tip, where strains approach infinity with decreasing element size. This is not physical behavior, and indicates that the measurement in the model is too close to the crack tip, and that why the magnitudes of the measurements are not accurate and comparable to SG measurements from the blade test. Considering the general trends of the FE strain range, it is very similar to the SG measurements. Both SG measurements and FEA results show a sharp increase in the strain range after introduction of the damage, followed by a slight decrease, and again followed by an increase in the strain range. For the SG measurement, a final decrease below the nominal strain range is observed (not visible in the plot due to axis limits).

- **SG8.5:** There is a large difference in the magnitude of changes in the strain range with increasing crack length. The model predicts an increase in the strain range of 7% with a damage length through the whole web height, whereas the SG measurements show an increase over 70%. The model predicted a change in the spanwise normal strain range comparable to the SG measurements of the shear strain range.

Inaccuracies of the FE model are deemed to be due to the model being relatively simple compared to, for example, a model with 3D solid elements with a fracture mechanics model for the crack. In general, although the FE model is not able to accurately approximate strain ranges for all the SGs, it is able to predict general trends in the changes occurring in some of the SG measurements due to damage initiation and progression.

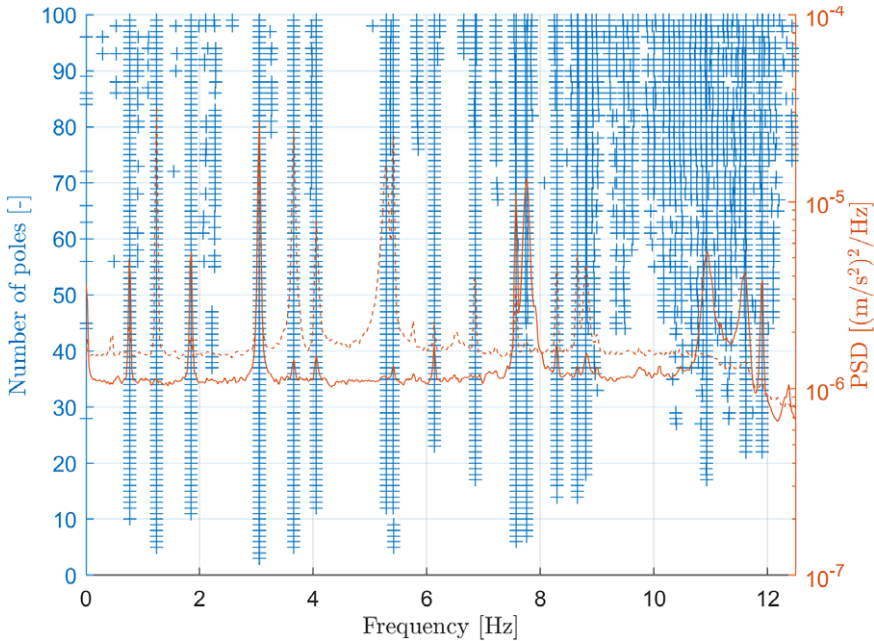
Figure 14 shows the stabilization diagram of the blade, calculated from 10 hr of accelerometer data sampled at 25 Hz during stand-still of the fatigue test. During the course of the blade test, excitation for OMA was mainly constituted by ambient excitation inside the test hall, such as machinery, as well as footsteps inside the blade during manual inspection. A limited number of datasets with manual excitation of the blade tip is also available. Inspection of the stabilization diagram in Figure 14 shows a number of well-separated stable modes in the range between 0 and 8 Hz. At higher frequencies, modal separation is poorer, and stable physical modes are more difficult to identify. By inspecting the mode shapes corresponding to the stable poles, physical modes of the blade can be determined. By overlaying the Welch power spectral density (PSD) estimate on the stabilization diagram, physical modes can also be inferred from peaks in the PSD. The estimates of physical modes of the blade identified through OMA are listed in Table 4, together with the estimates calculated by use of the blade FE model. Eigenmodes are estimated for the blade in healthy and damaged condition, respectively, where the damage state considered is the furthest propagation of damage #3.

For these physical modes, no significant change in the eigenfrequencies is observed as a consequence of the furthest propagation of damage #3. This is to be expected, since the damages, which are relatively small in size compared to the span of the blade, are not assumed to significantly decrease the global

Figure 14. Stabilization diagram from 10 hr of accelerometer data, sampled while the fatigue test was not running. Due to the limited ambient excitation inside the test hall, long time series of data are necessary to enable estimation of lower-order modes of the blade. Crosses mark stable poles; unstable poles are not shown. Solid and dashed orange lines show the Welch PSD estimate of the flapwise and edgewise acceleration signals, respectively.

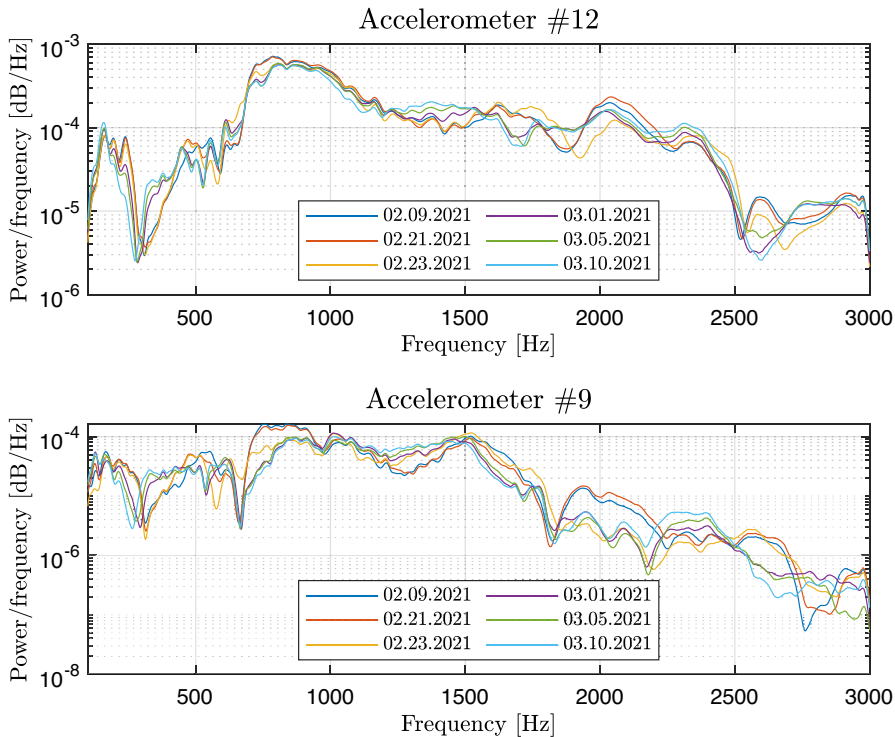
- **Peaks/valleys appearing/disappearing:** Around 2,600 Hz for accelerometer #12, a peak in the PSD is present in the healthy state of the blade. With increasing damage length, the peak disappears and turns into a valley.

Figure 16. Power spectral densities of chirp vibration signal, sampled at healthy and damaged states of the blade. Accelerometers #12 and #9 are placed 2 and 4 m from the damage in the spanwise direction toward the tip, respectively (see Figure 15).

- **Peaks/valleys shifting frequency:** Around 300 Hz for both accelerometers, valleys in the PSD decrease in frequency with increasing damage length.
- **Peaks/valleys changing magnitude:** Between 1,900 and 2,100 Hz for accelerometer #9, peaks decrease in magnitude after introduction of the damage.

Changes in the PSDs are deemed to be due to changes in the local vibration response of the blade as a consequence of initiation and progression of the damage. The change in local vibration response results in changes to the local modal parameters, which result in changes to the PSDs. As can be seen from the PSDs of the measurements from the two different accelerometers in Figure 16, the local structural response at the position of the accelerometer has a large influence on the frequencies and magnitudes of peaks in the PSDs. Thus, PSDs of the vibration measurements from accelerometers at different positions will have different magnitude distributions. As such, changes in the PSDs of vibration measurements from each individual accelerometer should be tracked over time and used as an indication for the initiation and propagation of damage.

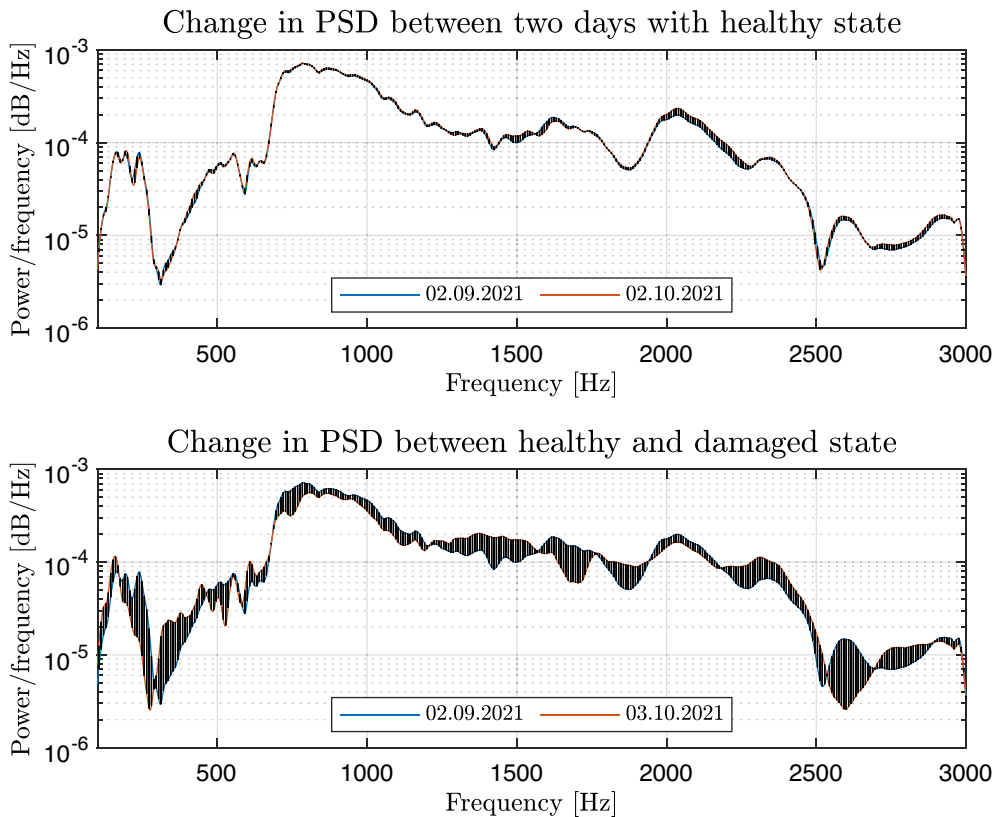
Figure 17. Change in power spectral density using accelerometer #12 between 2 days with healthy state as well as healthy and most severely damaged state. Shading with black lines highlights the change in magnitude.
