The Use of LOM, SEM, FIB and APT to Clarify the Sequences of Failure of a Hot Dip Galvanized Structural Steel Section

Michael Panzenböck¹ and Caroline Freitag¹

¹. Department of Physical Metallurgy and Materials Testing, Montanuniversität Leoben, Austria

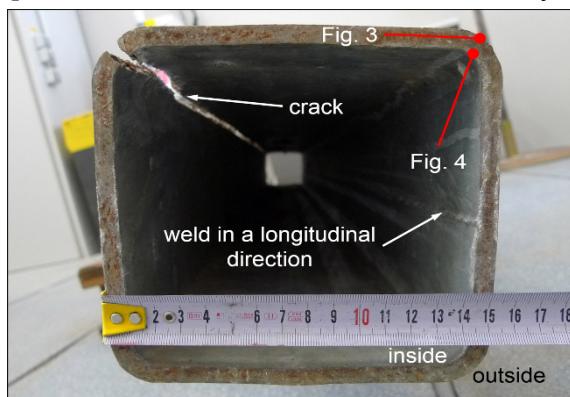
Structural hollow profiles are widely used for steel constructions. To protect such profiles against corrosion, normally they are hot dip galvanized. In this case of failure, a broken support of a staircase was detected. The used hollow profile (150 x 150 x 8 mm, material S355J0) depicted in Figure 1 contains a crack located at one corner and extending over the whole profile length (approx. 6 m). As can be seen from Figure 1 there is a certain distance between the crack flanks. After cutting out the fracture sections, the parts show a distinct curvature (Figure 2a). From this can be concluded that residual stresses in circumferential and longitudinal directions are prevalent.

Figure 1. Overview of the structural steel section with a crack located at the upper left corner, growing in a longitudinal direction. The profile is closed by a weld during manufacturing by cold bending.

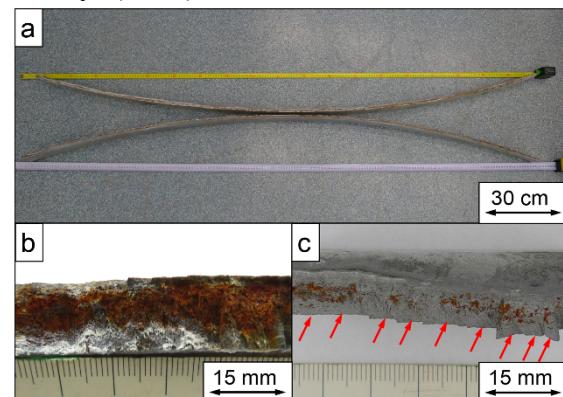
Figure 2b reveals a heavily corroded fracture surface. No features are visible in detail. After a cleaning with citric acid many cracks starting from the inside (red arrows in Figure 2c) become detectable. A macroscopic inspection reveals exclusively a brittle fracture surface. No plastic deformation is detectable. Metallographic investigations carried out at the outer surface, show a zinc layer with cracks in it (Figure 3). In contrast to this, huge cracks (150 – 300 µm of length) and very fine cracks beneath the cracks of the zinc layer are visible at the inner surface and only within the bend (Figure 4). After opening the crack shown in Figure 4 at room temperature, different fracture features within the steel are visible (Figure 5). At first, an intergranular damage is prevalent resulting from LME (Liquid Metal Embrittlement). This can be confirmed by FIB-investigations. The grain boundaries are covered with zinc (see insert in Figure 6). LME can be a result of copper and tin segregations at grain boundaries [1], which can be detected by APT. The transgranular fracture can be attributed to hydrogen induced stress corrosion cracking, where the hydrogen is a result of the cathodic reaction [2, 3]. The ductile fracture originates from the forced rupture at room temperature. A possible sequence of the damage process is given in Figure 7 (see legend).

Figure 2. a) Cut out of the fracture sections. The bend of the parts reveal residual stresses in the longitudinal direction. b) Heavily corroded fracture surface. c) Cleaned fracture, the arrows indicate crack initiation at the inside of the profile.

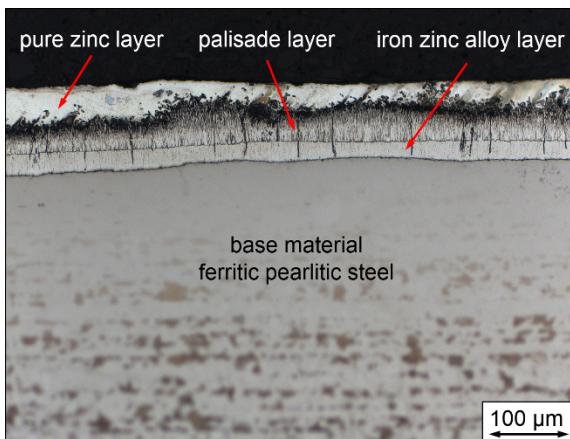
Figure 3. Light optical micrograph of the zinc layer and the steel after etching with nital at the outside of a corner. Crack arrest takes place within the iron zinc alloy layer.

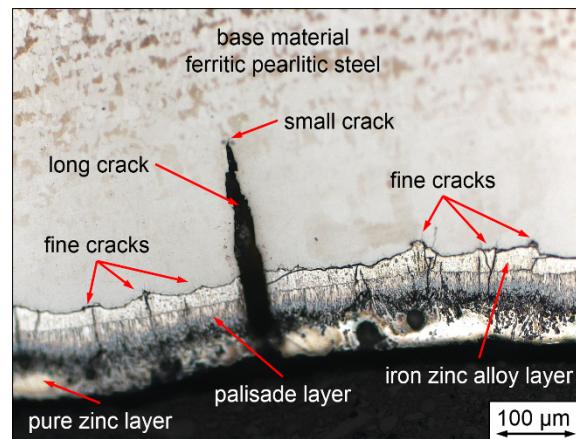
Figure 4. Light optical micrograph of the zinc layer and the steel after etching with nital at the inside of a corner. No crack arrest. The red arrows indicate fine cracks.

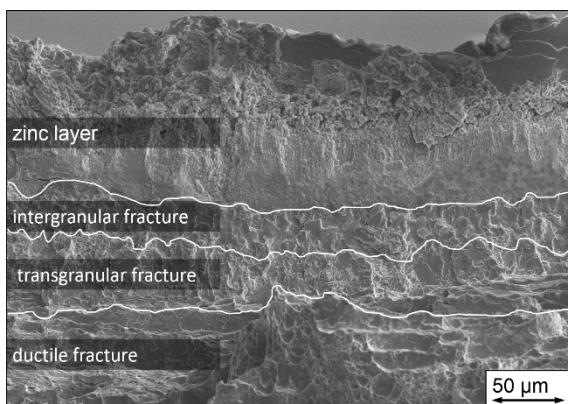
Figure 5. SEM micrograph of the fracture surface after opening the crack shown in Fig. 4 at room temperature. It is possible to distinguish between brittle fracture features and the ductile rupture at room temperature.

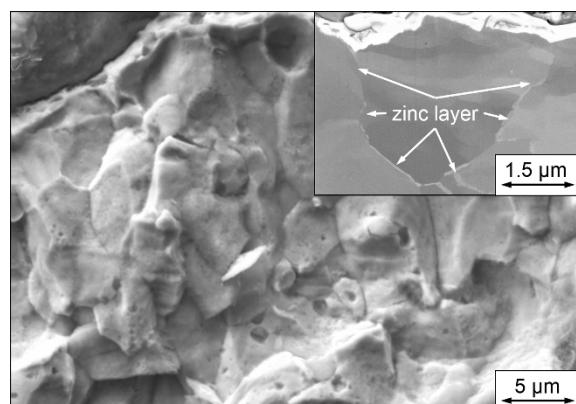
Figure 6. SEM micrograph, detail of Fig. 5. Intergranular fracture of the steel material beneath the zinc layer. The grains are covered with a zinc layer (see insert), caused by LME during the process of hot dip galvanization.

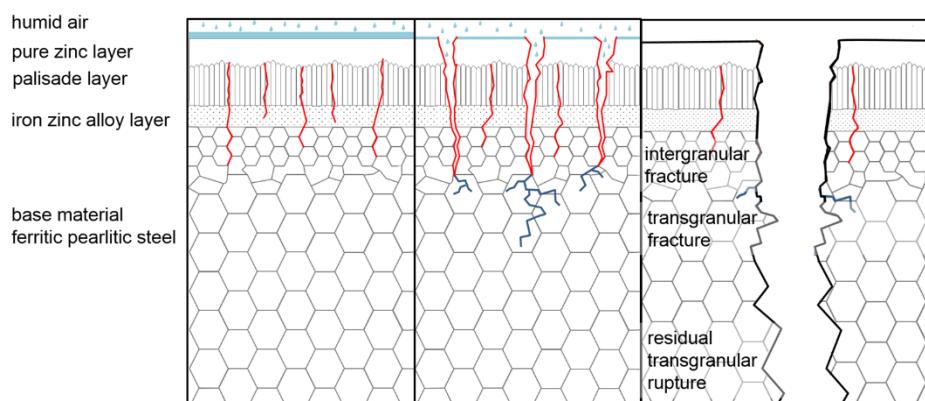
Figure 7. Schematic drawing of the sequences of damage. **Left:** Inside cracks at the corner are prevalent due to LME. **Middle:** Humid air and/or condensed water forces corrosion attack and leads to hydrogen induced stress corrosion cracking. **Right:** Deep temperatures, residual stresses and a low toughness of the structural steel are responsible for the brittle transgranular rupture.
