EDS Windows and Plasma Cleaning: Characterization and Damage Mechanisms

Jens Rafaelsen¹

¹ EDAX Inc, A division of Ametek, Materials Analysis Division, 91 McKee Drive, Mahwah, NJ

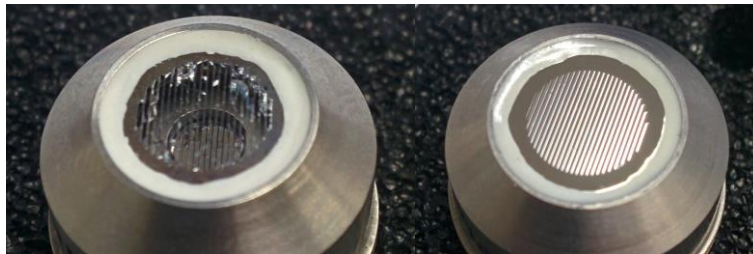
One problem with the combination of EDS and plasma cleaning is the question of window durability. Traditionally, EDS windows are made of a multilayer structure of polymer and aluminum with a new alternative being a multilayer structure of silicon nitride and aluminum. In this study we examine the damage mechanism to the polymer windows and the differences between silicon nitride and polymer windows. While both windows utilize a thin Al protective layer which also works as a light shield, the Al layer plays a vital part in reducing plasma cleaner damage to the polymer window as shown in Figure 3.

Figure 3. Optical photograph of two EDS detector modules with polymer windows. Both modules were exposed to oxygen radicals in a plasma asher chamber for 24 hours. The plasma source was running at 50 W at a pressure of $2 \cdot 10^{-2}$ mbar. The module on the left had a damaged Al layer and suffered complete window failure while the module on the right shows no obvious signs of degradation.

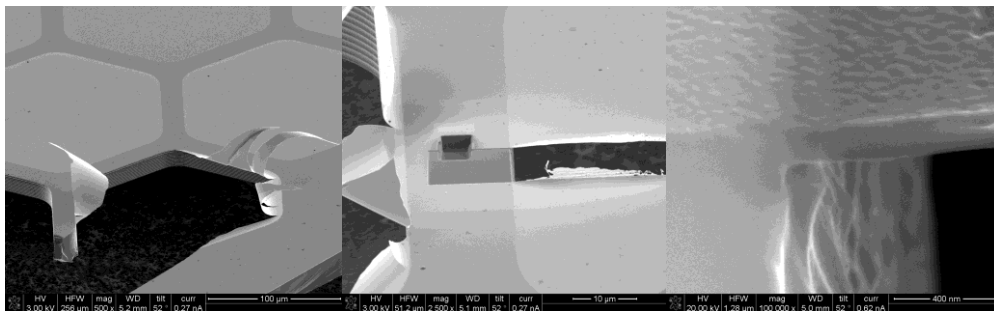
To characterize the efficiency of the plasma cleaning we measure the removal rate of carbon deposited on a Si substrate and the corresponding effect on an Al layer on a Si substrate. These findings are then applied to actual EDS modules with both polymer and silicon nitride windows. The damage effects are documented by EDS measurements and focused ion beam (FIB) preparation of the window structure as shown in Figure 4.

Figure 4. SEM images of silicon nitride window structure. (Left) The window has been removed from the detector module and the hexagonal support structure can be seen. (Center) FIB cut into the support structure and through the unsupported silicon nitride window. (Right) High magnification image of the silicon nitride structure with Al layer on top.
