Troubleshooting Fabricated Products via Microscopic Defect and Failure Analysis

Eddy Garcia-Meitin¹, Mridula Kapur² and Rajen Patel³

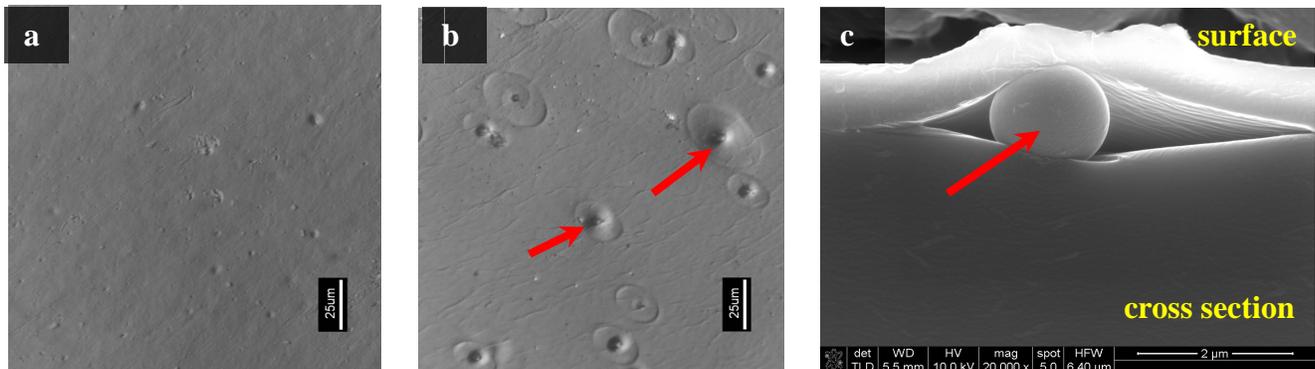
The first study involved a manufacturer of polyethylene based six-pack ring holders for beverage bottles. The polyethylene ring holders were slipping off product labels adhered to the bottles. The customer suspected the labels were at fault and provided three labels for analyses. Two labels had passed a ring holder support test and a third had not. Topographical comparison of the labels was done using reflected light microscopy on an Olympus Vanox-S compound LM (Figures 1a and 1b). Fish-eye type defects were found throughout the outer surface of a label having slippage of the ring holder. A Leica UC7 microtome was used to collect 5µm thick cross sections at -80°C across the fish-eye defects. Label cross sections were examined on an FEI Nova Nano600 SEM coupled with a 30mm² Bruker AXS silicon drift energy dispersive xray detector (EDX). SEM analysis showed that fish-eye defects were comprised of inorganic spheres of approximately 1-2µm in diameter causing bumps along the outermost film surface (Figure 1c). Elemental analysis detected Si and O in the spheres, which was consistent with a silicon dioxide slip additive. The surface roughness introduced by the spheres was causing the ring holders to slip from bottle labels. The label film manufacturer verified that a slip additive was used in other formulations and should not have been present in this application.

Figure 1. LM surface topography of (a) a control label film, (b) a film displaying fish-eye surface defects and (c) SEM image of film cross section exposing inorganic sphere causing fish-eye defects.

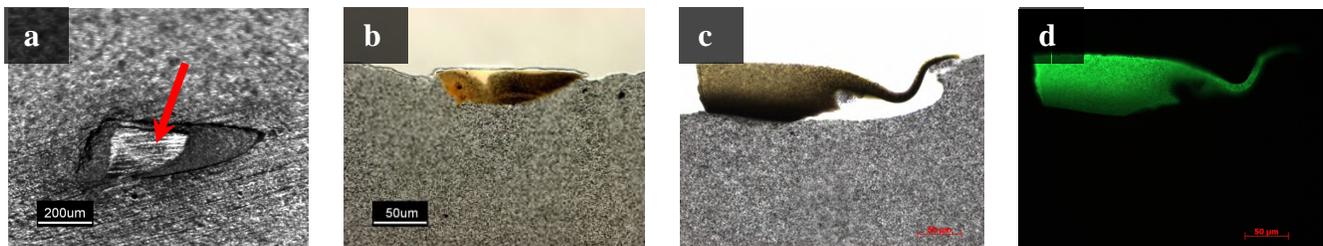
A second study dealt with a manufacturer of carbon black filled high density polyethylene pipe. The customer indicated that a high concentration of pit-like defects were present on the exterior pipe surface. A Leica MZ-16 stereo microscope was used to survey the pipe and determine that dark flake-like defects and white defects were present within the surface pits (Figures 2a and 3a). Defect cross sections were cryogenically sectioned at -80°C to approximately 5µm in thickness and placed on a glass slide containing immersion oil. A compound LM was used under transmitted polarized light to determine that the dark defects were brown and polymeric (Figures 2b and 2c). The white defects appeared inorganic and contained two types of crystalline material (Figure 3b). Epi-fluorescence imaging using an ultraviolet light source caused an intense emission of the brown defects, indicative of thermal oxidation (Figure 2d). Infrared micro spectroscopy verify that the brown defects were oxidized polyethylene that

Figure 2. (a) Dark flake-like defects causing pits on pipe surface, (b,c) defect cross sections under transmitted polarized light and (d) defect under epi-fluorescence illumination.

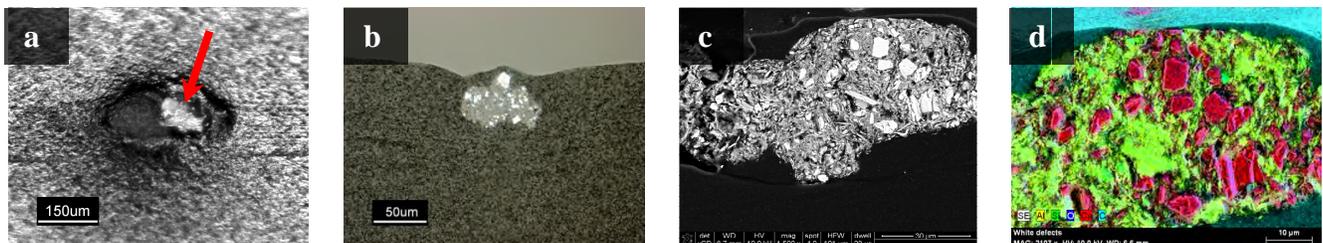
likely formed on the hot metal surfaces of the extruder and flaked off during processing. The white crystalline defects were examined using SEM and EDX from cryopolished block faces used to collect thin sections for light microscopy. A backscatter electron image of a white defect is shown in Figure 3c. Elemental analyses coupled with false color elemental mapping determined that the defects had a plate-like matrix phase containing Si, Al and O and solid particles containing Ca and O. The morphology and composition of the defects were consistent with clay and CaCO₃ and not part of the resin formulation. Defects causing pipe surface pits were introduced from improperly purged equipment during pipe fabrication and not related with the resin formulation.

Figure 3. (a) White defects causing pits on pipe surface, (b) defect cross section under transmitted polarized light, (c) backscatter SEM image of defect and (d) false color elemental map of defect with red particles representing calcium, oxygen and carbon and the lime matrix, silicon, aluminum and oxygen.
