## **Bolt failures - Case histories from the Norwegian petroleum industry**

B. Bøgner, G. Rørvik and L. Marken

Statoil Research Center, Materials Dept., Arkitekt Ebbelsvei 10, 7005 Trondheim, NORWAY

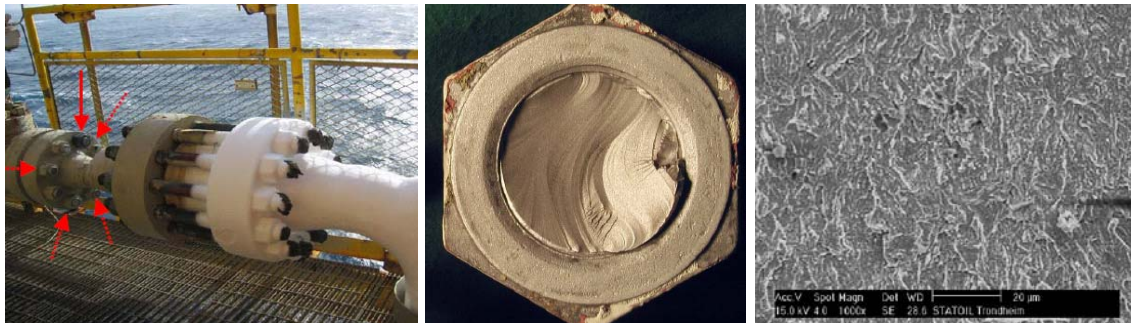
- (i) Fatigue failure: ASTM B7 low alloyed steel bolt grade. Fracture initiation along threads with typical and pronounced beach marks (i.e. cyclic fracture propagation) and transgranular fracture mode. See Fig.1.

Fig. 1 High cycle fatigue; beach marks and transgranular fracture morphology.

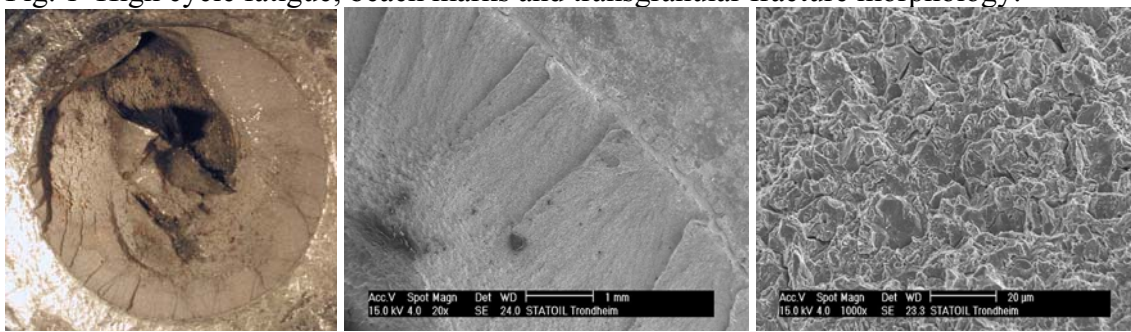
- (ii) Hydrogen embrittlement failure: ISO 10.9 low alloyed steel bolt grade. Multiple fracture initiation along bolt head transition with intergranular fracture morphology and heavy secondary cracking. Hydrogen source suggested from manufacturing (pickling stage) and/or cathodic hydrogen charging due to anodic Zn coating. See Fig.2.

Fig. 2 Hydrogen induced failure; multiple initiations, intergranular fracture and secondary cracks.

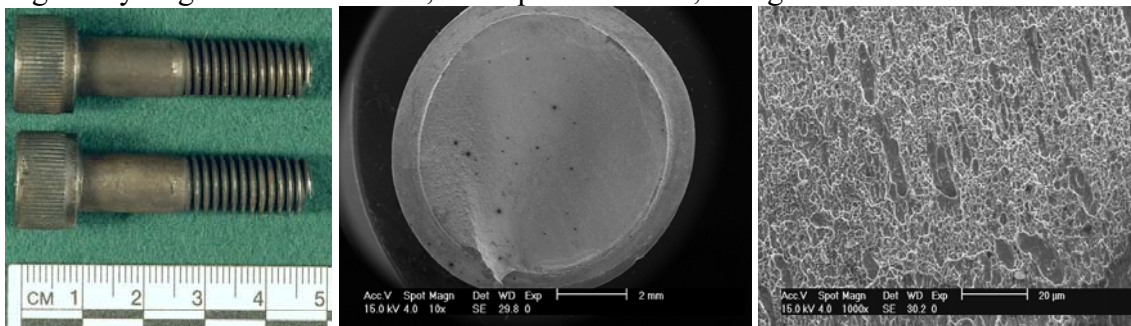
- (iii) Ductile torsional overload failure: ISO 12.9 low alloyed steel bolt grade. Smooth and flat fracture initiated from threads and with ductile dimpled fracture mode. See Fig.3.

Fig. 3 Ductile torsional overload failure; smooth fracture with ductile dimple fracture mode.

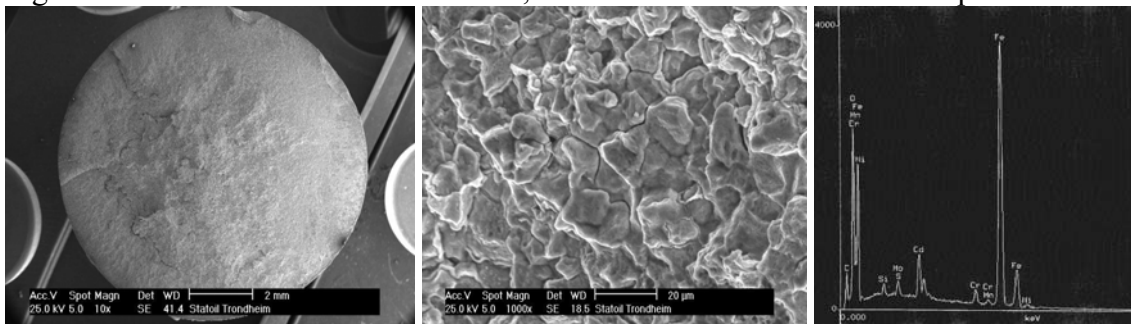
- (iv) Liquid Metal Embrittlement (LME) failure: ISO 8.8 low alloyed steel bolt grade with Cd coating used at higher temperature than recommended, i.e. above 230°C. Intergranular fracture mode with Cd penetration along the grain boundaries as evidenced by XRD analysis. See Fig.4.

Fig. 4 Liquid metal embrittlement (LME) failure. Intergranular failure mode with Cd penetration along the grain boundaries.
