Techniques Used in the Failure Analysis of Railcar Bolsters

D.A. Turnquist, F.E. Schmidt, PhD., M.J. Danko
Engineering Systems Inc., Colorado Springs, CO and Aurora, IL

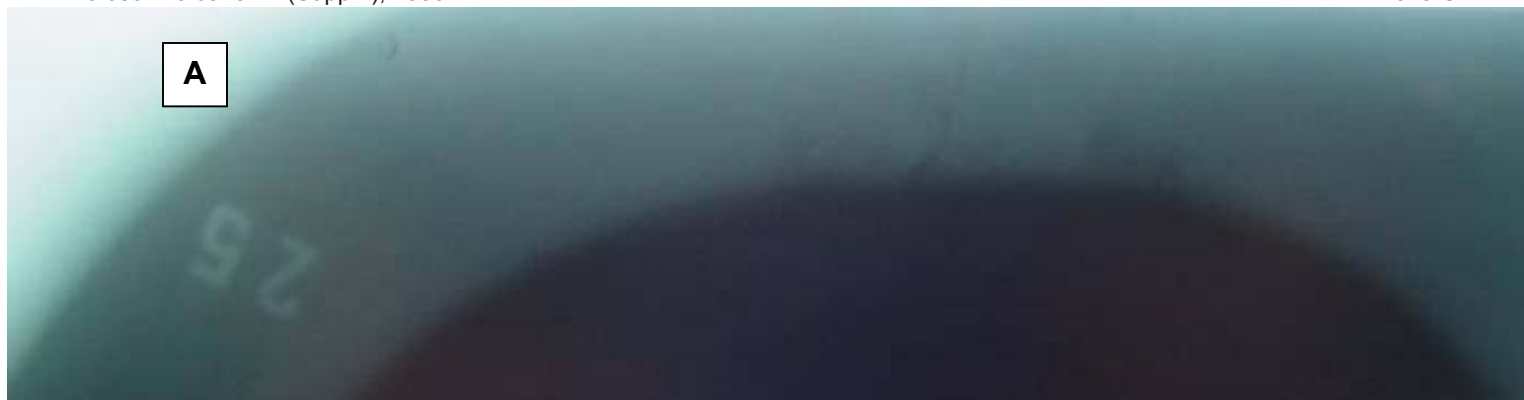
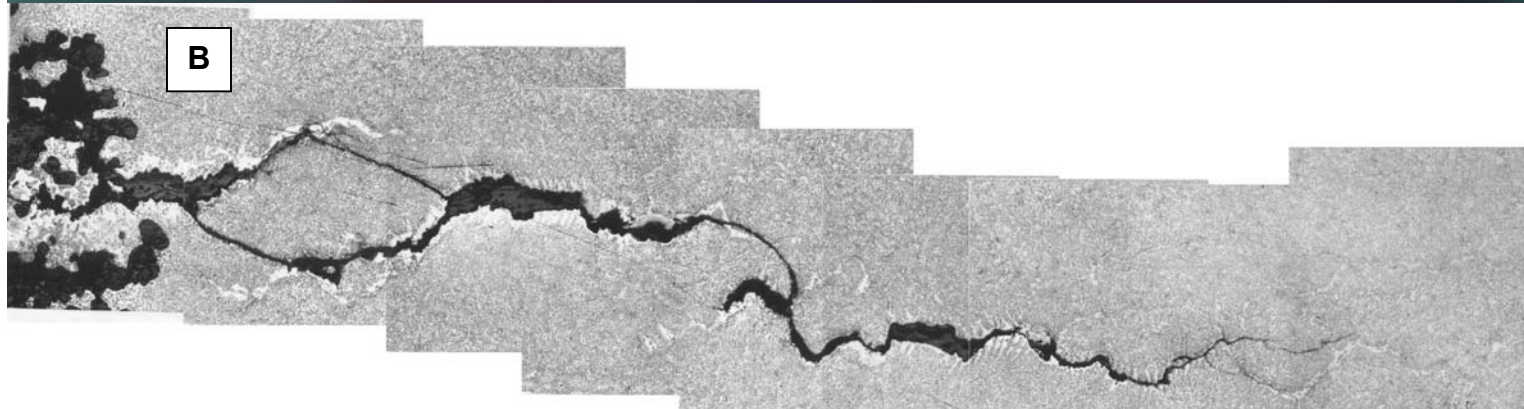
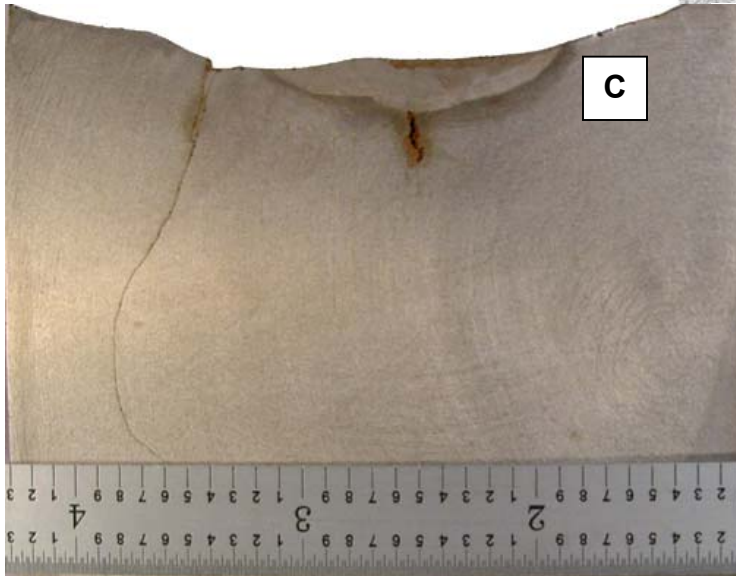
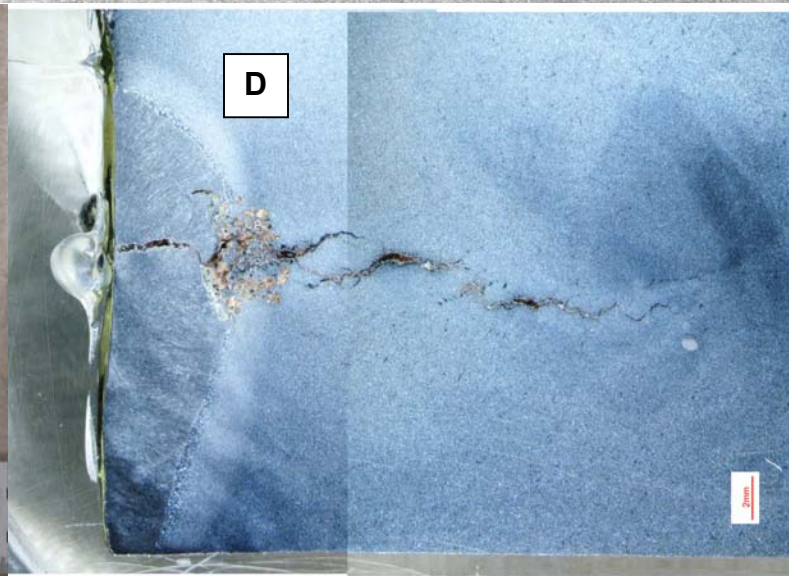
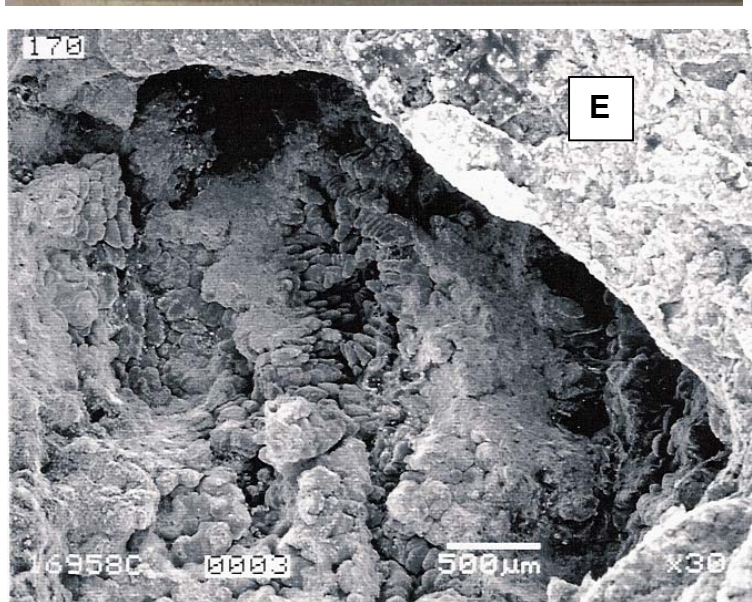
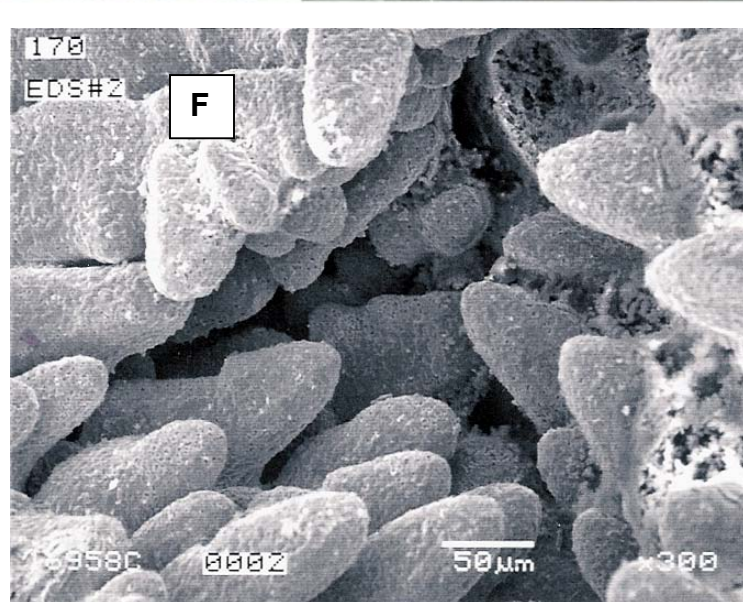
The selected rail cars were disassembled so that the 2,200 lb bolsters could be radiographed. X-rays confirmed the presence of horizontal and vertical cracks in the support webs of the bolsters. The radiographs show indications of porosity and lack of fusion at the mold parting lines. The bolsters were subsequently cut with a plasma-arc so that smaller sections could be sent to the laboratory for metallography.

Metallographic pieces were sectioned from the bolsters. Samples were ground and polished, and then micro etched using 10% nitol. Photographs were taken prior to etching, showing the pockets of sand solidified within the pieces. Examination of the bolsters showed extensive improper weld repairs and lack of post weld heat treatment on the surface of the internal support webs. Further examination showed large amounts of sand under the surface of the metal. The sand was eroded from the mold during the casting process and was entrapped at or under the surface. In multiple instances, the defect (sand) was not completely removed (ground out) before weld repairs were placed over the top, a direct violation of specifications set forth by the governing body. The appearance of microstructure shows that insufficient, if any post-weld heat-treatment was performed.

- A. Contact radiograph –vertical shrinkage porosity and associated cracking;
- B. Major crack, fatigue in bolster web, 23X;
- C. Macro-etch cross section of improper weld repair, two cracks: under bead and in HAZ, 2.2X;
- D. Weld after improper grinding. Sand deposit under bead instigated fatigue cracks, 3X;
- E. SEM of shrinkage cracks typical voids, 30X;
- F. Micro-porosity, shrinkage, 300X.
