EXAMINATION OF WATER-FORMED DEPOSITS IN STEAM BOILERS BY SCANNING ELECTRON MICROSCOPY

John N. Williard* and Mel J. Esmacher

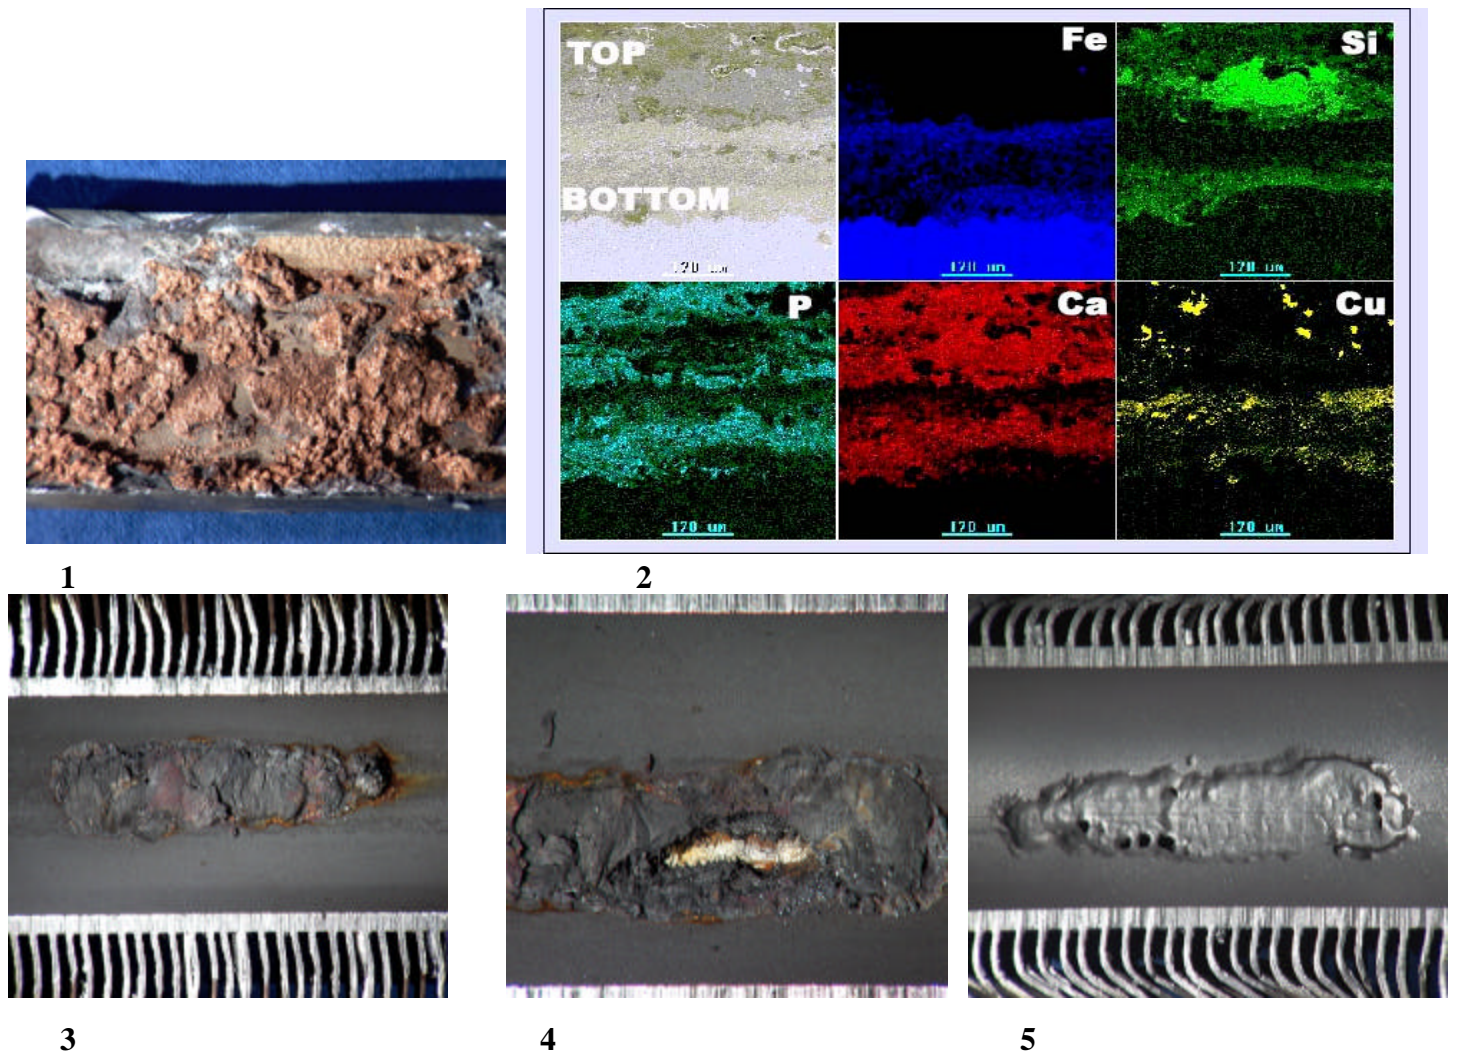
A boiler tube was analyzed that had failed in a bulged area via a longitudinal rupture, indicative of long term overheating. Figure 1 shows the severity of the internal deposit build-up on the waterside surface. Metallographic analysis confirmed overheating, as evidenced by decomposition of the carbide phase in the steel microstructure, and the presence of intergranular creep voids. Examination of the waterside deposit showed that it was composed of iron oxide, metallic copper, silica, and hardness scale, see Figure 2. These constituents indicate poor control of plant water chemistry. A subsequent review of on-line chemistry showed there were many upsets in feedwater chemistry and steam condensate quality being returned to the boiler as make-up.

Acid phosphate corrosion was determined to be the failure mechanism in boiler tubing removed from a heat recovery steam generator (HRSG). This plant was subject to significant cycling, which made it difficult to maintain consistent boiler feedwater quality. Figure 3 shows the black deposit on the internal surface of the tube. A whitish deposit layer which was revealed after the top layer was removed, see Figure 4. The extracted layers of the white deposit were analyzed by *i*XRD techniques. Maricite (NaFePO_4) and magnetite (Fe_3O_4) were confirmed as the two principal compounds. SEM-EDS analysis of the top layers of the deposit showed they were composed of magnetite/hematite and elemental copper. This fouling created a localized deposit accumulation increasing the potential for under-deposit acid phosphate corrosion, which perforated the tube, see Figure 5.

- FIG 1. Build-up of internal copper, silica, and hardness scale on the boiler tube waterside surface.
- FIG 2. SEM-EDS Mapping of elemental constituent concentration at 150x, cross-sectional view.
- FIG 3. Build-up of iron and copper deposits at corrosion gouge in a HRSG boiler tube interior.
- FIG 4. Discovery of white maricite (NaFePO_4) underneath magnetite (Fe_3O_4) at corrosion site.
- FIG 5. Topography of corrosion gouge, revealed after glass bead cleaning, note perforations.
