Correlating Microscopy Techniques for Understanding Root Cause of Defects in Coatings

Melinda Dent¹ and Tim Stecko²

¹PPG, United States, ²The Pennsylvania State University, United States

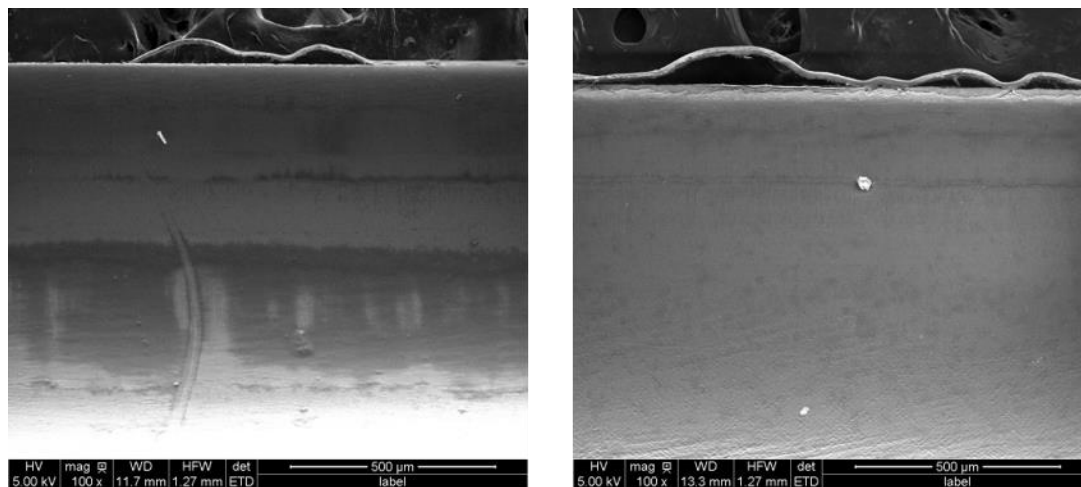
Scanning electron microscopy (SEM) was used to identify the location of the fiber and to compare coating damage between different types of coil coatings after the fabrication process. Using a systematic approach, it was determined that the fibers were being generated from the very edge of the metal part. To better understand the shape and morphology of the fiber, X-ray nano-radiography was performed. Fibers sourced from different coating systems were analyzed to generate a series of 2D projections at different angles to gain a multi-perspective view of each. These projections revealed that the fibers were laterally compressed, and that they were not hollow or porous. Additionally, heated stage confocal laser scanning microscopy (CLSM) experiments were performed to understand if the fiber was the result of an undercured film. A series of images were captured while the fiber was heated, monitoring any changes in shape or length. Little change to the fiber was observed upon heating above the coating's T_g, indicating that the coating was cured completely, ruling out this mechanism for creation of the fiber defect.

Figure 1. SE micrographs of two different types of fiber defect.

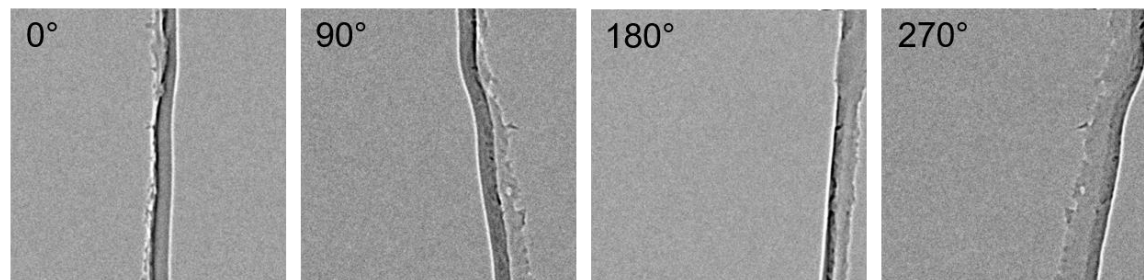
Figure 2. Nano-X-ray 2D radiographs collected at different angles of rotation of an individual fiber. Scale bars are approximately 48 μm .
