Unique Cracking Observations in Superheater Tubes

Dustin A. Turnquist* and George J. Theus**

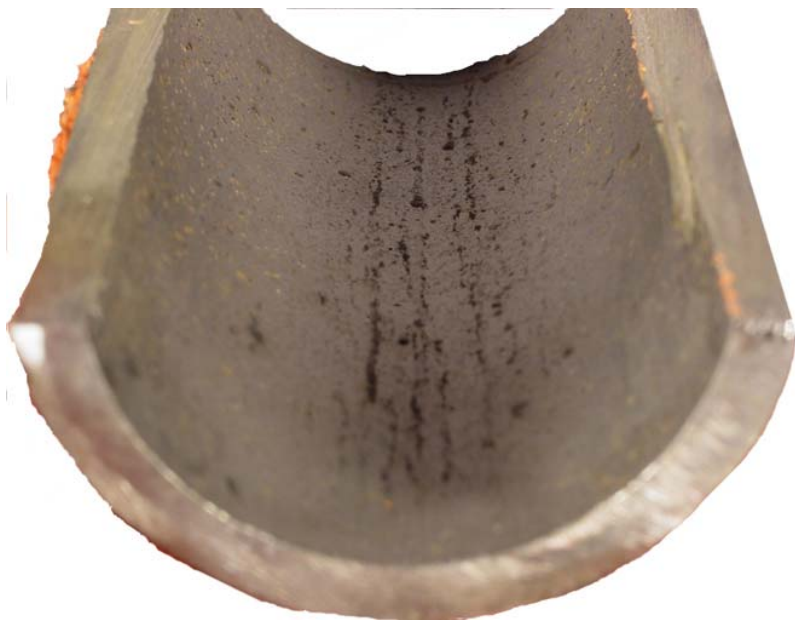
FIG 1: Photographs of the "alligator hide" appearance of the ID surface of a fossil fired boiler, vertical primary superheater tube (2-inch OD).

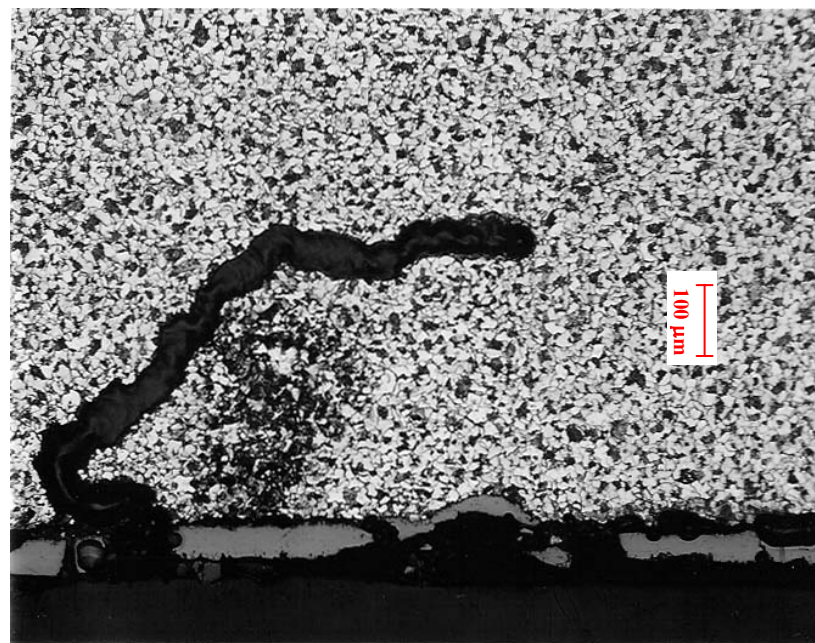
FIG 2: Micrograph of microstructural damage to the ID surface of a fossil fired boiler, vertical primary superheater tube.

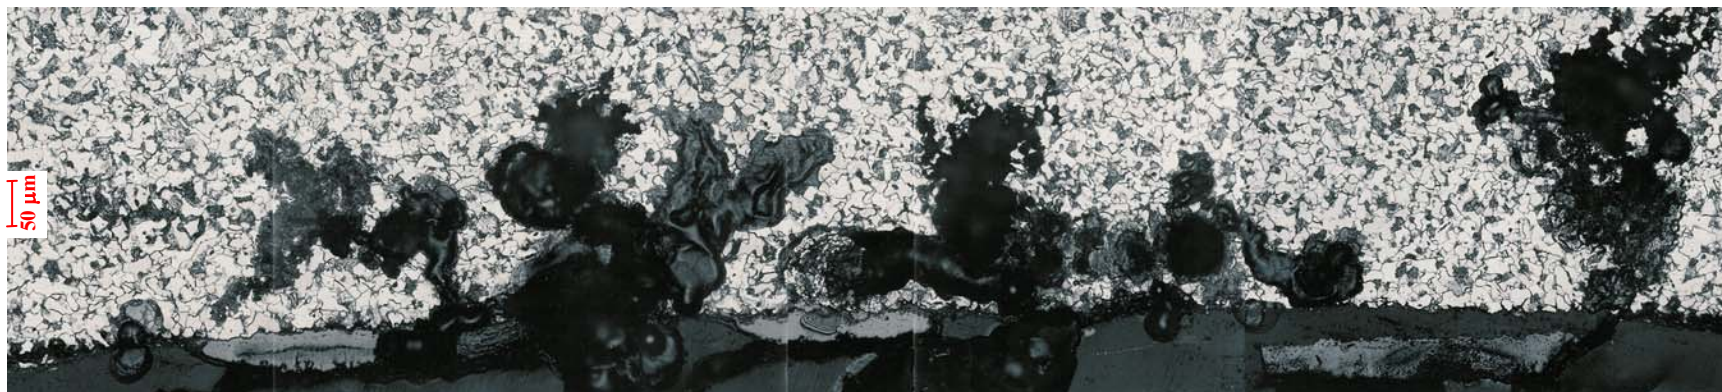
FIG 3: Micrographs of the pitting and intergranular attack at the ID surface of a fossil fired boiler, vertical primary superheater tube.
