Increasing the Corrosion Resistance of Mullite-based Catalyst Substrates in a Vehicle Exhaust Environment

Clifford S. Todd¹, Michael Malanga², Robin Ziebarth¹, Kevin Howard¹, Robert Newman¹, Alexander Pyzik¹, Daniel Grohol¹, Nick Shinkel¹, Niladri Das²

¹ Core Research & Development, The Dow Chemical Company, Midland, MI, USA

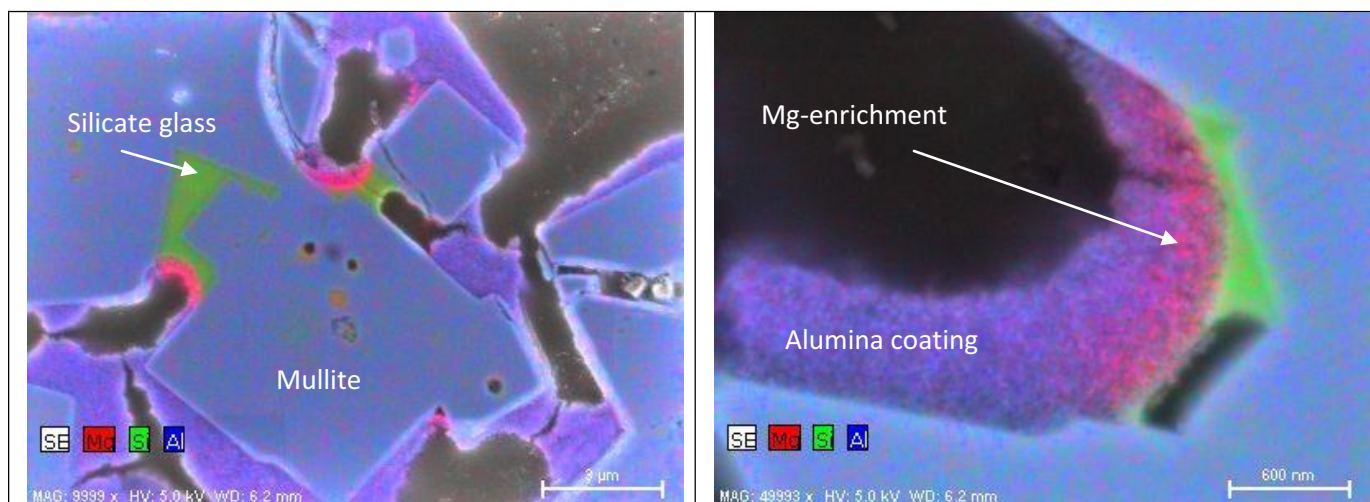
Corrosion of the glass had two characteristics. One was the migration of MgO from the silicate glass into the adjacent γ -alumina based catalyst coating. A zone of Mg-enrichment ~200 nm thick developed where glass was in contact with alumina coating (Figure 1). No other elements were found to migrate either way across this interface.

Figure 1. Embedded/polished cross section through sample. EDS element maps overlain on SEM image. Red = Mg, Green = Si, Blue = Al. MgO migrated from the glass into adjacent alumina coating where the two were in contact.

A research effort was undertaken to increase the corrosion-resistance of the ceramic. Simply removing MgO from the existing formulation was not an option because its absence was detrimental to the desired ceramic microstructure. We discovered a new formulation that maintained the overall product microstructure, but rendered the silicate glass stable when catalyst-coated and exposed to accelerated aging in vehicle exhaust environments.

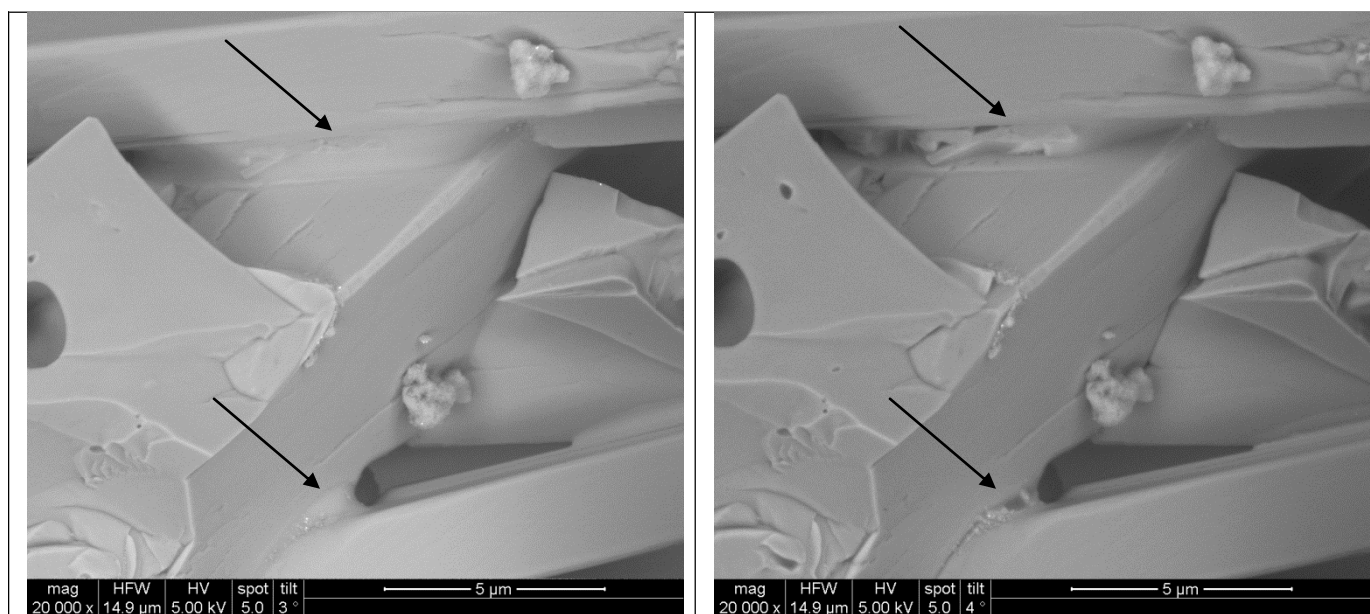
The second characteristic of the corrosion was disappearance of glass from some locations. Before corrosion, glass typically filled mullite grain junctions, forming smooth fillets. Microscopy of grain boundaries before and after corrosion showed that in some places glass was no longer there. Our hypothesis is that the glass re-melted and flowed away from these locations (Figure 2).

Figure 2. SEM images of catalyst-coated substrate before (left) and after (right) accelerated exposure to a vehicle exhaust environment. The silicate glass at grain intersections moved during exposure.
