Failure Analysis of Small Gap Brazing of a Stainless Steel Heat Exchanger

Michael Neff, *Michael Neff Associates, Culver City, California*

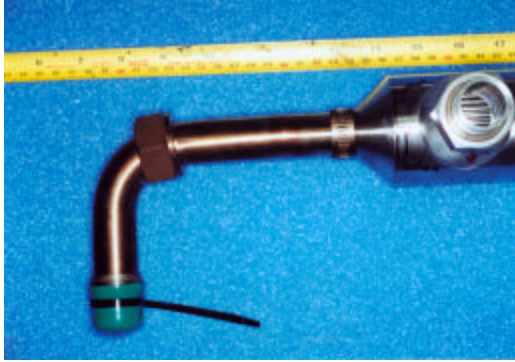
Figure 1. An optical photograph of the inlet side of the tube heat exchanger.

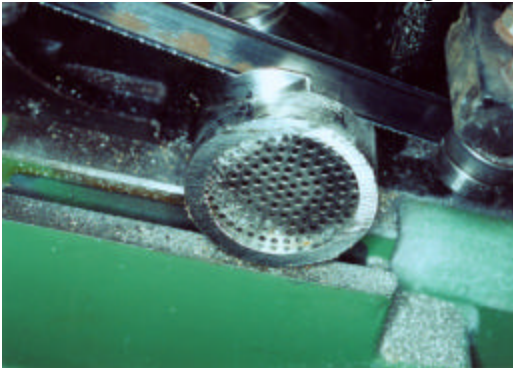
Figure 2. An optical photograph of the hydrogen inlet tubesheet braze assembly.

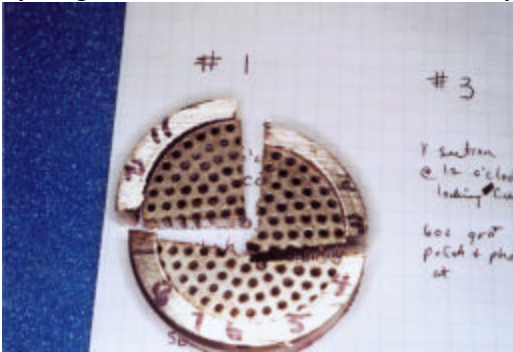
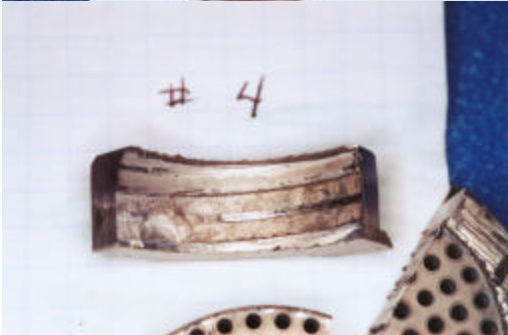
The crack failed the entire cross section of the brazed joint in the upper quadrants of the circle, between 9 o'clock to 3 o'clock, (Figure 3). Toward the bottom quadrants, the crack terminated, so that the total separation of the gap was 0.004" at 12 o'clock and only 0.001" at 6 o'clock. Metallographic examination of the fracture showed that the brazing alloy was thicker near the groove, and this was the area where the brittle fracture appeared to originate, Figure 7.

Figures 3 and 4. Optical photographs showing how the sections were removed for SEM examination and cross section. Also showing the brazing joint fracture.

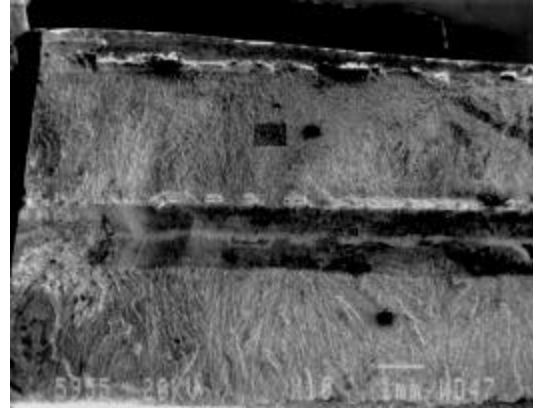
The recommended joint clearance for the Nicrobraz 51 alloy is very critical. While the flow characteristics of the alloy are good, the brazing joint failed in a brittle manner due to the high stresses introduced by the thermal differential. The brittle fracture was observed emanating from a groove in the center portion of the brazing joint, Figure 5.

Figure 5. An SEM photograph showing the fracture initiating along a void in the center of the brazing joint.

In order to further evaluate the strength of the brazing alloy, a series of tensile tests were conducted in order to correlate the gap thickness with the strength of the brazed joint. It was found that there was a sharp decrease in strength as the gap thickness increased for this alloy. The sensitivity of the brazing alloy strength to gap thickness was not as critical for standard boron modified brazing alloys. As a result of the testing, the brazing alloy was changed to a BNi-3 (3.1%B) which is much more forgiving with respect to embrittlement in thicker gaps, and the problem did not recur.

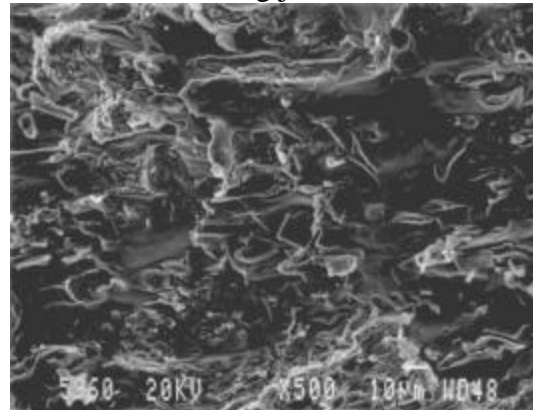
Figure 6. An SEM photograph showing the brittle fracture surface morphology.

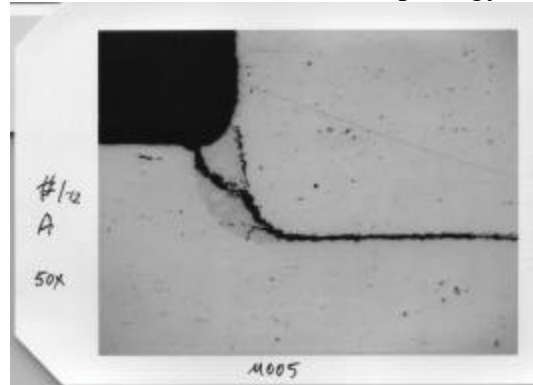
Figure 7. A metallographic section through the failed brazing joint showing the crack initiating in a thick portion of the braze joint next to the void.
