Methanol Pipeline Failure in the Canyon Express Pipeline System

George F. Vander Voort* and Gabriel M. Lucas**

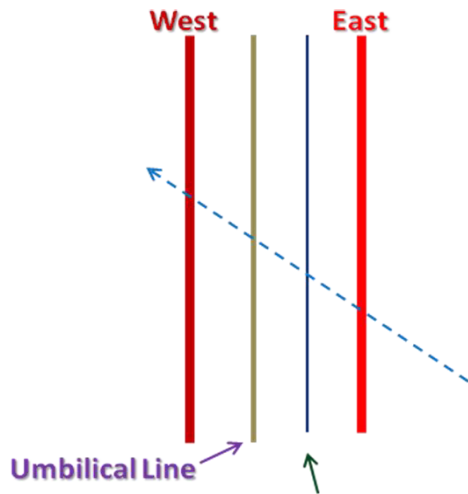
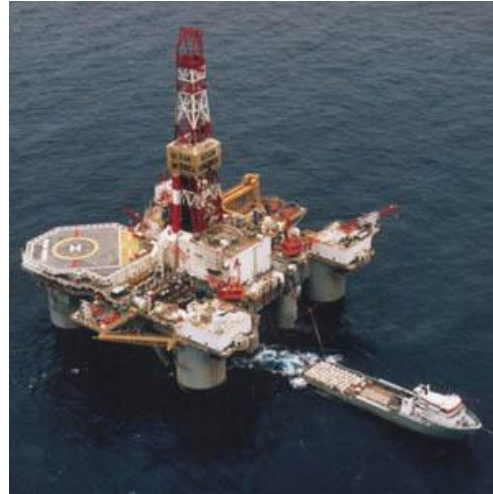
On 3 December 2004, the methanol pipe line stopped functioning, shutting down the CEPS. Subsequent searching of the sea bottom revealed a section of a broken 6X47 RRL 3.5" diameter mooring line 3.8 nautical miles west of the methanol pipe line. It was claimed that the dangling mooring line, and possibly the chain, ran over the methanol line damaging the surface, which led to failure nearly three months later. Figure 1 shows a schematic of the claimed damage path of the Ocean America; which is also shown in Fig. 1.

Figure 1: East and west 12” diameter steel pipelines carry hydrocarbons from the wells to the ‘filling station’. Green arrow points to the methanol pipe line. The dotted line is the claimed route of the Ocean America (right) during Hurricane Ivan, based on biased selected damage areas.

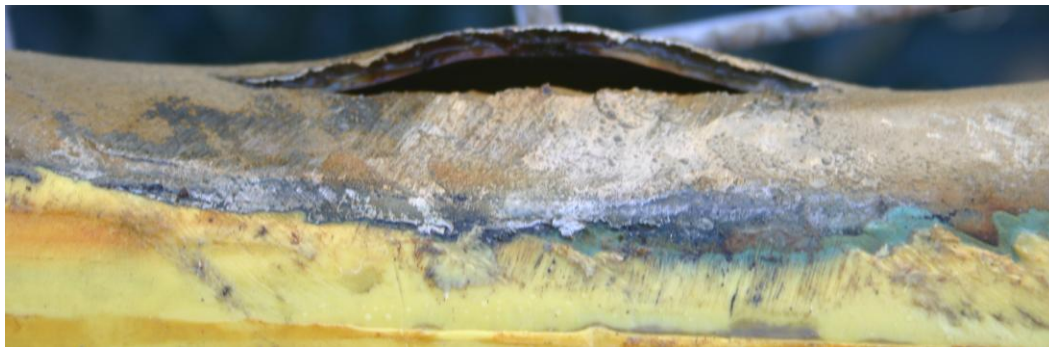
Figure 2 shows a side view of the failed methanol line pipe after it was removed when the line was repaired in January 2005. The pipe, no longer circular in cross section, was oval shaped due to the expansion of the pipe. This damaged the three layers of polymer on the pipe for corrosion protection. As the pipe line was galvanically protected electrically, calcareous deposits grew on the exposed surface. This was ground off by the robot during its initial examination of the extent of the damage, producing the shiny, scratched surface, which was claimed to have been caused by the Ocean America's mooring lines, and possibly the chain, running over the pipe. Figure 3 shows two plots revealing markedly different cross-sectional hardness profiles, indicating vastly different wire drawing practices. Similar differences were seen in the thicknesses and continuity of the galvanized zinc coatings.

Figure 2: Side view of the cracked methanol pipe (crack is ~4” long) after the surface was ground with a 4” diameter Weiler Power brush during the robot’s initial examination in December 2004.

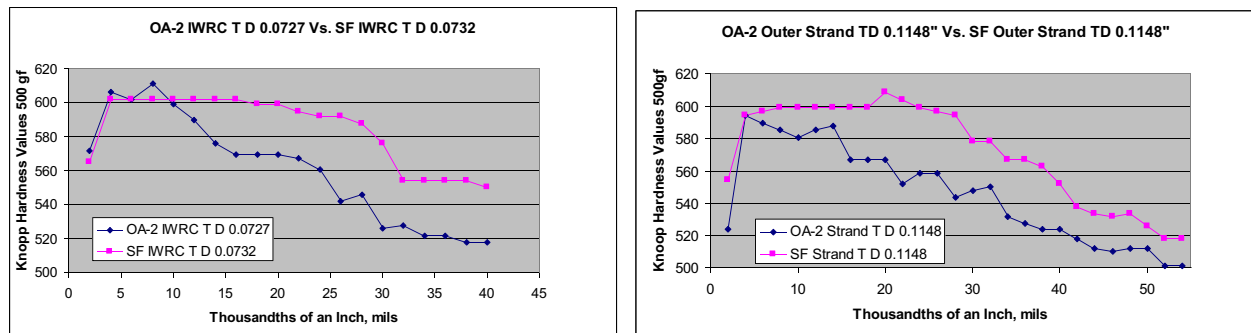
Figure 3: Two plots with markedly different wire cross-sectional hardness profiles that proved the mooring line found on the sea floor was not broken from the part still attached to the winches.
