HYDROGEN INDUCED CRACKING IN LINEPIPE STEELS

M.T. Shehata

**Materials Technology Laboratory/CANMET
Natural Resources Canada**

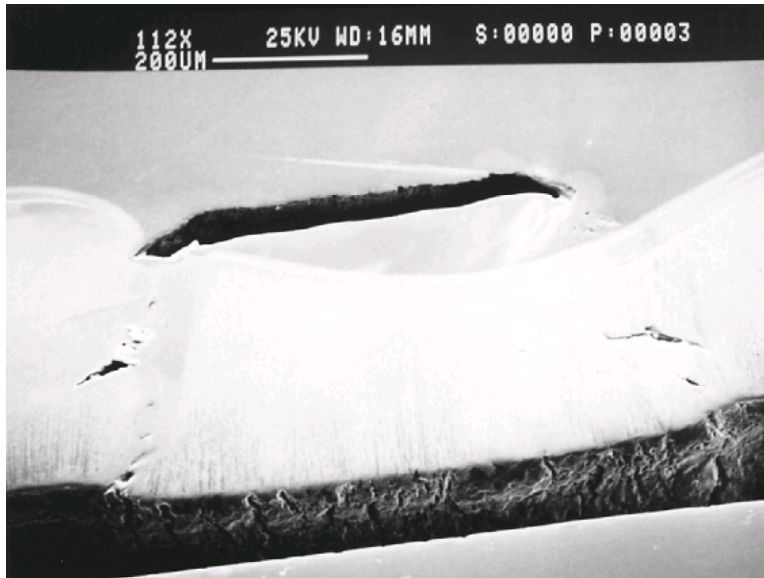
Line-pipe steels in sour service are susceptible to hydrogen induced cracking (HIC) which depends on both metallurgical and environmental factors (1). One of the important metallurgical factors is the presence of non-metallic inclusions in the line-pipe steel. Hydrogen atoms diffuse easily through the pipe wall and accumulate at internal micro-voids which have previously formed at the interface of non-metallic inclusions. Hydrogen induced cracks form as a result from the internal pressure of the accumulated molecular hydrogen. A typical example of such a crack is shown in figure 1. This particular crack is termed a blister crack since it appears as a blister on the outside surface of the pipe where the material is lifted by the hydrogen pressure.

Figure 1. SEM photomicrograph of a cross-section through the pipe wall showing a typical blister crack where the material is lifted by the pressure of hydrogen.

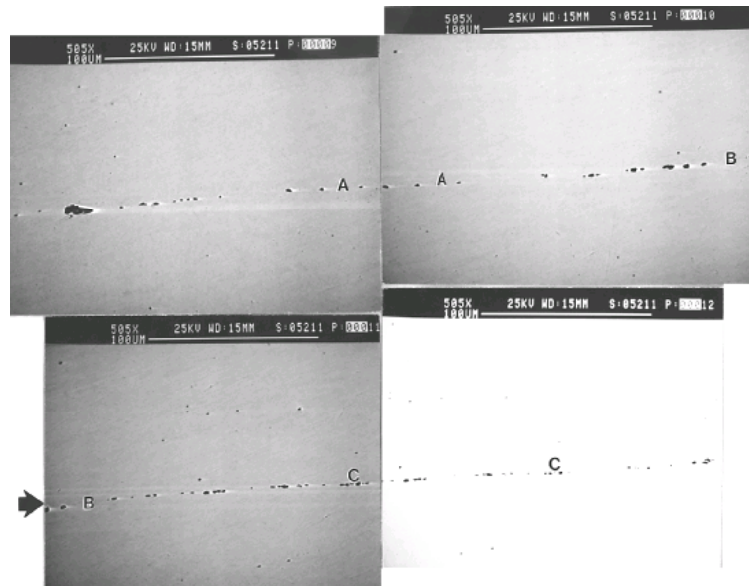
Planar arrays of fragmented inclusions were found to be connected to the formation of large HIC (1). Figure 2 shows a montage of SEM micro-graphs following a long string of fragmented inclusions on a polished metallographic section. In order to assess the relationship between HIC and non-metallic inclusions and in particular planar arrays of aligned inclusions, it was desired to obtain quantitative metallographic information for the inclusion population in a number of linepipe steels that were assessed for HIC. This was achieved by image analysis where two types of inclusion geometry were identified and measured separately, namely, long strings of fragmented inclusions and other dispersed inclusions. This is illustrated by the end map shown in figure 3. The end map is basically a low magnification assembly for the metallographic information observed at high magnification, which indicates the overall picture of the inclusion population through the wall thickness of the line-pipe steel. Excluding a band about 0.5 mm wide at the edge, the sample is covered by 12 microscopic fields through the wall thickness (6 mm) by 46 fields in the longitudinal direction (each field is 400x400 micrometers). It should be noted that the end map, shown in figure 3 provides the identification of susceptible area for hydrogen induced cracks on the sample as indicated by the solid lines indicating the presence of long strings of fragmented inclusions.

Figure 2. A montage of SEM photomicrographs showing a long string of fragmented inclusions on a polished metallographic section. Note the common areas A,B and C in the micrograph.

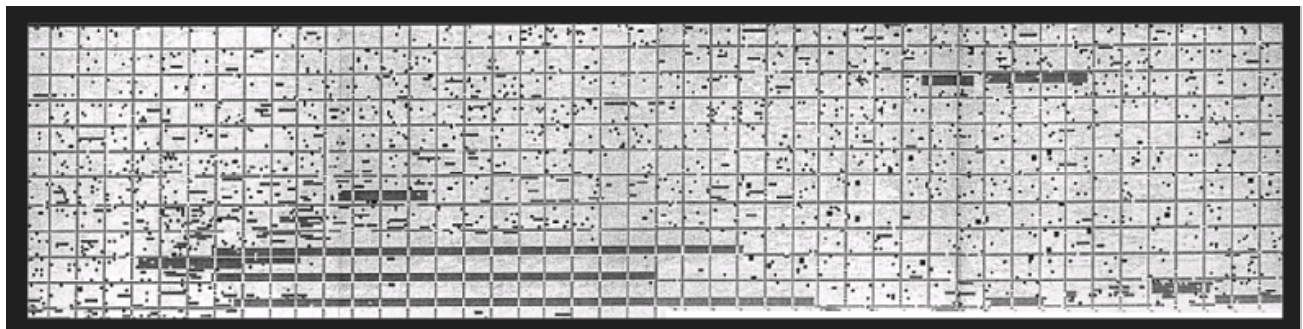
Figure 3. An End Map of 12x46 microscopic fields showing the overall picture of the metallographic examination through the wall thickness of 6 mm by image analysis. Long strings of fragmented inclusions are identified in the map by thick solid lines.
