# Microscopical Evaluation of Glass Delamination in Pharmaceutical Vials: A Look at Three Different Vial Manufacturers

Kristie Diebold

McCrone Associates

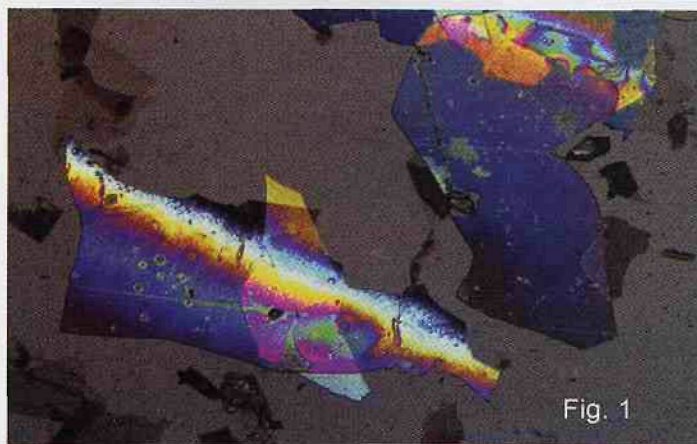
Fig. 1

As already suggested, glass delamination in pharmaceutical vials can occur during manufacturing of the vial, *e.g.* fusion at the neck or base, where delamination and/or pitting are frequently found; or by adverse reaction to the vial contents, *e.g.* etching due to an acidic or basic solution, or one with a high sodium/salt content. Solution-filled vials often show delamination at the fill line. The fill line is the top most point in the vial where the drug solution reaches. For analytical purposes, therefore, such suspect vials should be left filled for submission to the laboratory. From the standpoint of the microscopist this point must be emphasized. In the past we have been obliged to speculate a fill-line delamination in an empty vial based on previous experience with fill-line delamination problems. Filled vials are vastly preferred by analytical microscopists because such fill lines can be recorded, and, most importantly, the contents can be filtered under cleanroom conditions, in order to concentrate and study the glass delamination. Figure 1, for example, is a reflected-light photograph of delaminated glass recovered on a polycarbonate membrane filter; the brown colored flakes seen in the photo are thinner than those showing interference colors.

The findings from the study of the first set revealed pitting in vials from all three companies (pitting can be seen in the flakes in Figure 1). Company A's pitting was at the base of the vial; Company C's was at the base, and fine pitting was found at the neck of the vial; Company B's pitting was found throughout the vial. Delamination was definitely present in the vials from Company A and C; both delamination bands

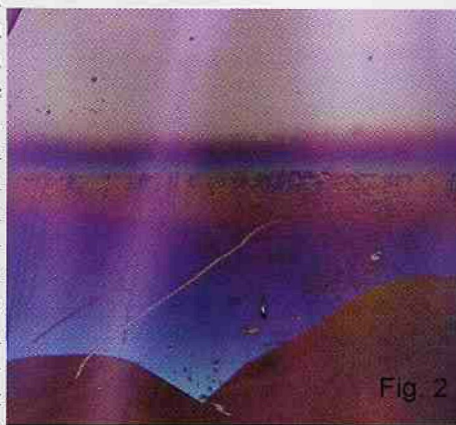
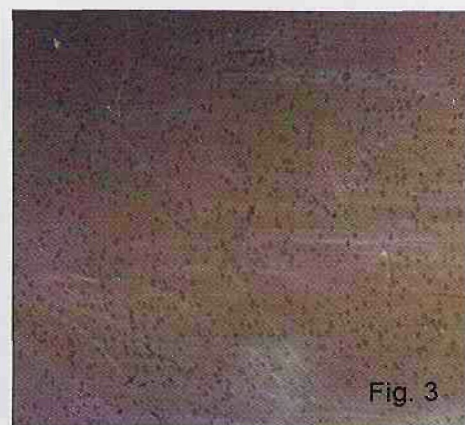
Fig. 2

Figures 2 and 3 show delamination and pitting for Company A's vials. There is a dark pink/brown residue below the delamination band; and there is pitting at the base of the vial that could be a thinner area of delamination. Scanning electron microscope (SEM) images show delamination (Figure 4) and pitting (Figure 5); a flake and a piece flaking off can be seen in Figure 4; pitting can be visualized going beneath the surface in Figure 5. The pink/brown residue seen in company A's vials was isolated for infrared spectrometry (IR), along with delamination flakes, to see if there was a similarity between them so as to be able to conclude whether or not the residue could be delamination. X-ray photoemission spectrometry (XPS) was also used to compare the delamination and residue. All IR spectra show the broad band at  $\sim 1100\text{cm}^{-1}$  which is characteristic of silica, suggesting glass. We can conclude from this information that the delamination and residue are similar.

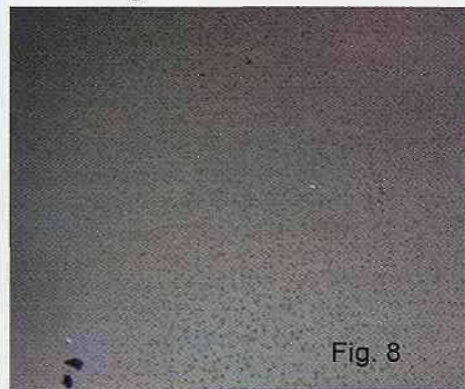
Fig. 8

in pitting at the base of the vial at all temperatures and finer pitting in the neck area, as seen in Figure 8. Delamination was found  $\sim 1/2$  inch from the top of the vial; this area is common to the fill line. The pinkish residue is seen, but only for the  $40^\circ\text{C}$  sample. Again, this residue is believed to be thin delamination.

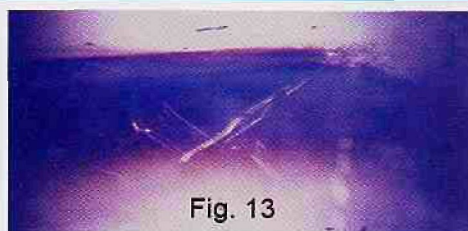
Fig. 13

that as temperature increases, delamination increases. The increase of delamination with an increase in temperature from Company A's vials is shown in Figures 13, 14, and 15. A thinner bluish color "delamination" is seen at 25°C (Figure 13). There are more colors seen at 30°C (Figure 14) and a blast of color at 40°C (Figure 15). Company C's vials had similar results with increasing temperature.

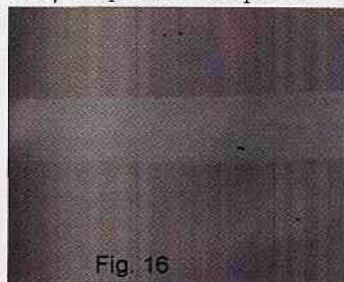
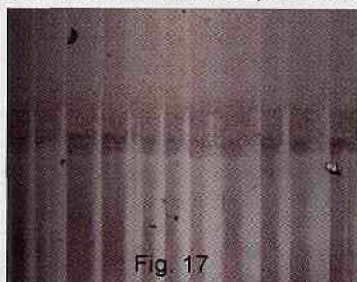
Fig. 16

Figures 16 and 17 show the striations and discoloration from Company B's vials; the eight week period shows more developed striations and discoloration than the four week period. Figure 16 shows an area with a clear space between the striations; it is possible this area was common to where the fill-line would be. X-ray photoemission spectrography (XPS) was used to analyze the surface of several pieces of each company's vials to determine delamination. Using XPS, one obtains a surface analysis of the outermost 1-5nm of a solid sample. An atomic percentage was measured for carbon, oxygen, silicon, aluminum, sodium, calcium, magnesium, nitrogen, and other trace elements (<0.5%) for each sample. Only vials of Company A and B were analyzed using this technique. The results show that many of these vials are delaminating.

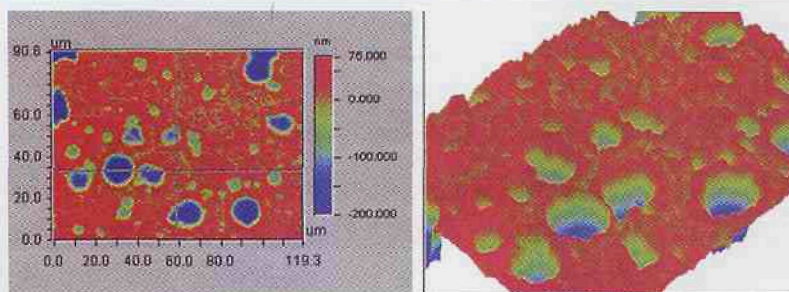
Can pitting be related to delamination? We have learned pitting occurs frequently and is common with delamination flakes. A vial not related to these studies, but of similar type, was sent out to a company that measures 3D surface texture. Their definition of surface texture measurement is derived from a measurement of the heights of the various image points. Pitting parameters and profiles were determined on the vial's base and center. The base area of the vial is shown in Figure 18. If the X and Y axes are visualized, they cross over certain pitting along the surface. The blue area is a larger pit that corresponds to ~100-200nm on the colored scale and in the horizontal profile, it can be determined that the pit depth is ~150nm. If the whole picture is looked at, the 3D image shows the blue areas spiking down from the surface. We can speculate that as these pits grow larger and/or appear in greater number, they can begin to form a flat surface resulting in the flaky appearance, which becomes glass delamination. Figure 19 shows measurements from the center of the provided vial; this seems to show

fine pitting. The data from these diagrams of surface texture measurements support a relation between pitting of a vial and glass delamination of a vial.
