Metallographic Observations of Delayed Hydride Cracking in Zr-2.5Nb

Z. Pan and A. Lockley

Materials and Mechanics Branch, Chalk River Laboratories, Atomic Energy of Canada Ltd.
Chalk River, Ontario, CANADA, K0J 1J0

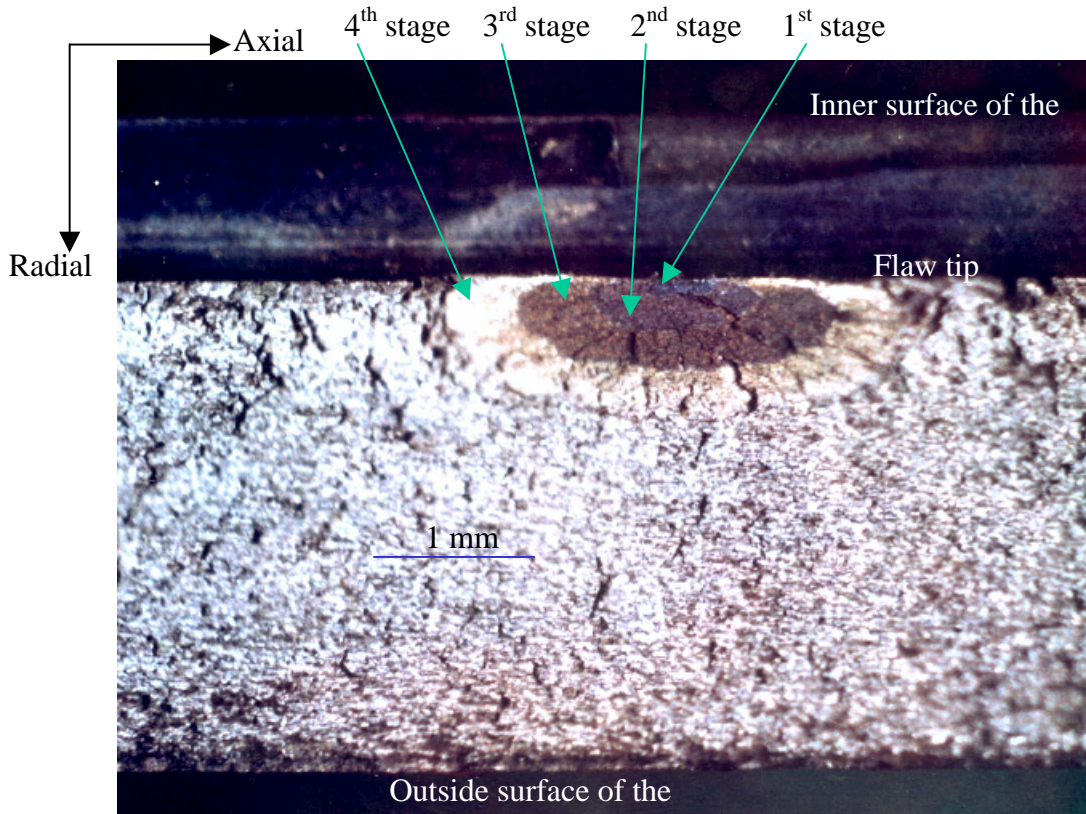
Figure 1 A typical DHC morphology on the broken-open surface. Four growth stages of the DHC from fifth to eighth thermal cycles can be clearly distinguished.

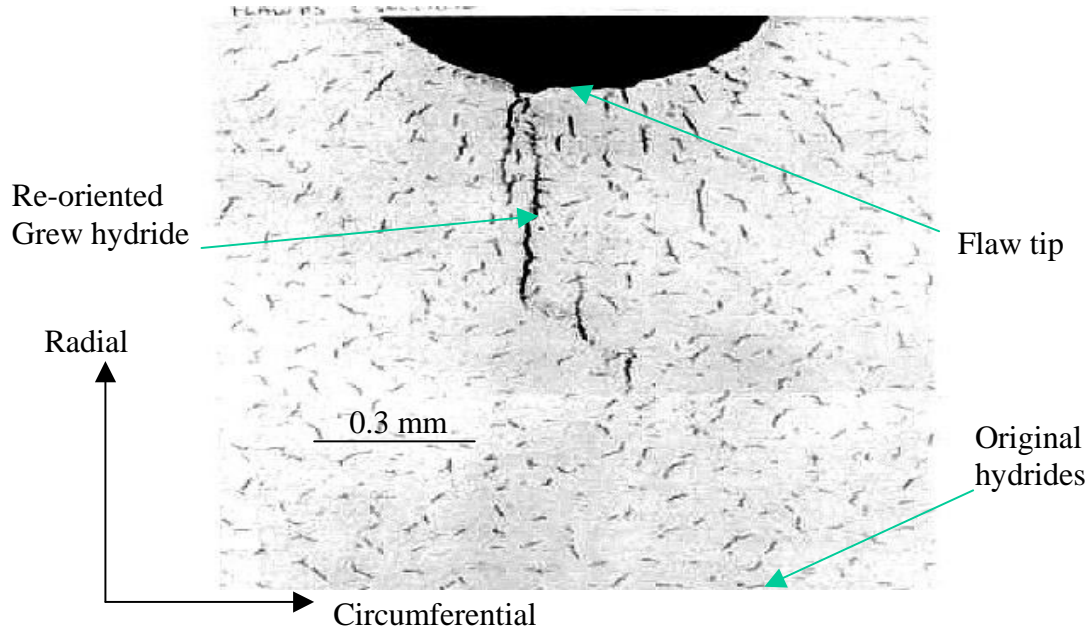
The evidence of the DHC initiation from hydrides at the flaw tip is found on the cross section of a simulated flaw, where the metallographic observation of hydride distribution around the flaw tip area indicates the presence of re-orientated, longer and denser hydride precipitates, Figure 2. The cross section surface was etched using a standard etching technique to expose the hydrides. Quantitative image analysis was used to determine the hydride reorientation degree and average length per unit area as a function of position on the cross sections. It was observed that both reorientation degree and length of hydride are the highest at the flaw tip while they are the lowest in the region remote from the flaw. Along the axial direction of the flaw, the hydride length and reorientation degree in the first cross section, close to the location of high residual stress, are apparently higher than that in other two cross sections far from this location. Measurements of hydrogen concentration, residual stress and mechanical properties in the failed tube section were conducted. It is shown that the observed hydride morphology and the DHC initiation in the pressure tube section during thermal cycling are dependent on the total hoop stress, hydrogen concentration and thermal cycling pattern.

Figure 2 Hydride reorientation and growth under the flaw tip on a cross section, located at the position of high residual stress and high concentration of hydrogen.
