Coupling Multi-Scale Mechanical Testing Techniques with FIB and TEM Characterization to Reveal Mechanisms of Embrittlement of High Dose Inconel X-750

CD Judge^{*1}, C Howard¹, V Bhakhri¹, C Dixon¹, C Mayhew¹ and S Hoendermis¹

¹ Canadian Nuclear Laboratories, Research and Development, Chalk River, Ontario, Canada.

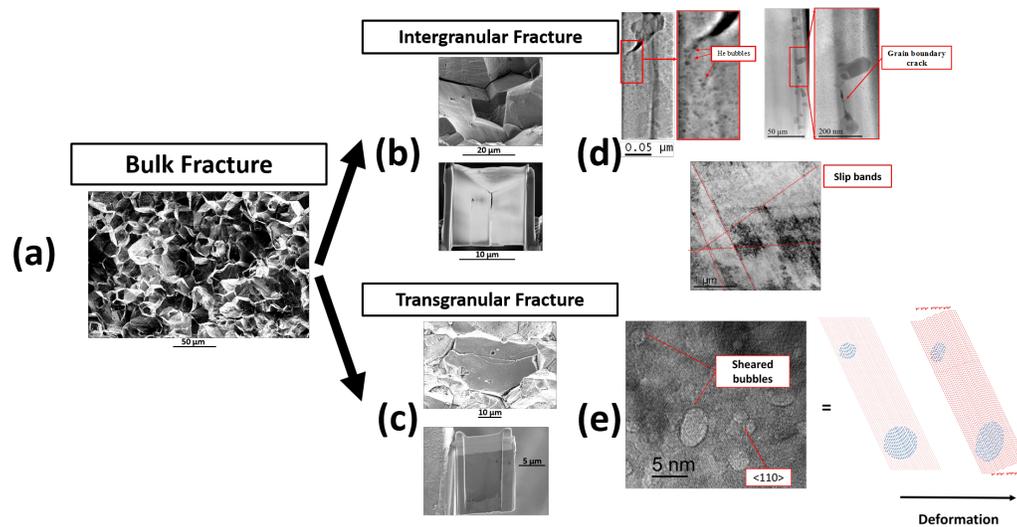
In this study, advanced microscopy techniques are used to investigate bulk mechanical testing and small scale testing of heavily irradiated Inconel X-750 to elucidate the mechanisms of embrittlement and fracture. When subjected to a high thermal flux, the naturally occurring Ni-58 in X-750 undergoes transmutation reactions, (n, α), (n,p) and (n, γ), which results in an enhancement of the total atomic displacement damage (dpa), and the production of high concentrations of Helium and Hydrogen [1]. Material in this investigation has been irradiated up to 84 dpa and 26000 appm Helium. Bulk component testing has shown that the material has lost strength and ductility following irradiation, and that the fracture surfaces are brittle, mixed mode, which are predominantly intergranular, with evidence of transgranular facets (**Figure 1 a**) [2, 3]. In-situ, small scale mechanical testing has been performed in attempt to assess the grain boundary strength [2, 4]; however, the grain boundaries were found to be inherently stronger than the bulk material [2, 4], and the easiest fracture path occurs exclusively along flow localization pathways (i.e., shear bands) consistent with the transgranular facets observed in the bulk fracture surfaces in **Figure 1 a**.

The intergranular fracture is a direct result of accumulated helium bubbles aligned along grain boundaries, and carbide-matrix interfaces (**Figure 1 d**). In addition to observing the interlinking of helium bubbles and resulting crack propagation at the crack tip, independent bubble coalescence and fracture ahead of the crack tip was observed. Along the entire fracture surface and secondary cracks, shear bands in the grain interior were found intersecting the grain boundary. It is important to note that no such shear bands are observed in as irradiated, non-deformed material. This deformation seems to be a predecessor to cracking. It is hypothesized that the intersection of these slip bands with the compromised grain boundary decorated with M₂₃C₆ carbides and grain boundary helium bubbles, resulted in a stress concentration, and assisted in the crack propagation.

The transgranular fracture seems to follow shear bands within the grain interior. **Figure 1 e** shows a high resolution TEM micrograph imaged close to the (111) zone axis. The image provides direct evidence of the mechanism of bubble elongation following subsequent deformation within the grain interior. Although not observed from these TEM specimens, it can be hypothesized that elongated helium bubbles may eventually shear to the point of coalescing to form large bubble ligaments, and ultimately result in the transgranular facets observed in the bulk fracture surfaces as has already been seen in the TEM examinations of small-scale mechanical test specimens [2]. What remains unknown, is

Figure 1. Examination of (a) bulk mechanical testing fracture surface, (b) FIB lift-out of an intergranular fracture surface, (c) FIB lift-out of a transgranular fracture surface, (d) TEM evidence of grain boundary helium bubble embrittlement, and shear band formation following subsequent deformation, (e) evidence of dislocation shearing of helium bubbles.

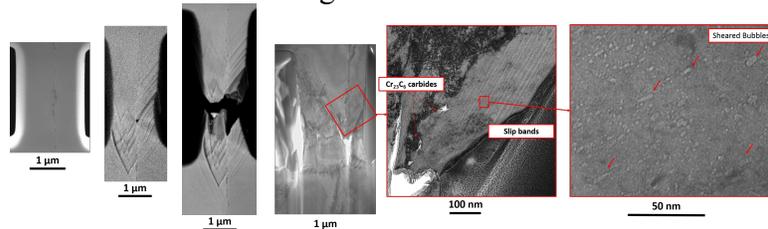
the interaction between these flow localizations and the embrittled boundaries decorated with helium bubbles (i.e., the synergies of the two mechanisms). To answer this question, a small scale test specimen with a vertical boundary along the gage length has been tested (**Figure 2**). This style of test forces the shear bands to hit the boundary such that the interaction can be examined with subsequent microscopy. Transmission electron microscopy (TEM) of the deformed micro-tensile specimens has confirmed both the fracture along discrete shear bands within the bulk material, and the nucleation of cracking at the shear band and grain boundary carbides. As expected, more extensive strain localization was observed in the small scale test specimens (**Figure 2**) compared to the bulk material (**Figure 1 e**) with more significant bubble elongation; however, the observations remain consistent.

Figure 2. Small scale mechanical testing of X-750 with a vertical boundary, and subsequent TEM examination after deformation and fracture.
