Improper Materials Selection in Motorcycle Stud Bolt

F.E. Schmidt¹, M.A. Hineman¹, B.F. Schmidt²

During the investigation of a motorcycle accident, it was noted that a bolt had fractured that was part of the rear wheel suspension. The shoulder bolt was located underneath the main frame of the two passenger vehicle. The left rear shoulder bolt broke causing the motorcycle to become unstable. Others were evaluating the dynamics of the incident. We were asked to determine the nature of the bolt failure, whether the bolt was appropriate for the attachment of the air suspension system to the motorcycle, and if the bolt was fit for use.

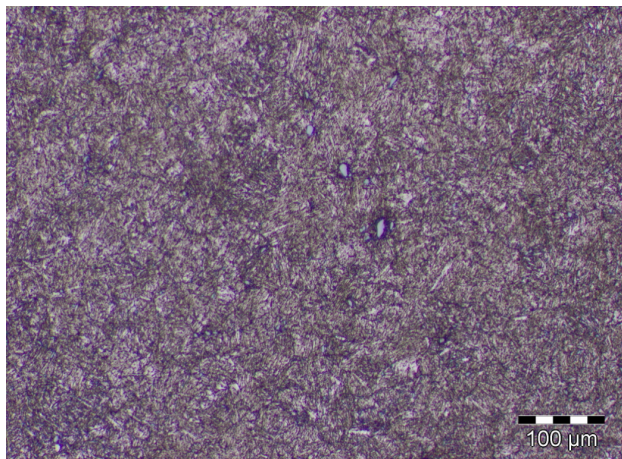
1. The shoulder bolt was fabricated from a resulfurized steel that conforms to an AISI (American Iron and Steel Institute) 1137 grade as seen in Table 1. Generally, this steel is used to fabricate “screw machine parts” where machinability is the primary concern. Its microstructure consisted of manganese sulfide particles in a matrix of tempered martensite.

4. Metallographic examination and hardness testing, presented in Table 2, revealed the shoulder bolt was heat treated using a classic quench and temper treatment as seen in Figure 1. It is likely that a quench crack at the root of one or more threads was responsible for crack initiation and progression as seen in Figure 2.

Figure 1. Typical example of microstructure of fractured bolt.

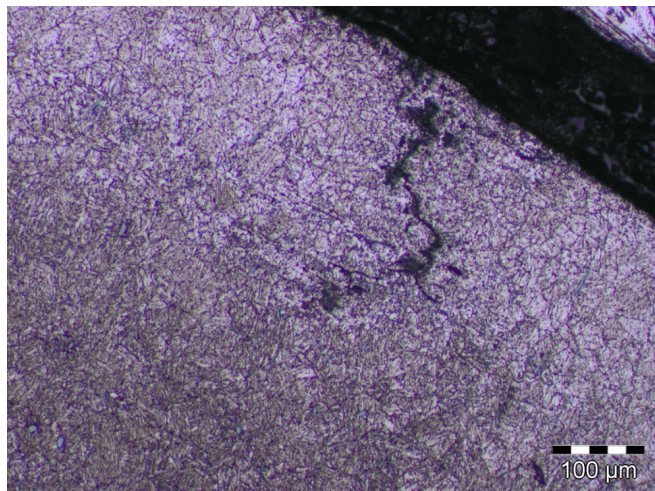
3. The shoulder bolt failed by the growth of several “notches” in the perimeter of the thread root by a progressive “fatigue” failure mechanism as observed during SEM examination.

Figure 2. Example of secondary crack near outside of bolt.

5. Prior to production, an engineering analysis and testing should have been performed on the connecting fasteners between the frame swing arm and suspension components in order to justify use of an ungraded bolt.

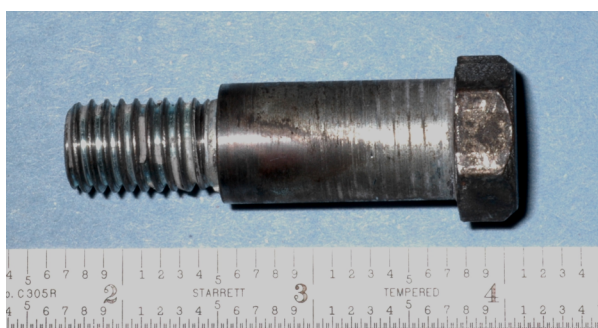
Figure 3. Example of an unfractured bolt.

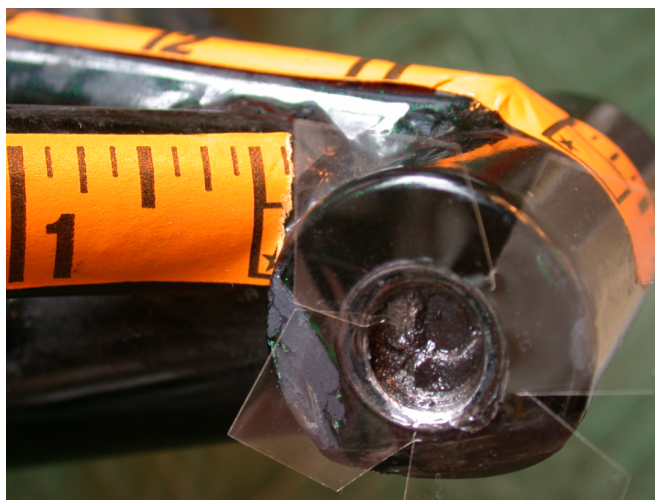
Some of the work performed included: 1) directed X-Ray Radiography testing, 2) prepared ASTM E –1351 Acetate Tape Replica Nondestructive impressions as shown in Figure 4; and 3) performed an engineering analysis of all evidence, materials received and testing.

Figure 4. Replication of the bolt fractured surface.
