Importance of SEM in the Study of Fractography, Camshaft Failure

González-Mancera G.¹ and González-González D. E.¹

¹ Universidad Nacional Autónoma de México, Facultad de Química. Departamento de Ing. Metalúrgica, Ciudad Universitaria, D. F. México.

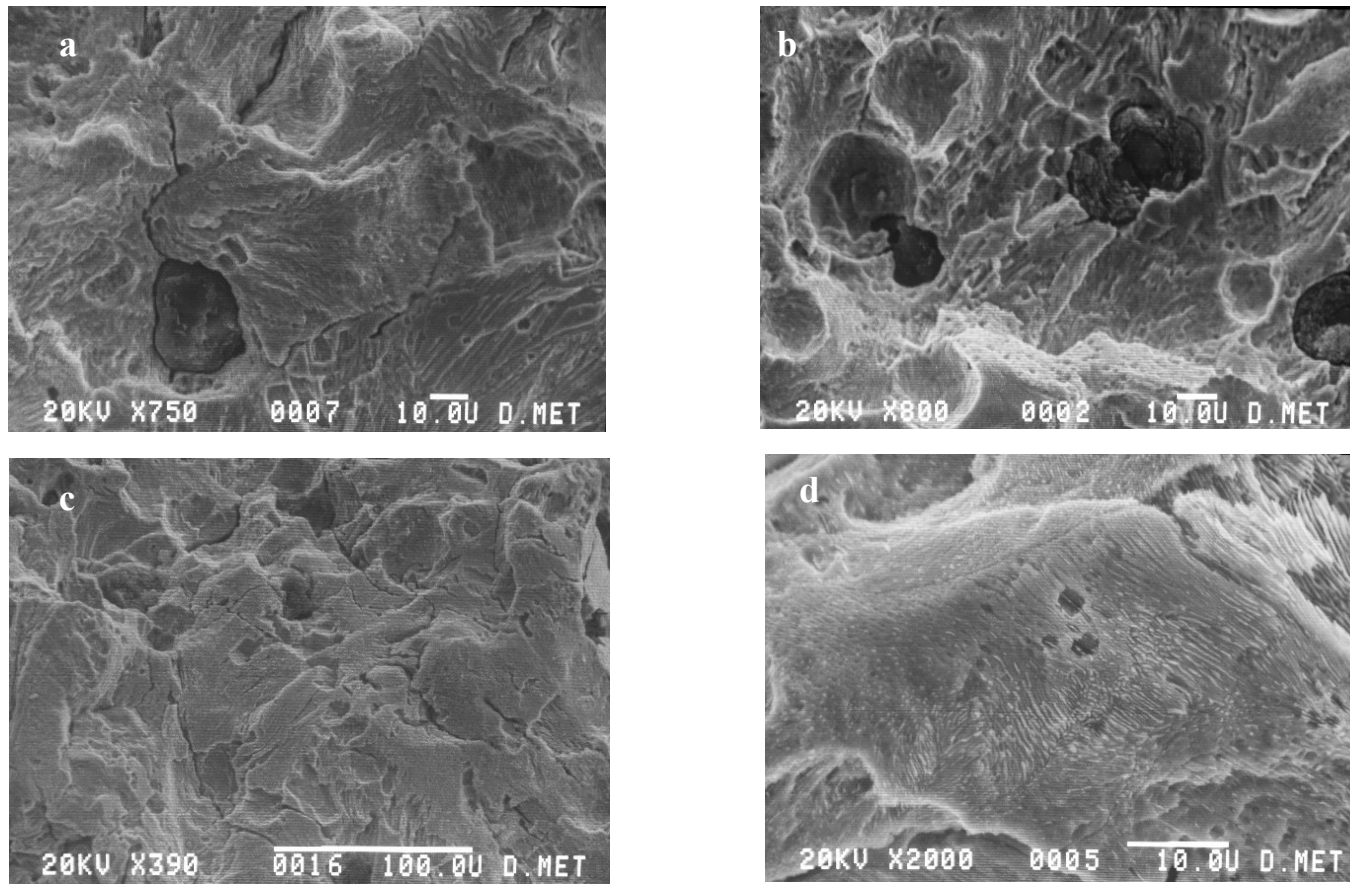
The current work examines the fracture of a camshaft using fractography. The sample was cleaned with water-based, organic solvent and acetic acid in ultrasonic baths to eliminate possible contamination and atmospheric oxidation. After the sample was analyzed by Scanning Electron Microscopy (SEM) observation, it shown this material is a nodular cast iron. At low magnification the characteristic fracture pattern indicates a torsion stress failure [1, 2]. It was observed v-shaped cracks known as Chevron marks and they converge in the fracture initial zone. The initial crack grows due to stress concentration known as fatigue. Those marks are parallel to each other and perpendicular to the propagation direction (Figure 1a), called beach or clamshell marks. Also, there were Ratchet and River marks in the fracture surface and inside respectively, showing a fast-growing crack propagation (Figure 1a). The fracture surface was a combination of initial crack zones surrounded by a fatigue propagation area and a final ductile zone with plastic deformation (Figure 1b). There was no evidence of creep deformation or corrosion. The fracture initial zone was brittle involving cleavage looking cracks, indicating transgranular fractures with bright flat surfaces (Figure 1c). The fatigue zone presented small parallel marks called striations that are a clear evidence of trans granular fatigue propagation (Figure 1d). In conclusion the cast iron material is fragile due nodular structure of carbon, it presents brittleness and rapid fatigue crack propagation, besides nodular carbon generates river marks that speed up the material failure.

Figure 1. Micrographs of SEM of Camshaft failure. (a) It shows crack propagation from nodular carbon. (b) It reveals fatigue propagation in a ductile zone. (c) It presents the brightness zone where origin the fracture. (d) It shows the striation characteristic of transgranular fracture.
