## Effects of Evactron® Plasma Cleaning on X-ray Detector Windows

E. A. Kenik\*, H. M. Meyer\*, R. Vane\*\* and V. Carlino\*\*

\*Oak Ridge National Laboratory, Metals and Ceramics Division, Oak Ridge, TN, 37831, USA

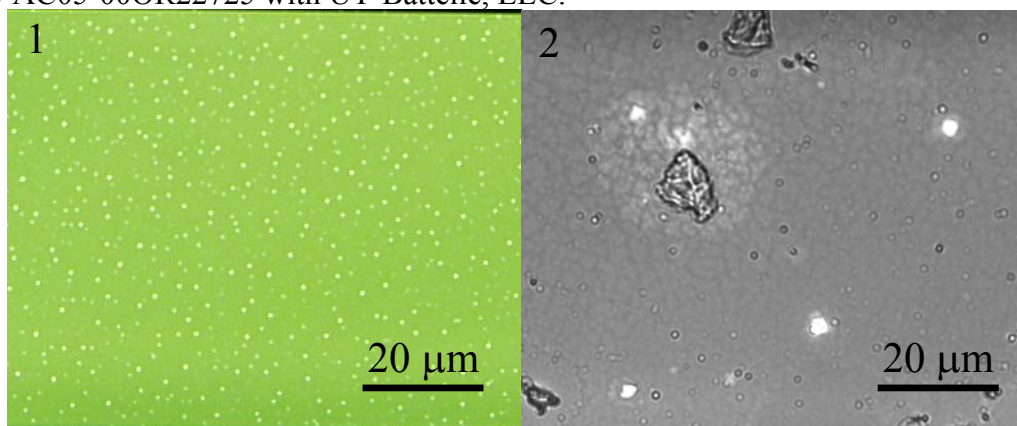
Figure 1 is a transmitted light image of a window exposed to the Evactron plasma for 30 hours. The light transmitted through the window is actually green, presumably the result of absorption by one of the window's layers. Unexposed windows do not exhibit the localized light leaks apparent in Fig. 1. Although there are a number of pinholes present, there was no significant increase in either their size or number density with additional exposures of 40, 30, 27 and 33 hours for a total exposure of 160 hours. It has been speculated that oxygen radical corrosion of the grain boundaries of the Al film is the origin of this degradation. Unfortunately, this window was damaged in shipment and microstructural examination was not possible. A second window was exposed for 160 hours in multiple exposures of about 20 hours each and a single, larger (~80 μm) pinhole formed. SEM examination of the pinhole revealed an impurity particle containing Si, Cl and K embedded in the window at the pinhole, indicating that this pinhole had resulted from particle impact. A third window was exposed to plasma cleaning for 60, 24, 62 and 14 hours. Figure 2 is a black-and-white transmitted light image of that window after a total of 160 hours exposure. Unfortunately, that window was contaminated with foreign particles between the plasma cleanings and the SEM examination. There is a difference in the number and size of the pinholes for these three windows (e.g., Figs. 1 and 2). However, it is not clear from the limited data whether those differences arise from differences in plasma cleaning or in the condition of the windows before exposure.

Fig.1. Transmitted light image of first Moxtek AP3.3 window exposed to plasma for 30 hours.

Fig.2. Transmitted light image of third Moxtek AP3.3 window exposed to plasma for 160 hours.

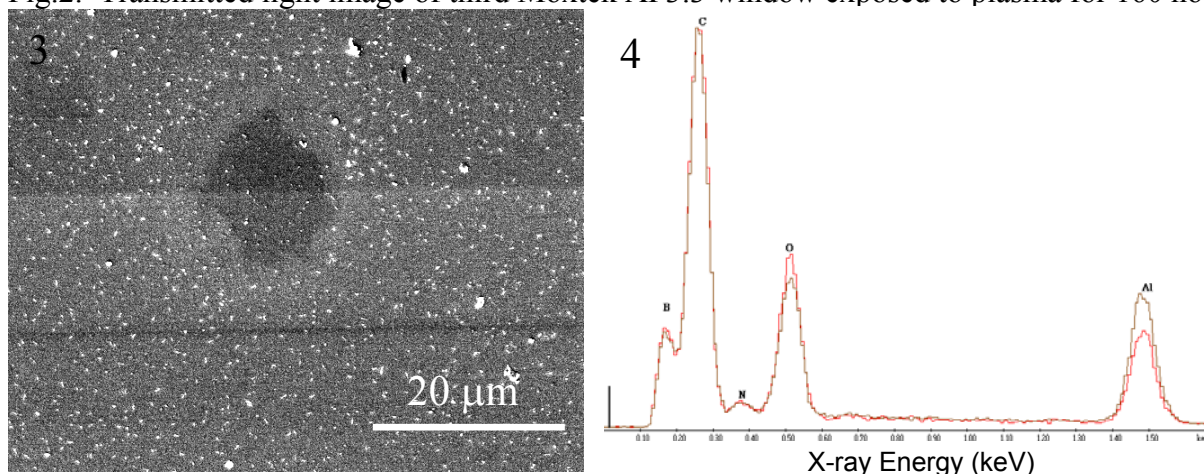
Imaging the pinholes in the SEM proved problematic: the thin (~30 nm) Al layer on the much thicker polymer film has a significant external oxide layer. Localized differences in the depth of oxidation do not provide significant secondary electron (SE) contrast. It was hoped that backscattered electron (BSE) imaging at low voltages (1-2 kV) would provide adequate contrast. However, as a result of the low probe currents (~0.3 nA) used to minimize damage to the window, the efficiency of the BSE detector at those low voltages and currents limited useable contrast. Although the contrast mechanism is not clear, it was found that secondary electron imaging at 2-3 kV and maximum contrast provided useable images (Figure 3). The pinhole was located by comparisons of both transmitted and reflected light images with the SEM images. The pinhole is significantly larger (~15 μm) than the grain size of the aluminum layer, which was estimated as ~30 nm from the granular structure of the Al surface at high magnifications.

Low voltage EDS microanalysis of the pinhole and the surrounding film showed increased oxygen relative to aluminum in the pinhole. The relative difference varied from pinhole to pinhole. Spectra

that show a significant increase are given in Figure 4. The O/Al intensity ratio for the pinhole was 1.31 at 3 kV, whereas the ratio for the film was 0.85. For comparison, the intensity ratio for an aluminum specimen with a native oxide was 0.254 at 3 kV, whereas the ratio for pure  $\text{Al}_2\text{O}_3$  was 2.69. There is a significantly thicker oxide layer on the window relative to the Al specimen and the oxide is thicker in the pinhole [3]. Auger elemental mapping and depth profiling of a pinhole have been used to further characterize the three-dimensional elemental distribution.

Fig.3. SE image of pinhole in third Moxtek AP3.3 window exposed to plasma for 160 hours.

Fig.4. Comparison of EDS spectra from pinhole (red) and adjacent film (brown) acquired at 3 kV in raster mode.
