Effects of Evactron® Plasma Cleaning on X-ray Detector Windows

E. A. Kenik*, H. M. Meyer*, R. Vane** and V. Carlino**

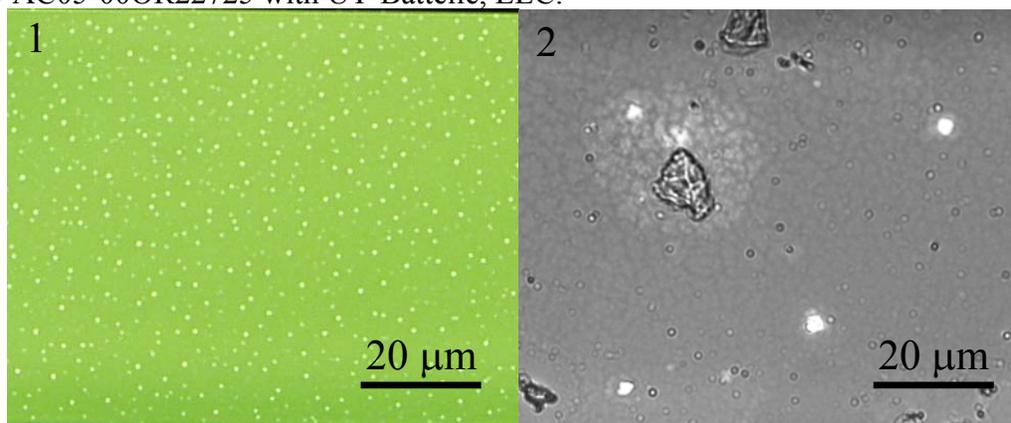
Figure 1 is a transmitted light image of a window exposed to the Evactron plasma for 30 hours. The light transmitted through the window is actually green, presumably the result of absorption by one of the window's layers. Unexposed windows do not exhibit the localized light leaks apparent in Fig. 1. Although there are a number of pinholes present, there was no significant increase in either their size or number density with additional exposures of 40, 30, 27 and 33 hours for a total exposure of 160 hours. It has been speculated that oxygen radical corrosion of the grain boundaries of the Al film is the origin of this degradation. Unfortunately, this window was damaged in shipment and microstructural examination was not possible. A second window was exposed for 160 hours in multiple exposures of about 20 hours each and a single, larger (~80 µm) pinhole formed. SEM examination of the pinhole revealed an impurity particle containing Si, Cl and K embedded in the window at the pinhole, indicating that this pinhole had resulted from particle impact. A third window was exposed to plasma cleaning for 60, 24, 62 and 14 hours. Figure 2 is a black-and-white transmitted light image of that window after a total of 160 hours exposure. Unfortunately, that window was contaminated with foreign particles between the plasma cleanings and the SEM examination. There is a difference in the number and size of the pinholes for these three windows (e.g., Figs. 1 and 2). However, it is not clear from the limited data whether those differences arise from differences in plasma cleaning or in the condition of the windows before exposure.

Fig.1. Transmitted light image of first Moxtek AP3.3 window exposed to plasma for 30 hours.

Fig.2. Transmitted light image of third Moxtek AP3.3 window exposed to plasma for 160 hours.

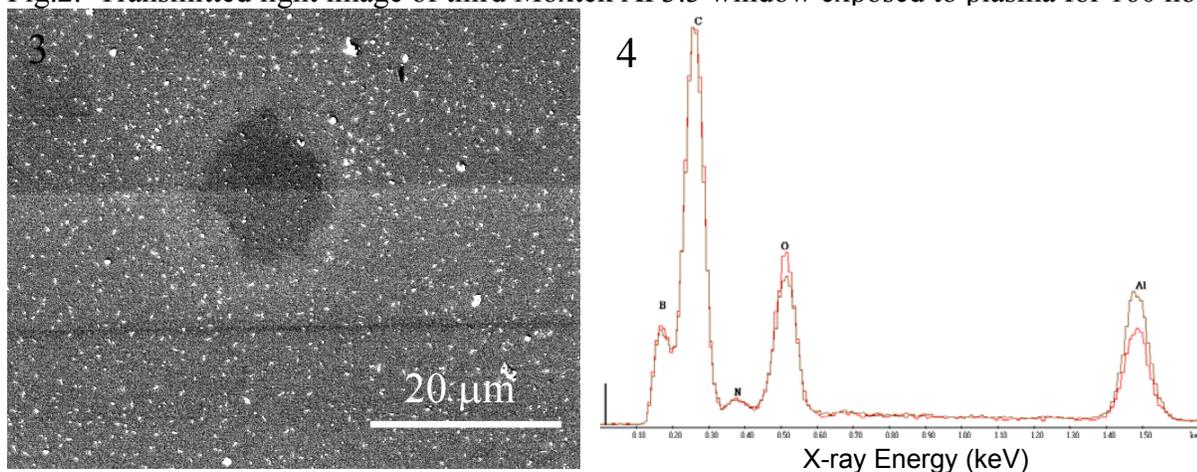
Imaging the pinholes in the SEM proved problematic: the thin (~30 nm) Al layer on the much thicker polymer film has a significant external oxide layer. Localized differences in the depth of oxidation do not provide significant secondary electron (SE) contrast. It was hoped that backscattered electron (BSE) imaging at low voltages (1-2 kV) would provide adequate contrast. However, as a result of the low probe currents (~0.3 nA) used to minimize damage to the window, the efficiency of the BSE detector at those low voltages and currents limited useable contrast. Although the contrast mechanism is not clear, it was found that secondary electron imaging at 2-3 kV and maximum contrast provided useable images (Figure 3). The pinhole was located by comparisons of both transmitted and reflected light images with the SEM images. The pinhole is significantly larger (~15 µm) than the grain size of the aluminum layer, which was estimated as ~30 nm from the granular structure of the Al surface at high magnifications.

that show a significant increase are given in Figure 4. The O/Al intensity ratio for the pinhole was 1.31 at 3 kV, whereas the ratio for the film was 0.85. For comparison, the intensity ratio for an aluminum specimen with a native oxide was 0.254 at 3 kV, whereas the ratio for pure Al_2O_3 was 2.69. There is a significantly thicker oxide layer on the window relative to the Al specimen and the oxide is thicker in the pinhole [3]. Auger elemental mapping and depth profiling of a pinhole have been used to further characterize the three-dimensional elemental distribution.

Fig.3. SE image of pinhole in third Moxtek AP3.3 window exposed to plasma for 160 hours.

Fig.4. Comparison of EDS spectra from pinhole (red) and adjacent film (brown) acquired at 3 kV in raster mode.
