The Case of the Overcooked Solder: Failure Analysis of AuSn Solder Die Attach using Optical and Electron Microscopy and EDS

T. J. Barbieri* and B. W. Condie**

*Arizona Product Analysis Lab, Freescale Semiconductor, Inc., 2100 E Elliot Rd, MD: EL315, Tempe, AZ, 85284

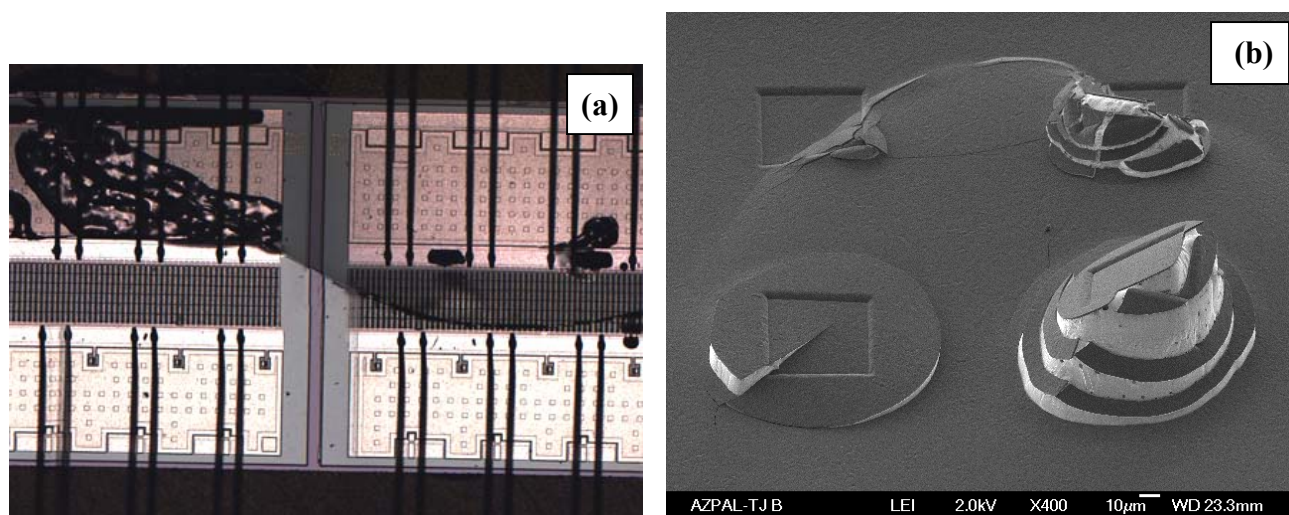
An internal research team was conducting accelerated robustness experiments on a power CMOS design. The experimental die (<5 mils thick) needed to be mounted in a carrier package for testing. For lack of a better option, the die were mounted on a CuW header in a ceramic-lidded package using Au-20wt%Sn eutectic solder at a reflow temperature of 320°C. The parts were baked for 16 hours at 200°C, followed by functional testing, which all parts passed. The same procedure was repeated at 50° increments until the parts failed (note that typical reliability tests occur at a maximum temperature between 150°C and 200°C). Catastrophic failure occurred after baking for 16 hrs at 300°C. Multiple fractures were observed in each die, along with metal blisters, and the die appeared to be folded upwards. The parts were submitted to the Failure Analysis (FA) lab in order to determine: a) the cause for failure, and b) to confirm if the source of the blistered surface metal was related to the large fields of aluminum metal used in the circuitry, indicating that the failures occurred during electrical testing.

A review of the binary phase diagram for the Au-Sn system revealed the root cause for failure. The melting temperature for eutectic AuSn solder is approximately 275°C [1]. Historically, reflow temperatures for conventional PbSn solders have typically been 15-20° above the melting temperature, but reflow time has been limited to under a few minutes because of the rapid dissolution of surface metals by the liquid solder [2,3]. By taking these parts with AuSn die-attach to 300°C and making the mistake of holding them there for 16hrs, the AuSn solder was given extensive time to melt, reflow, and interact greatly with the surrounding materials. The positive aspect of this conclusion was that failure was not related to the die, but due to an incorrect choice of test bed combined with excessive test parameters.

Figure 1: Excessive physical damage observed on the failed die: (a) Optical image of die cracking and metal blistering, (b) SEI image of AuSn eruptions.

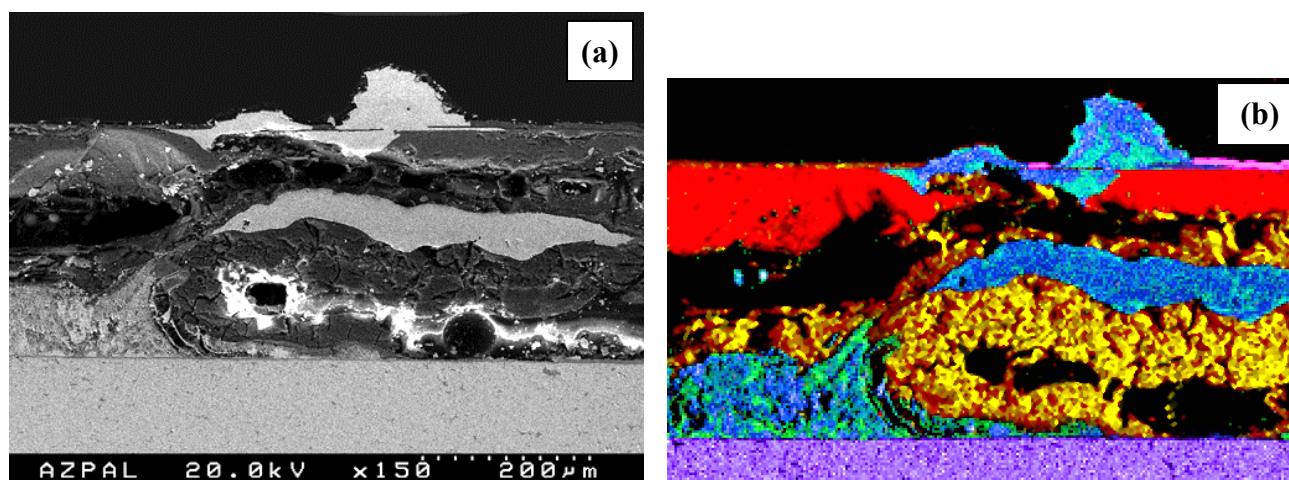
Spectroscopy. EDS analysis of the surface confirmed that all of the reflowed metal responsible for the damage came from the AuSn die-attach, and excess AuSn located away from the die contained large amounts of Si. A cross-section was prepared through one of the AuSn eruption sites. Through the use of SEM imaging and EDS mapping of this cross-section, a series of events that had generated the violent chemical-mechanical damage was formulated.

Figure 2: Analysis of an AuSn cross-section: SEI image of the cross-section, (b) EDS map of the cross-section (blue=Au, green=Sn, red=Si, yellow=O, purple=W, pink=Al). Note the varying, chewed appearance of the Si die, the large field of SiO₂, and the 3 islands of AuSn: one adjacent to the substrate, one embedded in the SiO₂ field, and one bursting through the top of the Si die.
