Role of Metallography in a Failure Investigation

D.A. Turnquist*, M.E. Stevenson**

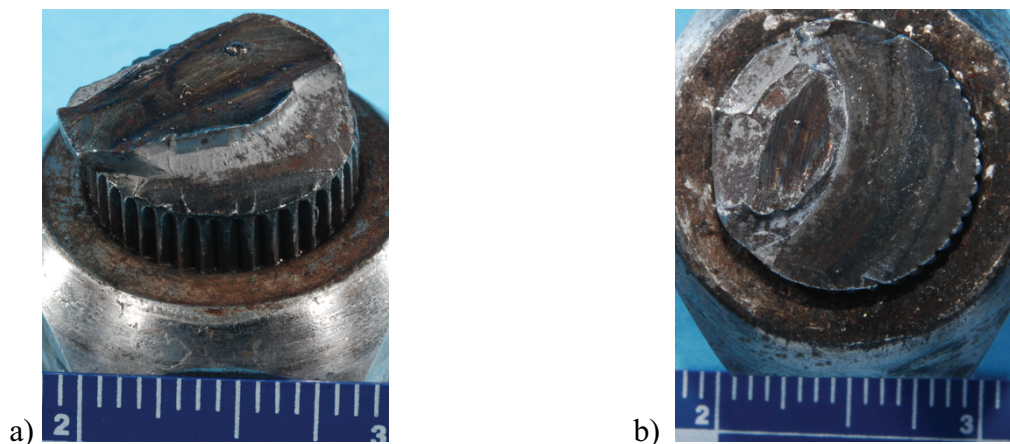
When performing failure investigations, the initial appearance of bulk, physical evidence can dictate the ensuing steps undertaken in laboratory analysis. In this case study, macroscopic and microscopic examinations of two wheel bolts, shown in Figure 1, clearly indicated that the mode of failure was fatigue. Often, a significant amount of time is spent looking at the fracture surfaces under a stereomicroscope or in a scanning electron microscope in an attempt to determine the cause, while many more fundamental techniques are ignored. In this investigation, metallography played a key role in determining the root cause of failure.

FIG. 1. Photographs showing the heads of two fractured wheel bolts. Beach marks and other indications of fatigue are present on each fracture surface.

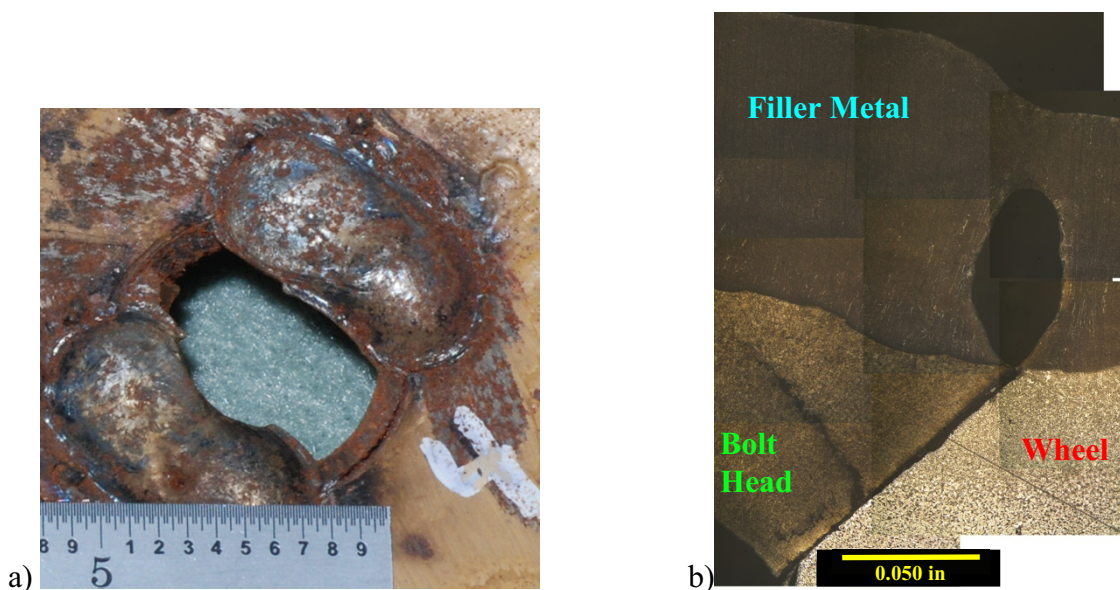
After determining that the mode of fracture was fatigue, determination of the source of cyclic loading for the fasteners became the primary focus of the investigation. During examination of the mating fracture surfaces, it was noted that welds were present, fusing the bolt heads to the wheel, Figure 2a. The apparent purpose of the welds was to fix the heads and prevent them from rotating. Based on the physical evidence an investigator could be tempted to state that the welds were the cause of failure without any further analysis. But the question was, is that really the case?

FIG. 2: a) representative photograph showing a weld that was made over the head of one fractured wheel bolt. Welds were placed over three of the bolt heads; b) A macroscopic view of a wheel bolt and weld cross-section shows a poor weld and multiple fractures.

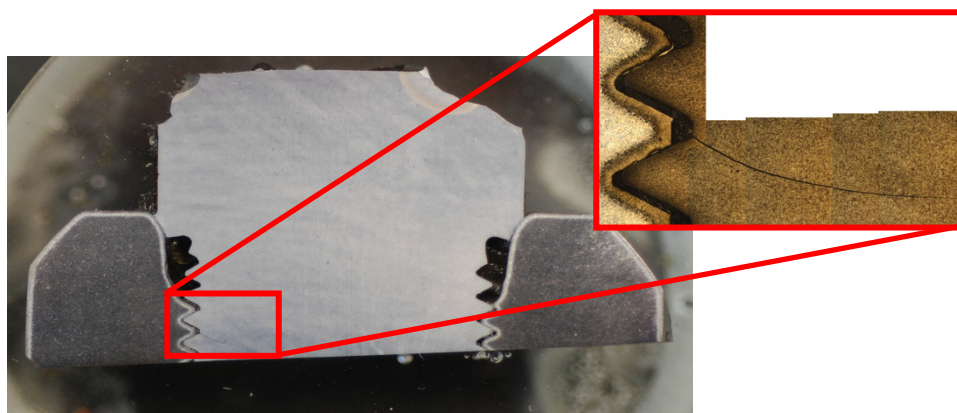
Technical literature supports that maintaining proper joint stiffness and preload is required to minimize the likelihood of fatigue failure.[1,2] While welding the heads of the bolts could have an embrittling effect, it does not necessarily explain how fatigue cracks could initiate. The bolts were sectioned and metallography was performed. Due to the amount of insight that can be gained, metallography should be carefully considered as a tool in most metallurgical failure investigations.[3] Examination of the cross-sections showed that the welds were of poor quality and multiple fractures existed, some of which were outside the heat-affected zone (HAZ), Figure 2b. Examination of a section taken from a bolt/nut combination showed that cracks were present in the bolt at a significant distance from the HAZ. The position of the crack on the loaded side of the bolt thread would be consistent with the fastener being over-torqued, not the weld.

While the failure mode was fatigue, metallography showed that the root cause of failure was over-torquing of the fastener, resulting in crack formation of cracks, leading to the loss of joint pre-load, resulting in cyclic loads being applied to the bolt, leading to fatigue fractures; the welds on the bolt heads played no role in the cause of failure

FIG 3. Metallography revealed another crack located at the second thread of engagement.
