Scanning Electron Microscope, an Essential Equipment for Failure Analysis

Michael Panzenböck¹

¹ Department of Physical Metallurgy and Materials Testing, Montanuniversität Leoben, Austria

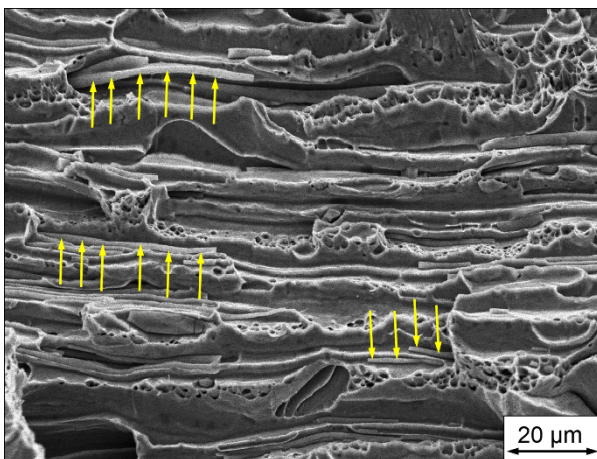
Fig. 1 shows a picture of a ductile fracture. The formation and the orientation of the dimples give information of the material condition and loading direction. In this case a valve made of a machinable steel failed. Within the dimples -elongated in the longitudinal direction- MnS are visible (see yellow arrows) [1]. The same steel reveals a transgranular brittle fracture (Fig. 2) due to high strain rates caused by an explosion [1]. Steels reveal brittle intergranular fracture, too (Fig. 3). Such a phenomenon can be caused by precipitations at grain boundaries, intergranular corrosion or due to hydrogen in high strength steels [2]. A faceted fracture surface is visible due to stress corrosion cracking [3] or such features can be identified within the first stage of fatigue at austenitic stainless steels (Fig. 4). Another important feature is the presence of dendrites (Fig. 5), which reveals inadequate solidification of the material during casting or welding. The evidence of striations proves the damage due to fatigue (Fig. 6). Finally, a damage due to cyclic loading is caused by crack initiation. Sometimes the triggering event for crack initiation is a non-metallic inclusion (Fig. 7a), which can be identified with EDX (energy disperse x-ray) and BSE (Fig. 7b). In this case the non-metallic inclusion appears dark. Other examples will be given during the talk.

Figure 1. Typical ductile fracture of a machinable steel (11MnS5), which contains a high amount of MnS elongated in longitudinal direction (indicated by yellow arrows). Therefore elongated dimples are visible.

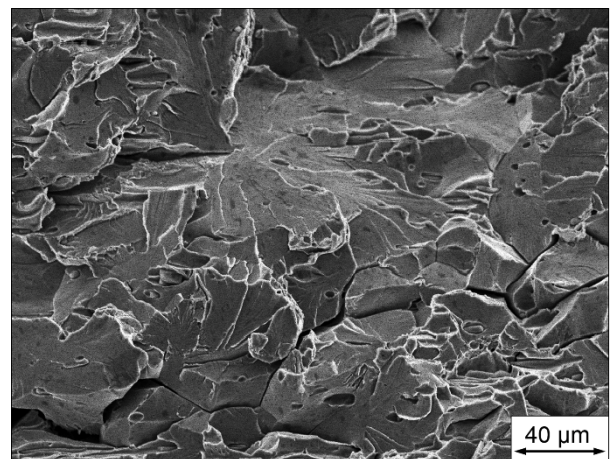
Figure 2. Typical transgranular brittle fracture of a machinable steel (11MnS5) caused by a very high strain rate. Terraces, smooth areas, river patterns and tongues are remarkable features of such a damage.

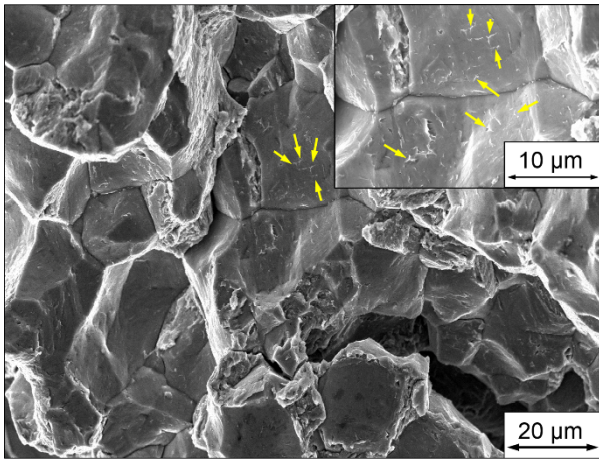
Figure 3. Intergranular fracture of a heat treatable steel (42CrMo4) due to hydrogen. Yellow arrows indicate “crow’s feet” (see insert).

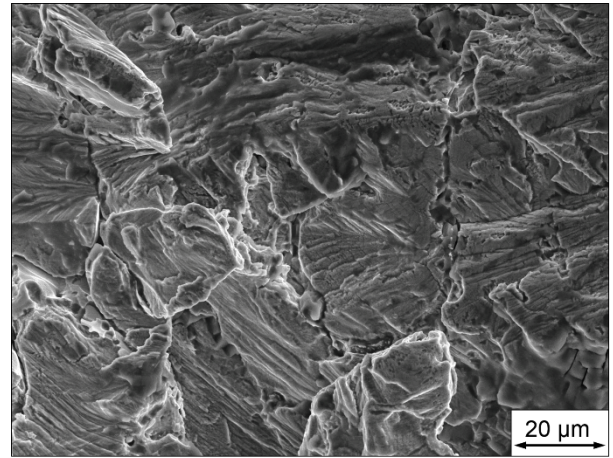
Figure 4. Transgranular fracture of a stainless steel (X5CrNi18-10) due to stress corrosion cracking.

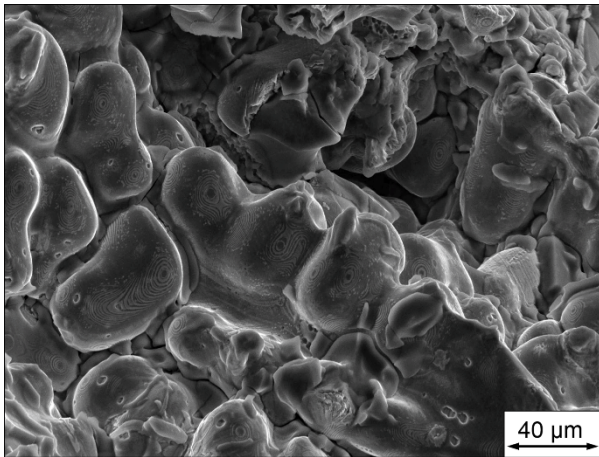
Figure 5. Hot cracks originating during solidification of a stainless steel (X5CrNi18-10). Dendrites and rounded structures are visible

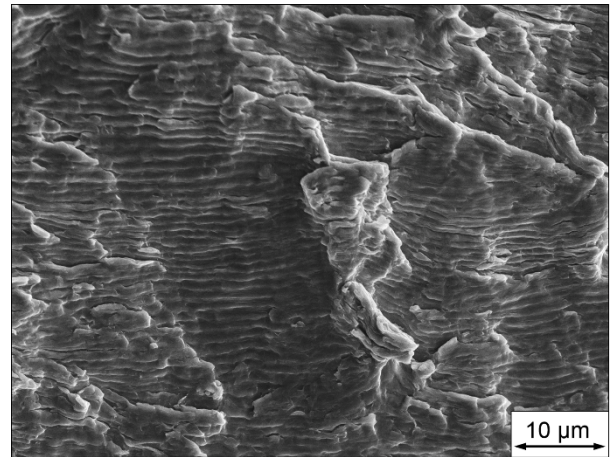
Figure 6. Typical fracture features of a martensitic steel (X5CrNiMo13-4) after fatigue. Striations are remarkable features.

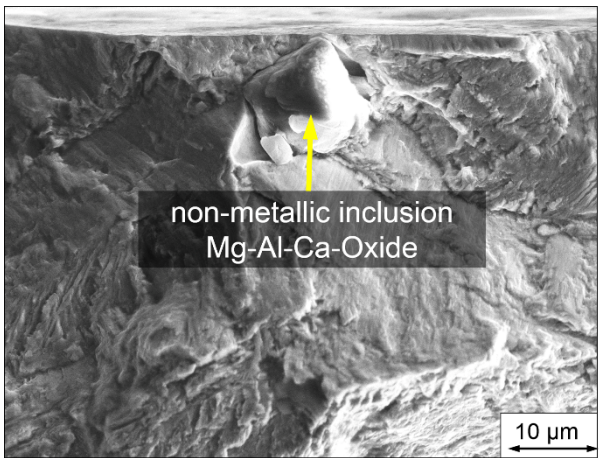
Figure 7a. Crack initiation during fatigue of a stainless steel (X5CrNiMo13-4) due to a non-metallic inclusion (topographical contrast)

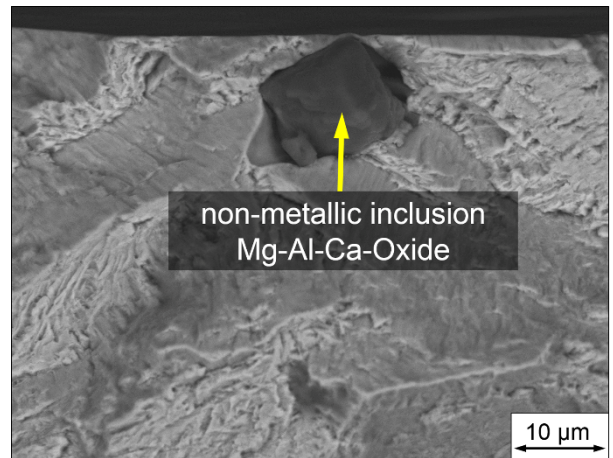
Figure 7b. Same position as in Figure 7a. The non-metallic inclusion appears dark (material contrast)
