Thermal Fatigue and Failure Analysis of Cu-Plated Through Hole Solder Joints

D.F. Susan, A.C. Kilgo, P.T. Vianco, and M.K. Neilsen

*Sandia National Laboratories, Albuquerque, NM

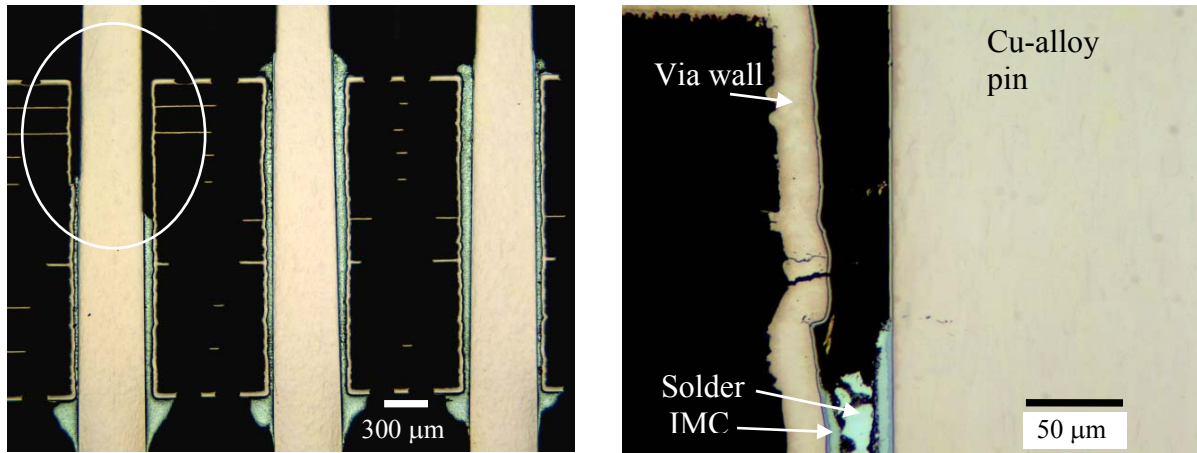
A thermal cycle fatigue study and post-mortem failure analyses were conducted on through hole solder joints. Two types of joints were evaluated: connector-to-board and internal circuit board through holes (vias). The through hole vias in the former assemblies contain a Cu-based alloy pin, Fig. 1a, while those in the latter are either empty or solder-filled, Fig. 2a. In both assembly types, the via walls (barrels) are made from electroplated Cu. During thermal cycling, cracks develop in the Cu via walls, Figs. 1b and 2b. The thermal cycle employed was typical for assessment of high-reliability military and aerospace microelectronics, with temperature limits of -55°C and $+125^{\circ}\text{C}$, 15 min hold times, and ramp rates of $10^{\circ}\text{C}/\text{min}$. The effects of thermal cycling and partial solder filling on the propensity for Cu via cracking were investigated experimentally. The Cu fatigue cracking is caused by differential thermal expansion between the circuit board materials and the copper. Cross-sectional metallography was used to analyze the solder joints in the as-received condition and after 100, 200, 300, 500, and 1000 thermal cycles. The observations of via cracking were quantitatively summarized – the crack counting procedure is given in Ref. [1]. The phenomenon of thermal-mechanical fatigue of the Cu-plated barrels was also simulated by finite element analysis (FEA).

Fig. 1. a) Low magnification optical micrograph of three connector pins showing a partially filled through hole solder joint. b) Via cracks in a partially filled solder joint after 500 thermal cycles.

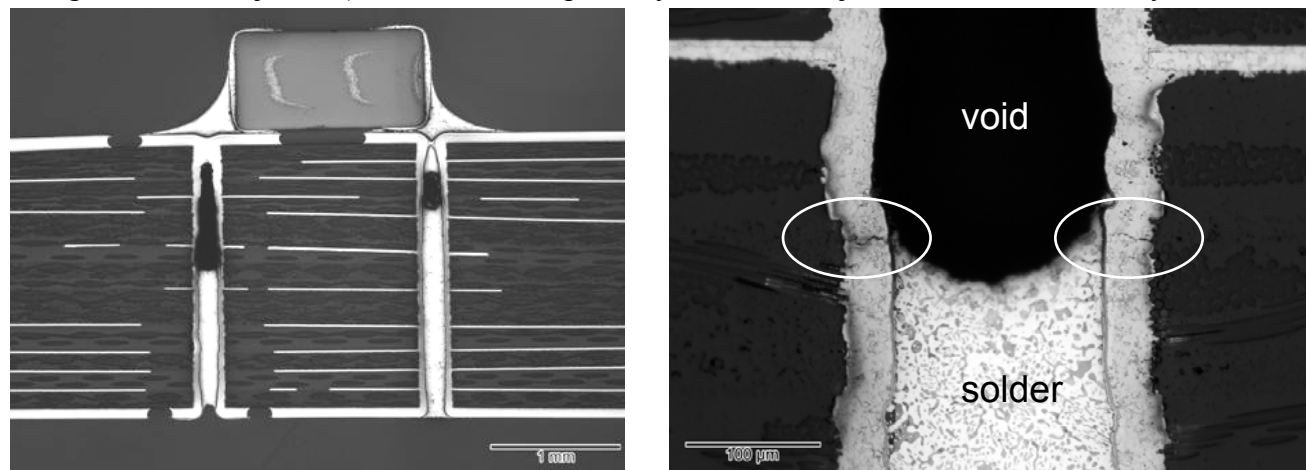
Fig. 2. a) Low magnification optical micrograph of a surface mount device with underlying solder-filled vias (no pins). b) Via cracks in a partially filled solder joint after 100 thermal cycles.

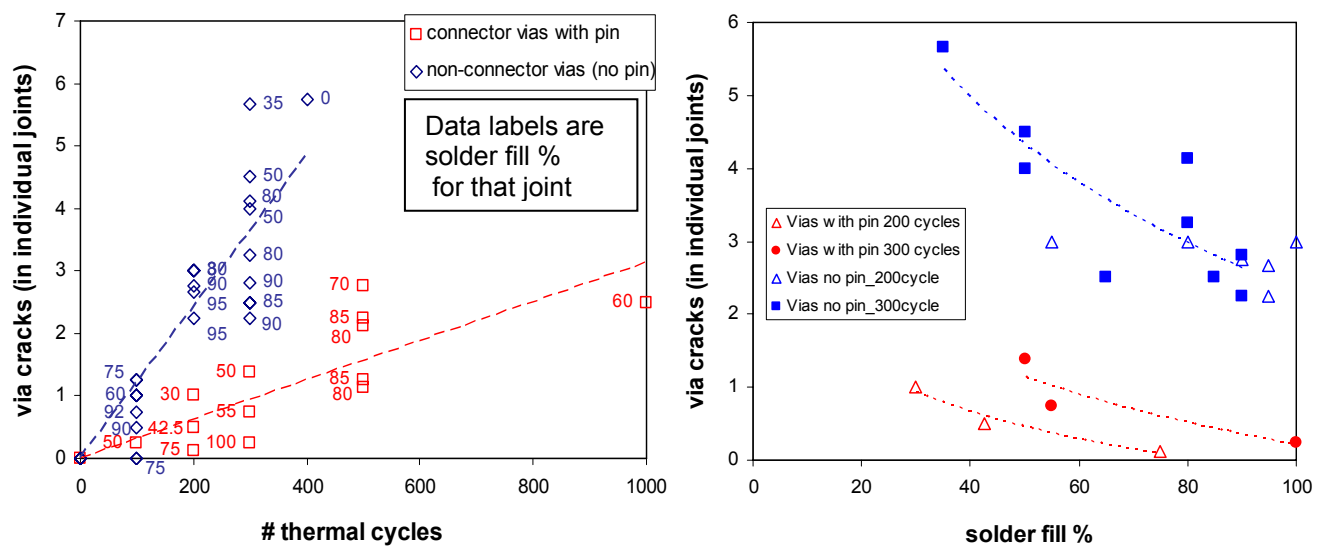
Figures 3a and 3b show the effect of joint type on fatigue cracking tendency. For connector-to-board through holes containing a connector pin, the cracking susceptibility was less than through holes internal to the circuit boards that were empty or partially filled with solder. The Cu-alloy pin alleviates some of the mismatch in thermal expansion coefficient (CTE) since it has the same CTE as the Cu via walls. For joints that were completely solder filled, the soft solder is able to accommodate the strain built up during thermal cycling. In partially filled joints or regions with large voids in the solder, the strain becomes concentrated in the via walls due to CTE mismatch with the adjacent circuit board materials, eventually leading to cracking. For empty or solder-filled internal through holes, the absence of a Cu-alloy pin increases the cracking tendency because of greater CTE mismatch strains. This work highlights the importance of controlling soldering processes to produce joints with 100% solder filling in both connector-to-board and non-connector through hole joints.

Fig. 3. a) Measured number of via cracks as a function of thermal cycling. b) Number of via cracks vs. solder fill level of individual joints for samples subjected to 200 and 300 thermal cycles.
