MICROSPOTS ON IIIa-J PLATES ("GOLD SPOT DISEASE")

M. Elizabeth Sim
UK Schmidt Telescope Unit, Royal Observatory
Edinburgh EH9 3HJ, UK

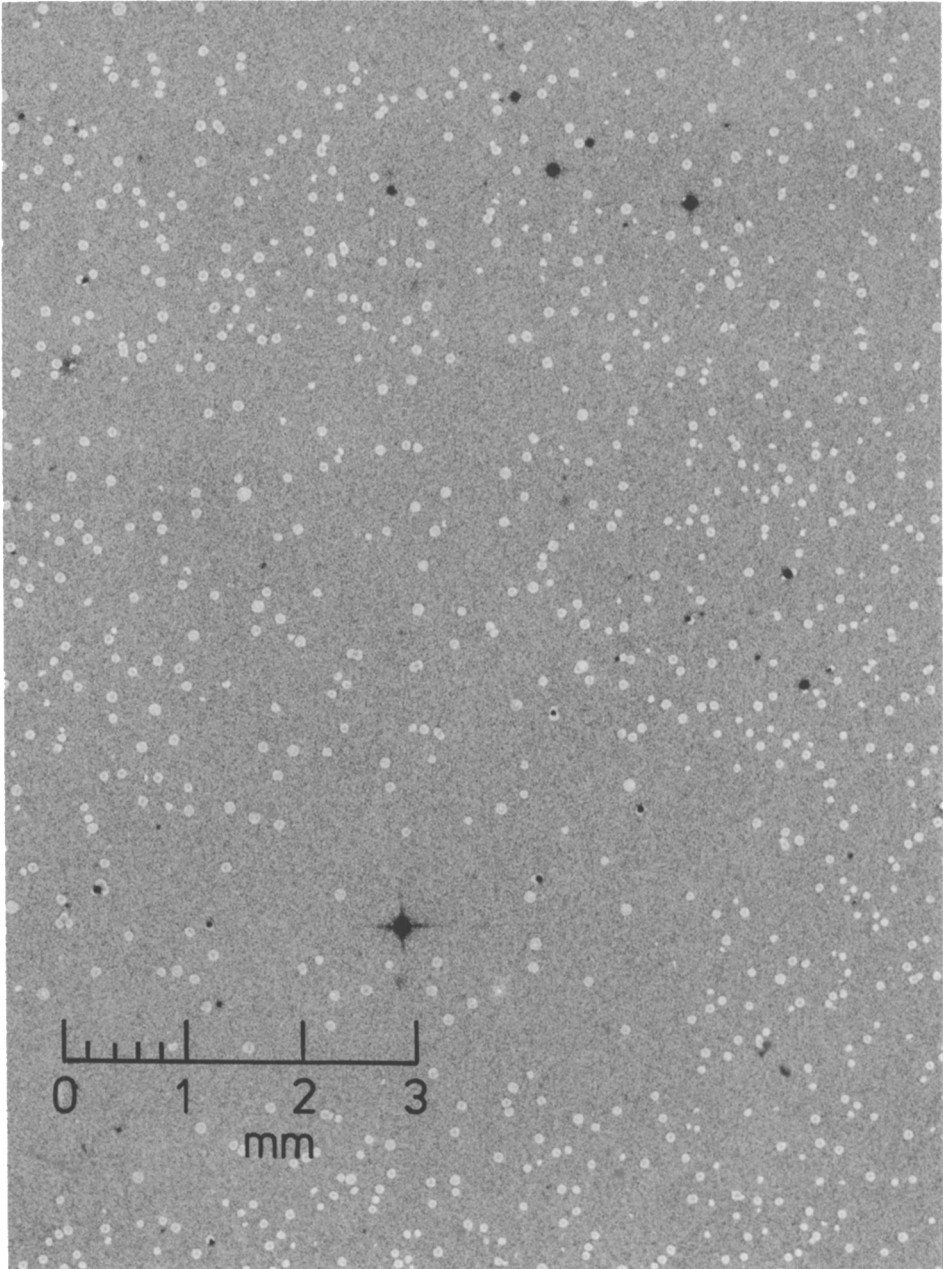
The causes of microspot formation have still not been convincingly established, but the list of primary suspects include pick-up of contaminants in processing solutions, hydrogen peroxide fumes and fumes from fresh oil-based paints (1, 2). IIIa emulsions, unlike most others, are based on pure silver bromide, and there is some evidence to suggest that gold spots may be formed if the IIIa-J

Figure 1. Microspots, which appear white in this print, may form around existing images or at random in the field.

picks up iodides or chlorides left in the processing solutions by other types of emulsion. To minimise this risk, the processing system at Siding Spring has been modified, along the lines of recent Kodak recommendations, to provide a separate, dedicated processing line for IIIa-J and IIIa-F plates so that they cannot pick up contaminants deposited into the solutions by other emulsions.

The soft foam packing that was used to protect plates during shipping is a potential source of hydrogen peroxide. Users are therefore asked to discard all such foam packing. Polystyrene sheets provide sufficient protection for the plates without any harmful chemical effects. Plates should never be stored in or near areas which have recently been painted, to avoid the risk of spot formation from contamination of paint fumes.

To protect plates from spot formation, Eastman Kodak have recommended treating plates for 3 minutes in a 1+19 solution of Rapid Selenium toner. This deposits a thin protective coat of selenium over the image silver. Further investigations of possible adverse effects of toning will be made before it is included in our processing system. If the affects of toning are acceptable, it may then be possible to treat unaffected and slightly affected plates to inhibit spot formation.
