Failure of Mountain-Anchors as Consequence of Hydrogen Embrittlement

Michael Panzenböck¹, Caroline Freitag¹

¹ Department of Physical Metallurgy and Materials Testing, Montanuniversität Leoben, Austria

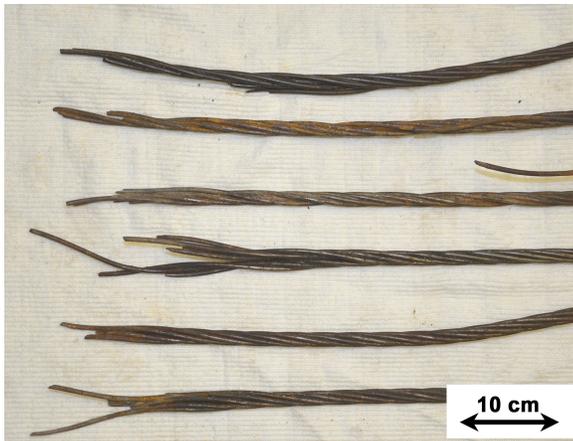
During inspection of several hundred mountain-anchors, many of them were found broken. Furthermore, most of them lost nearly completely their pre-stress. The strands were manufactured from seven high strength steel wires in this case.

Figure 1. Macroscopic overview of broken mountain-anchors (anchor strands) made from high strength steel wires.

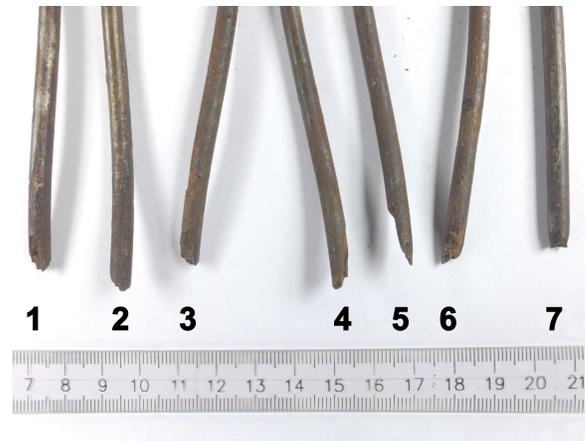
A macroscopic overview of 6 broken strands is given in Fig. 1. All strands, especially the wires, are covered with soil, lubricant and corrosion products. Fig. 2 shows a strand after disassembly. Each strand consists of 6 wires arranged at the circumference (wires 1-6) and 1 wire located in the center (wire 7). From macroscopic inspections it can be noticed that wires located at the outside show a heavily corroded surface. In addition, the fracture surfaces are inclined to the wire axes (Fig. 2, wires 1-6). In contrast to this, the wire located in the center reveals less corrosion attacks and symmetrically cup and cone fracture (Fig. 2, wire 7).

The sequences of damage can be summarized as follows: A damage of the corrosion protection leads to penetration of water and local corrosion. The damage is caused by hydrogen resulting from the corrosion process. Bending stresses and the texture of the microstructure are responsible for crack propagation in nearly longitudinal direction. The continuous damage of the outer wires causes high tensile stress in the center wire, which fails by cup and cone fracture.

Figure 2. Disassembled strand, wires 1-6 circumferential wires. Wire 7 from the center failed by cup and cone fracture.

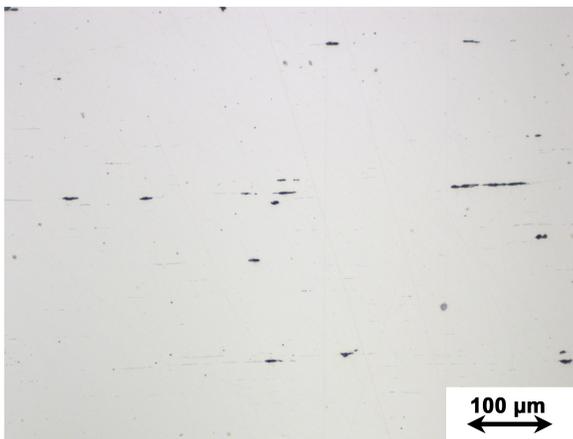
Metallographic inspections in a longitudinal direction of the wires are shown in Figs. 3a and 3b. Some wires exhibit a very high content of non-metallic inclusions (Fig. 3a). The wires are manufactured from an unalloyed carbon steel with a carbon content of nearly 0.8 wt-%. Fig. 3b reveals the microstructure, which consists of a very fine and heavily deformed pearlite structure (Sorbite) with a small amount of ferrite located at grain boundaries. The measured tensile strength ranges from 1780 MPa to 1980 MPa, and is influenced by the inclusion content. Metallographic investigations near the fracture surfaces in longitudinal direction reveal many cracks starting from the outside and crack branches (Fig. 4). These features are exclusively present in the wires located at the outside. Scanning electron microscopy (SEM) reveals transgranular fracture as exemplified in Fig. 5. The centered wire shows a ductile fracture behavior.

Figure 3a. Light optical micrograph in a longitudinal direction. Many nonmetallic inclusions are visible.

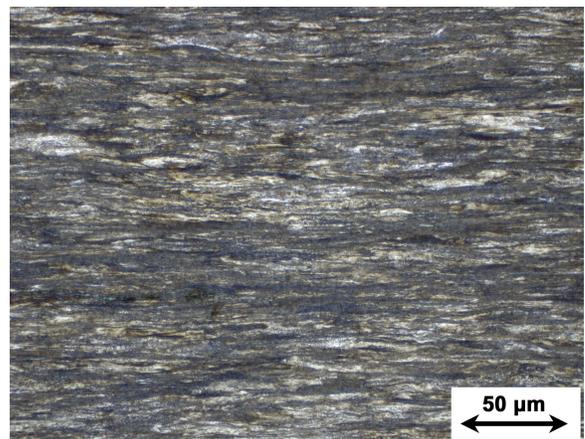
Figure 3b. Light optical micrograph of the microstructure after etching. Sorbite and Ferrite at the grain boundaries are visible.

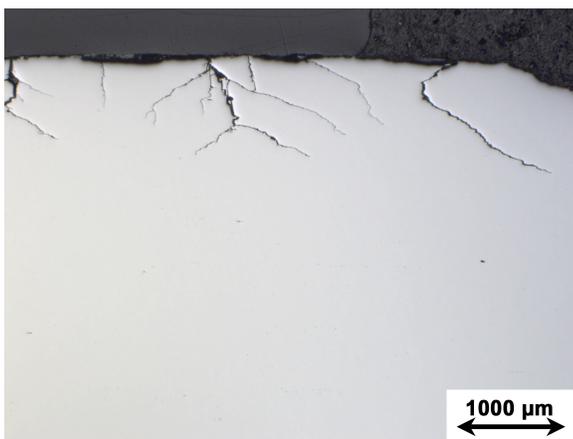
It is known that high strength steels are susceptible to hydrogen. Therefore, we developed a simple testing method by using a bending equipment in diluted hydrochloric acid. The tested specimens taken from wires revealing the same features as damaged ones (Figs. 4 and 5). From these results we can conclude that the wires failed due to hydrogen induced stress corrosion cracking.

Figure 4. Cracks are initiated at the surface and propagate in the direction of the texture. Many crack branches are visible.

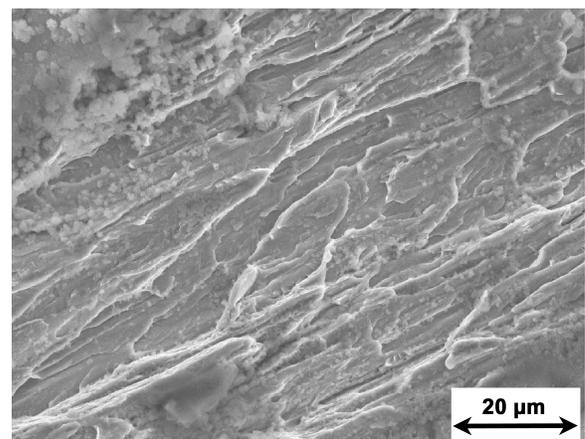
Figure 5. SEM micrograph reveals a brittle fracture surface. Cracks propagate exclusively transgranularly.
