Microstructural Evolution of the Boiler Tubes After Long-Term Service

Liming Xu¹, Yinsheng He² and Si-yeon Bae² and Keesam Shin^{1*}

¹ Advanced Metallurgical and Materials Engineering, Changwon National University, Changwon, Korea

² KEPKO Research Institute, Korea Electric Power Corporation, 105 Munji-ro Yusung-Gu, Daejeon, Korea

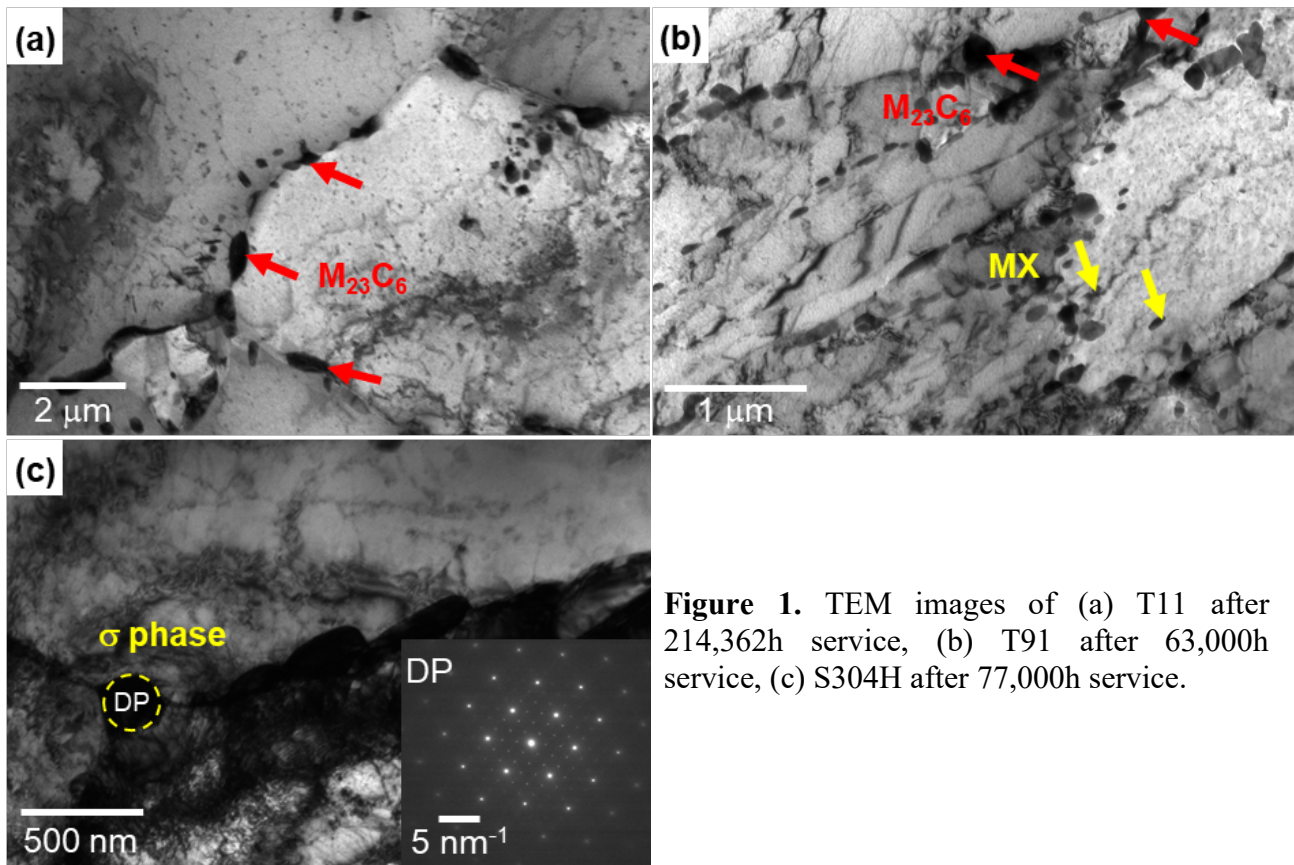
For low alloy steel T11/T22, the disappearance of original lamellar pearlite structure and the coarsening of $M_{23}C_6$ precipitates are observed after long-term exposure.

For martensitic steel T91, the coarsening of the main strengthening precipitates $M_{23}C_6$ distributed along grain boundary were observed being influenced by the diffusion of Cr, while the fine MX type precipitates are relatively stable at grain interior after long-term exposed.

For austenitic steel S304H, the formation of coarse Cr-rich and brittle σ phase on grain boundary are the dominant microstructure changes after long-term exposure [4].

Figure 1. TEM images of (a) T11 after 214,362h service, (b) T91 after 63,000h service, (c) S304H after 77,000h service.
