Characterization of Failure Surfaces of Epoxy Adhesive Under Various Fatigue Loading Conditions

Hafiz Ali

Mechanical Engineering Department, Faculty of Engineering, Taif University, AlHawaiah, Kingdom of Saudi Arabia

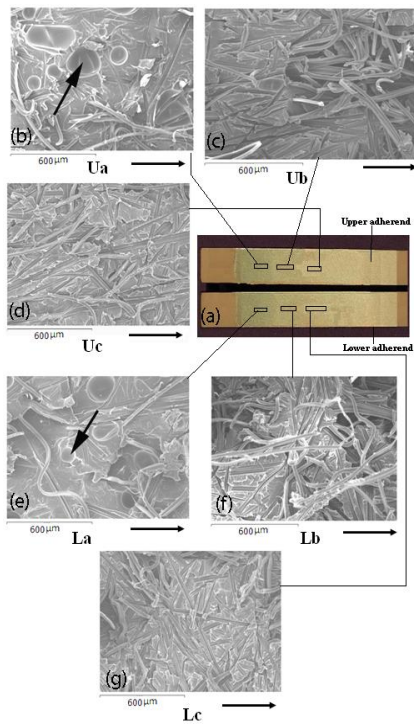
A visual and scanning electron microscopy (SEM) investigation showed fracture propagated in a cohesive fashion within FM73 adhesive for almost every test conducted. For SEM analysis of the fracture surfaces, samples were gold coated with a 8 nm thick layer. A Hitachi S3200N scanning electron microscope (SEM) was fully used to examine the fractured specimens. A 20kV electron beam was used for scanning to minimize any charging effects. Fig. 1 shows test specimen and corresponding SEM images after pure mode I analysis. A unique feature of the epoxy failure was observed as marked with arrow in Fig. 1(b & e). It is evident that adhesive failed when applied tensile (mode I) force exceeded the bearable strength and the phenomenon is cohesive rather than interfacial. Similar failure modes/features have been reported in literature for epoxy resins [3, 4]. It is suggested from SEM analysis of Figure 1 that initially fracture is dominated by cohesive regime that is later transformed into interfacial. This is attributed due to absence of circular regions in the Figure 1(c & d) that at middle and end positions of test specimen.

Figure 1. SEM images of Mode I fatigue surfaces

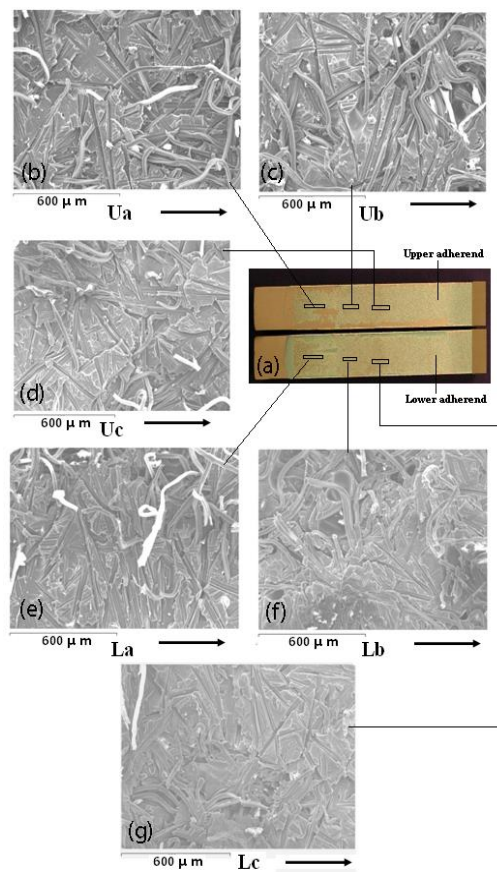
Figure 2 shows the mixed mode (mode II dominant) test specimen and related SEM images. The arrow shows the direction of crack propagation. It is suggested that crack growth rate decreases as the crack length increases for fatigue experiments carried out under displacement control. Moreover, it is evident that adhesive fracture is clearly different in both failure modes. There is no evidence of circular regions (cohesion failure) in Figure 2(b to f). This suggests that fracture is dominated by a combination of cohesion and interfacial of the epoxy resin and is limited by the presence of polyester. The applied stress tends to distribute around fibers. Therefore, this failure is suggested to be not pure cohesive rather than a mixture of both cohesive and interfacial.

Figure 2. SEM images of Mixed-Mode fatigue specimens
