## Metallographic Characterization of Thermal Damage in Boiler Tubes

Michael P. Carroll<sup>1</sup>

<sup>1</sup> Lisin Metallurgical Services, Portland, OR USA

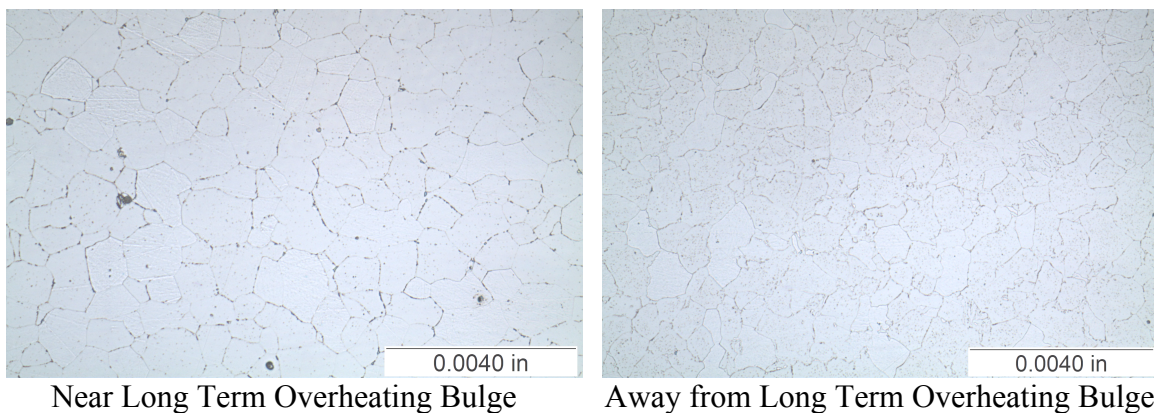
Long Term Overheating is implied in more boiler tube failures than any other mechanism, which occurs when local temperatures exceed the design limit for time scales ranging from days to years [1]. Long Term Overheating often manifests as creep and stress rupture, which can be diagnosed with metallographic examination. Stages of creep and stress rupture follow a predictable course including nucleation of creep voids at triple points, continued nucleation along grain boundaries, coalescence of voids, and eventual rupture. Thermal oxidation may also be involved, which lowers the effective wall thickness and therefore increases local stresses. Exposure to elevated temperatures for a prolonged period may also produce microstructural changes that aid in determining the peak temperature ranges. For example, spheroidization of pearlite lamellae implies long term exposure to elevated temperatures below the Ac1 temperature, whereas the observation of fresh pearlite and/or bainite is produced by heating above Ac1 and slow cooling.

**Figure 1:** Optical photomicrographs showing metallographic cross sections taken at (left) and away from (right) long term overheating damage. Both microstructures are ferritic, but creep void formation along grain boundaries is apparent in the overheated area. Fractography of the main fracture surface revealed a predominately intergranular pathway. 2% nital etch.

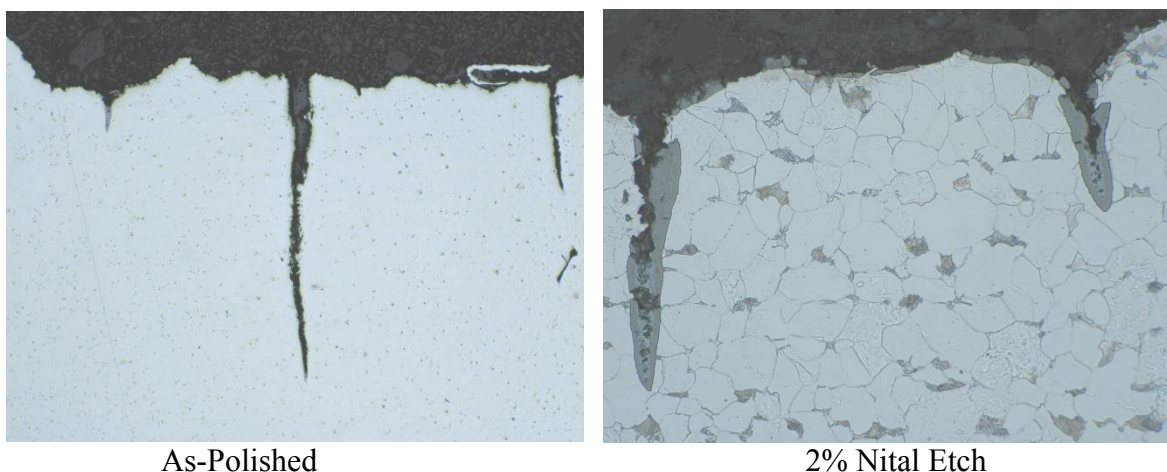
Thermal Fatigue may refer to high or low cycle fatigue, where thermal cycling imposes mechanical stress on the tubes due to expansion and compression. Crack morphology is consistent with mechanical fatigue failure, and appears as straight unbranched cracks that propagate perpendicular to the maximum tensile stress. Depending on conditions within the tube, the cracks may exhibit oxidation as well as other symptoms of long term overheating damage.

**Figure 2:** Optical photomicrographs showing longitudinal sections through adjacent cracks. The straight, unbranched, wedge shaped cracks are characteristic of thermal fatigue. The microstructure of the tube consisted of lamellar pearlite in a ferrite matrix. Evidence of overheating damage was not revealed by the metallographic examination. As-polished (left) and 2% nital etch (right).
