An Unusual Microstructure for a Carbon Steel Tube

Mark A. Hineman,* Michael J. Danko,* Kent L. Johnson,* and Frederick E. Schmidt, Jr.*

*Engineering Systems Inc., 3851 Exchange Avenue, Aurora, IL 60504

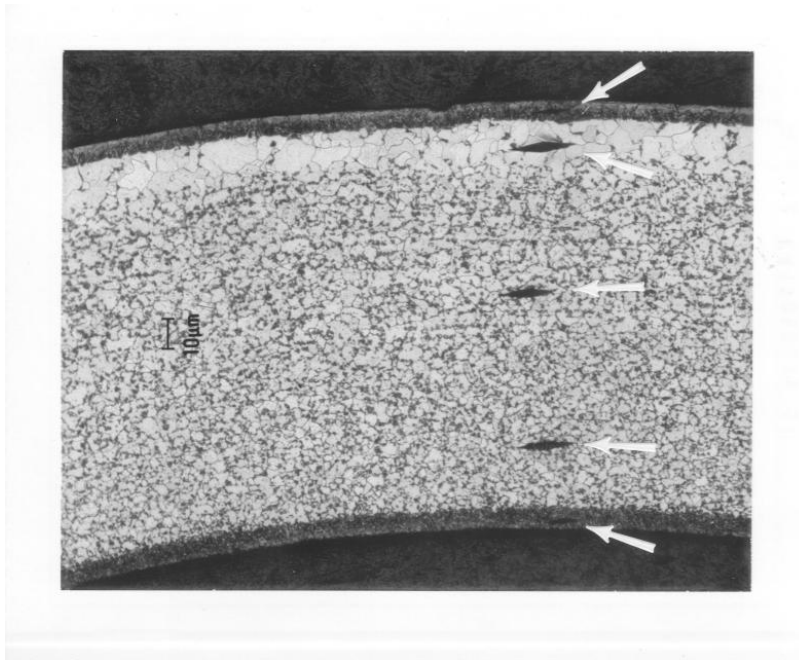
Microhardness tests performed on the carburized case at the inside and outside surfaces indicated converted values of 36 and 41 on the Rockwell C scale. In the decarburized layer near the outside surface, hardness was converted to be 64 on the Rockwell B scale. Tests performed in the typical core area of the tube indicated values of 82 and 88 on the Rockwell B scale. Examples of the structures exhibited by this cross section are shown as photographs 1 and 2.

Photograph 1: An etched cross section of the elbow. Hardness impressions can be seen on the section in the carburized case, decarburized layer and in the core. Five hardness impressions (arrows) can be seen to the left of center. (mag: 40X)

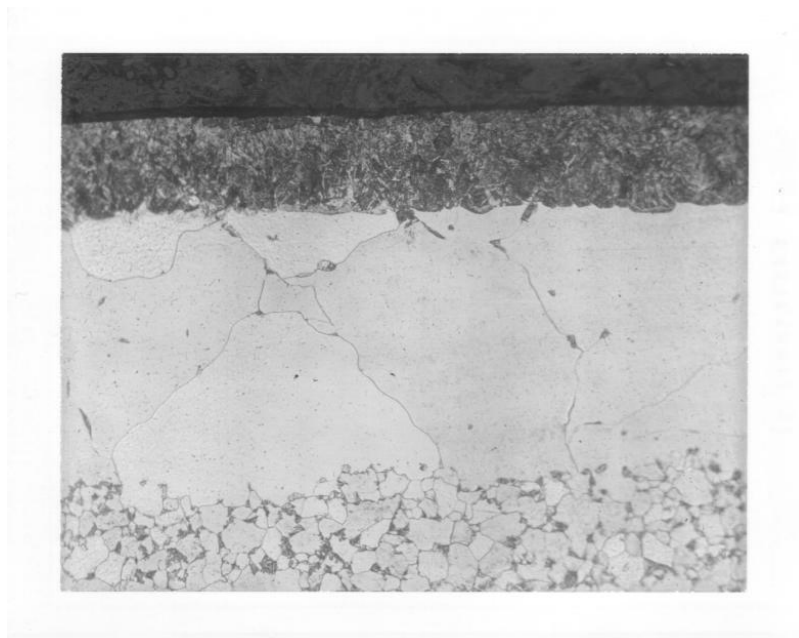
The annealing operations performed on this tubing often results in decarburization at the outside surface. Because of the length of the tubes, very little decarburization occurs on the inside surface. In addition, the cold working can promote grain growth of the decarburized layer during annealing. This would account for the light etching band below the outside circumference in the examined cross section.

The dark bands at the inside and outside surface of the cross section were approximately 0.003" (0.075 mm) deep. This carburized layer was comprised predominantly of martensite with some indications of bainite. Carburizing can be performed at temperatures between 1550° F (840° C) and 1700° F (930° C). Because the carburized layer was relatively shallow on these parts, a lower temperature would be expected to have been used. At the lower temperature of the range, 1010 steel is in a two phase region (ferrite + austenite) on the iron-carbon phase diagram. Generally, the higher carbon content of the pearlitic areas of the as-manufactured tubing transform to austenite while the lower carbon areas of ferrite grains would be minimally affected. Again, using the phase diagram, a 1010 steel will not transform to 100% austenite until a temperature above 1600° F (870° C). This is further verification that the carburizing temperature was in the lower range. After carburizing the part is quenched to promote formation of martensite. Typically, a tempering treatment is performed to reduce the brittleness of the case.

Photograph 2: The outside circumference of the tube displayed these microstructures. The dark carburized layer is at the surface. The light etching decarburized layer is below that and the core structure is shown near the bottom of the photograph. (mag: 160X)
