Failure Analysis of Firearm and Ammunition Components

Frederick E. Schmidt, Jr.,* Michael J. Danko,* and Kent L. Johnson*

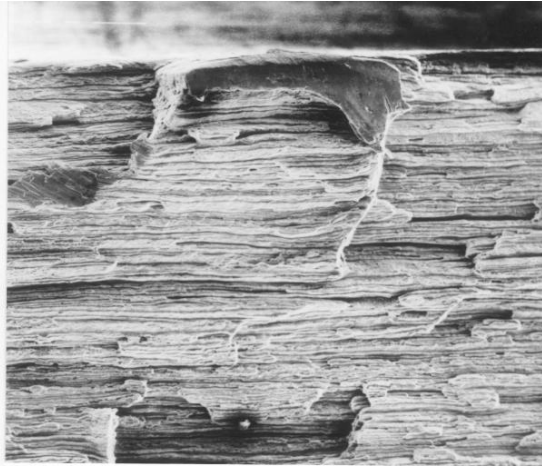
In this instance the incrementally hot forged (1100 hits/minute) steel has a microstructure that is highly fibered. The Manganese Sulfide (MnS) stringers are surrounded by a soft ductile ferrite phase. Photograph 1 at 100X, illustrates the woody, fibrous fracture characteristic of a transverse crack. Photograph 2 shows the inside diameter where the crack initiated at 760X magnification. At magnifications above 2000X it can be clearly seen, Photograph 3, that ductile micro-void coalescence, (MVC), has preceded the macroscopic fracture. In fact areas of serpentine glide are observed around the interfacial fractures of the ferrite encapsulated inclusions.

Photograph 1
Fibrous Characteristic of Transverse Crack
(Magnification: 100X)

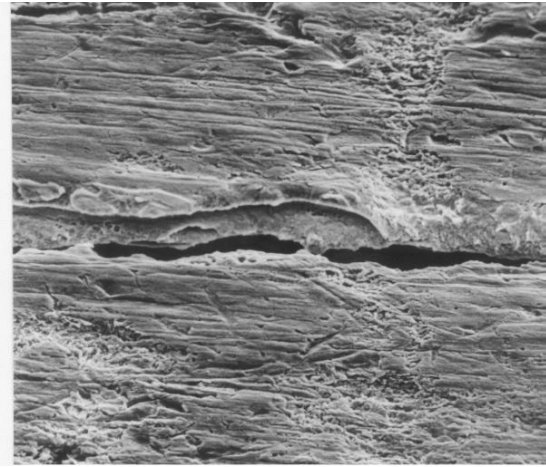
Photograph 2
Crack Initiation on Inside Diameter
(Magnification: 760X)

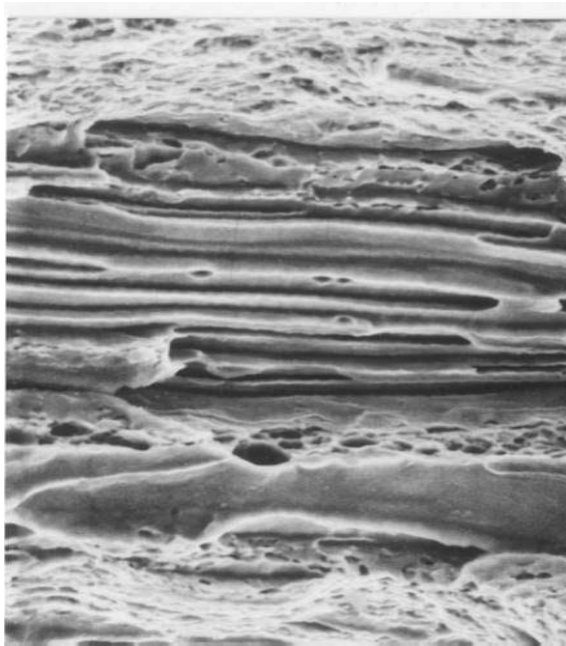
Photograph 3
Ductile Micro-voids (MVC) and Serpentine
Glide around the MnS inclusions
(Magnification: 2000X)

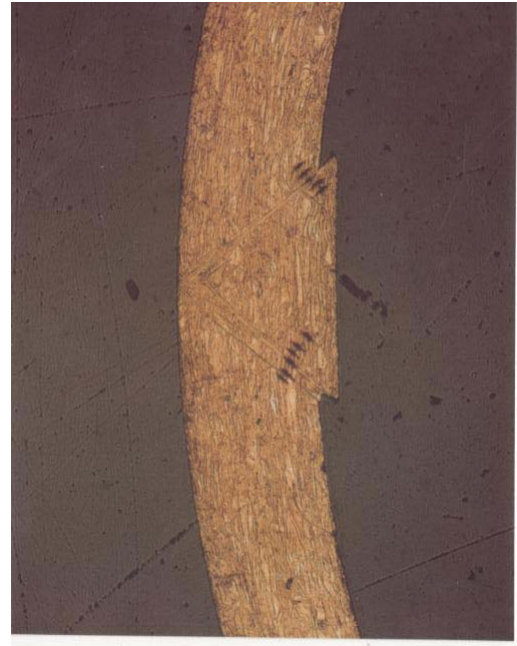
An example of adiabatic shear in Cartridge Brass is shown in Photograph 4. During the discussion of the steel failure which has been incorrectly diagnosed as an impact fatigue failure, a similar example of adiabatic shear will be shown to illustrate the value of a complete microstructural analysis of a failure. It is essential to conduct a complete analysis of the subject microstructure in order to arrive at the proper determination of failure mode. Photograph 4 is taken from a 5.56 mm center fire cartridge Lake City Army Ammunition Plant, SCAMP.

Photograph 4
Adiabatic Shear in 5.56mm Cartridge
Brass 70:30 Center Fire Case
(Magnification: 75X)
