Steel Hull Corrosion of USS Arizona with Applications to Submerged Resources

D.L. Johnson,* D.J. Medlin,** M.A. Russell,*** D.L. Conlin,*** L.E. Murphy,*** J.D. Carr****

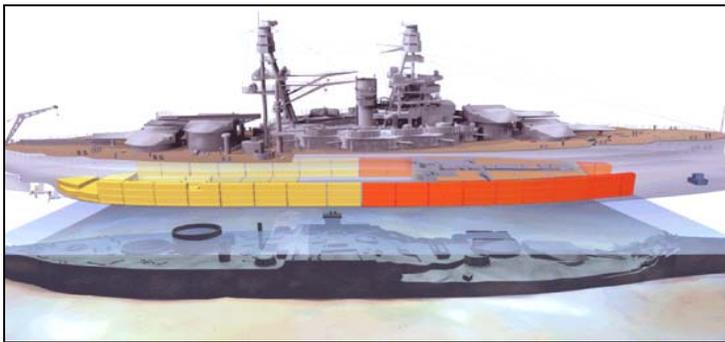
Fig.1. USS Arizona - Destroyed bunkers in red; intact in yellow (courtesy of National Geographic and NPS).

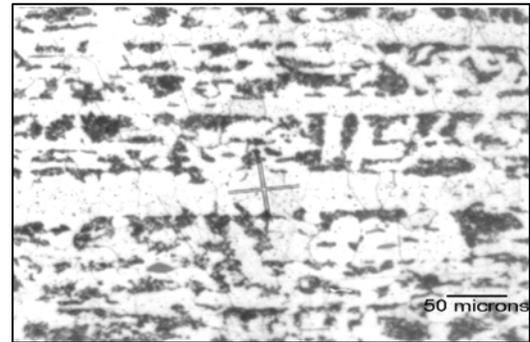
Fig. 2. Alignment of ferrite and pearlite in bands, 0.1 C, boat deck plate, (1913).

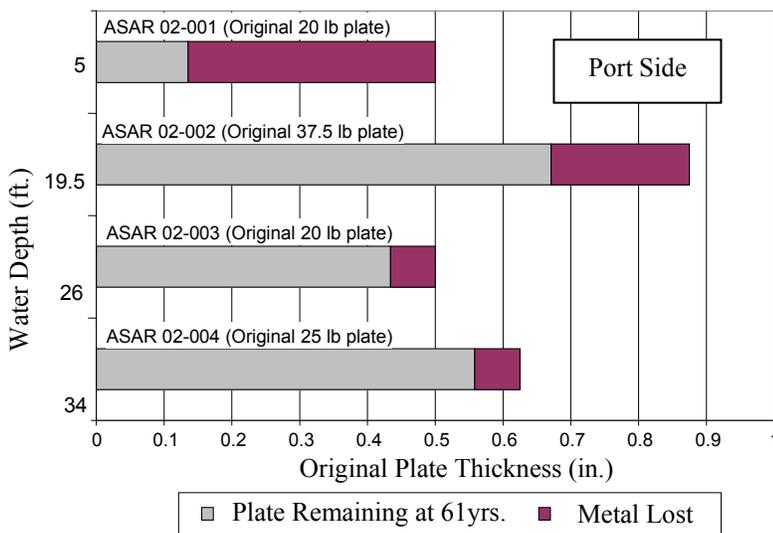
Eight 10 cm (4 in) diameter hull samples (coupons) were removed, four each from port and starboard sides near midship, at vertical positions from 5 ft (1.5m) to just below the mudline at 34 ft (10.4m). Corrosion rate was determined by subtracting final thickness from original thickness and dividing the difference by the submerged time interval, 61 years. Fig. 3 is a port side bar graph of hull plate thickness as a function of water depth [2]. At 5 ft (1.5m), the metal loss is over 50% of original thickness due to fresh seawater exposure on both sides. At 19.5 ft (6m), the loss is less than 25%, at 26 ft (8m) and lower, the loss is less than 15%. Corrosion rate varies from 2.7 mpy (0.07mmpy) near the surface to 1.2 mpy (0.031mmpy) at the mudline. USS Arizona's complete structural deterioration and eventual release of oil inside the hull is, by all indications, not imminent.

Fig 3. Plate loss as a function of water depth.
