Application of a Correlative fs-Laser Workflow for Fast and Easy Feature Access in Failure Analysis of Recycled Automotive Body Parts

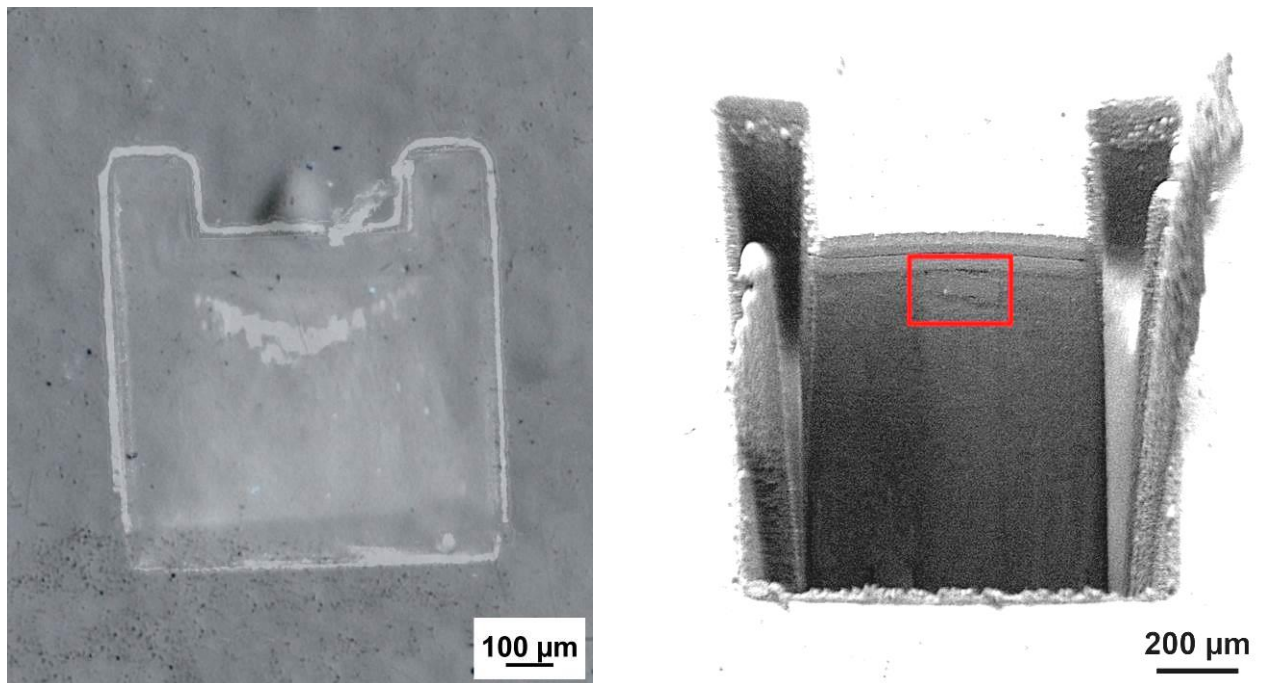
Figure 1. Left: LM image with SEM image overlay of fs-Laser trench shows precision of correlative microscopy approach; right: fs-Laser prepared cross section through surface defect shows peculiar feature just under the lacquer layers.

After relocating the defects in the SEM a location specific fs-Laser preparation was conducted. The advantage of fs-Laser preparation is the rapid material removal rate with minimal to no heat affection of the material due to the rapid energy input of the fs-Laser. Figure 1 right shows the resulting laser trench at the location of a surface defect. The cross section has a width of $\sim 500 \mu\text{m}$ and a depth of $> 800 \mu\text{m}$. Already in the overview image a peculiar particle embedded in the base material right underneath the lacquer layers can be observed.

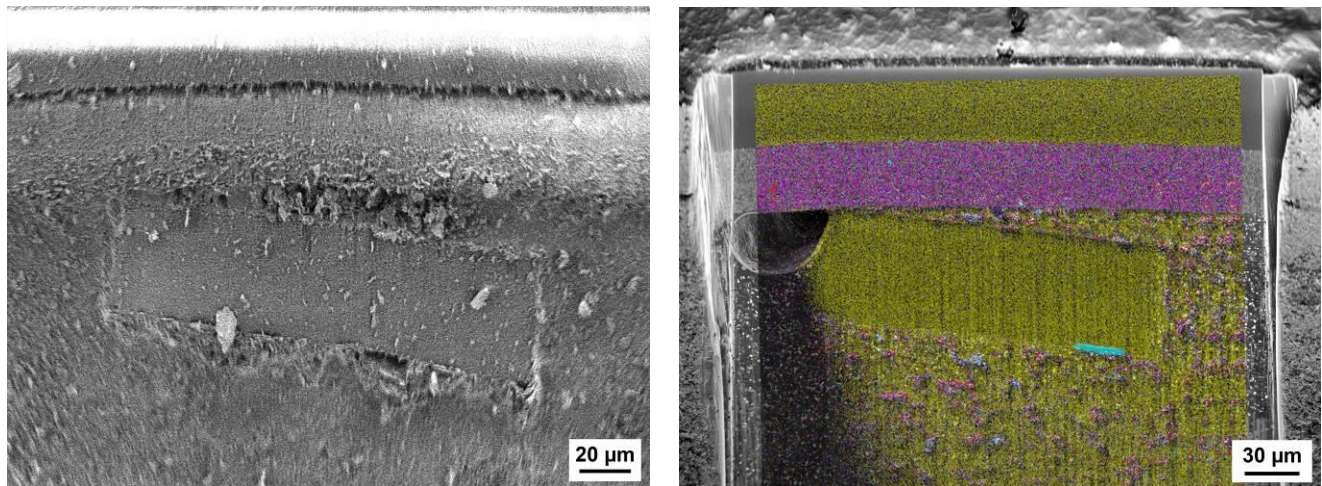
With a specifically developed recipe beforehand, the laser preparation time was < 1 minute and the resulting surface quality of the laser cut was already sufficient to clearly see the embedded unstructured particle in the base material (see figure 2 left) however, a FIB post-polishing was applied to get a more clear view of the microstructure surrounding the particle and to conduct a good quality EDS analysis of the area of interest.

Figure 2. Left: Embedded unstructured particle underneath lacquer layers in laser prepared state; right: EDS elemental mapping on FIB post-polished cross section surface; yellow: C-intensity, blue: Al-intensity, pink: Ti-intensity, red: Si-intensity.

Figure 2 right shows the FIB polished cross section with an EDS elemental mapping overlay. Yellow represents the Carbon signal, pink represents a strong Titanium signal and blue shows a high Aluminum content. The unstructured foreign particle shows a high C-signal with an adhering Al-rich particle. The absent inner structure of the particle and the high C-signal as well as the solitaire adherent Al-particle indicates that the particle is a residue of a clear lacquer layer. Furthermore, a large cavity can be observed on the interface of the foreign particle and the surrounding base material (Figure 2 right).

The conclusion of the conducted investigation is that during recycling of old bumper material for new parts, the lacquer layers were not sufficiently removed before shredding and thus can be found sparsely distributed in the new material.

When a residual lacquer particle is coincidentally located on the surface of the new material right underneath the new lacquer layers a combination of humidity and temperature changes during aging tests might result in the formation of pores at the interface between plastic and residual lacquer particle due to weak adhesion. The resulting volume change then leads to the observed local bulging of the overlying lacquer layers.
