Embrittled Ancient Silver and Iron Objects and Their Conservation

Russell Wanhill

National Aerospace Laboratory NLR, Amsterdam, the Netherlands, P.O. Box 90502, 1006 BM Amsterdam

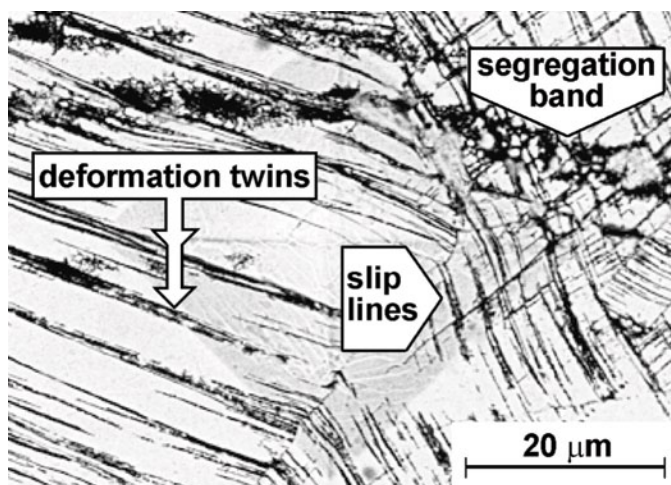
Corrosion-induced embrittlement is due to several forms of selective corrosion. Intergranular corrosion is the most commonly reported. This can occur in mechanically worked and annealed objects, which constitute the majority. Interdendritic corrosion can occur in castings, which are uncommon, especially in the Old World. Corrosion along slip lines and deformation twin boundaries can occur in objects that have not been annealed after (final) mechanical working, which includes striking a coin and decorating by chasing and

Figure 1: Corrosion-induced embrittlement along deformation twins, slip lines, and copper-rich segregation bands in the Egyptian vase [1].

stamping. Inside the metal these kinds of corrosion can lead to additional corrosion along segregation bands. These bands are the remains, modified by working and annealing, of solute element segregation (coring) and interdendritic segregation that occurred during solidification of an ingot or cupelled button.

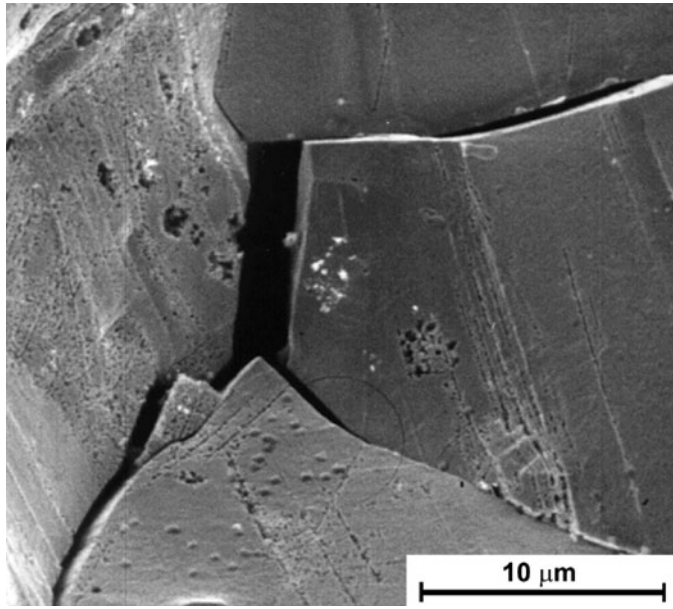
Microstructurally induced embrittlement is characterized by brittle intergranular fracture, with sharply defined cracks and grain boundary facets. The embrittlement is most probably a consequence of long-term low-temperature aging, whereby an impurity element, or elements, segregates to grain boundaries. The available evidence indicates lead to be the most likely perpetrator [2, 3], though this has yet to be verified directly. Other impurity elements might be involved, notably bismuth [3].

Figure 2: Microstructurally induced brittle intergranular fracture in the Egyptian vase [2].

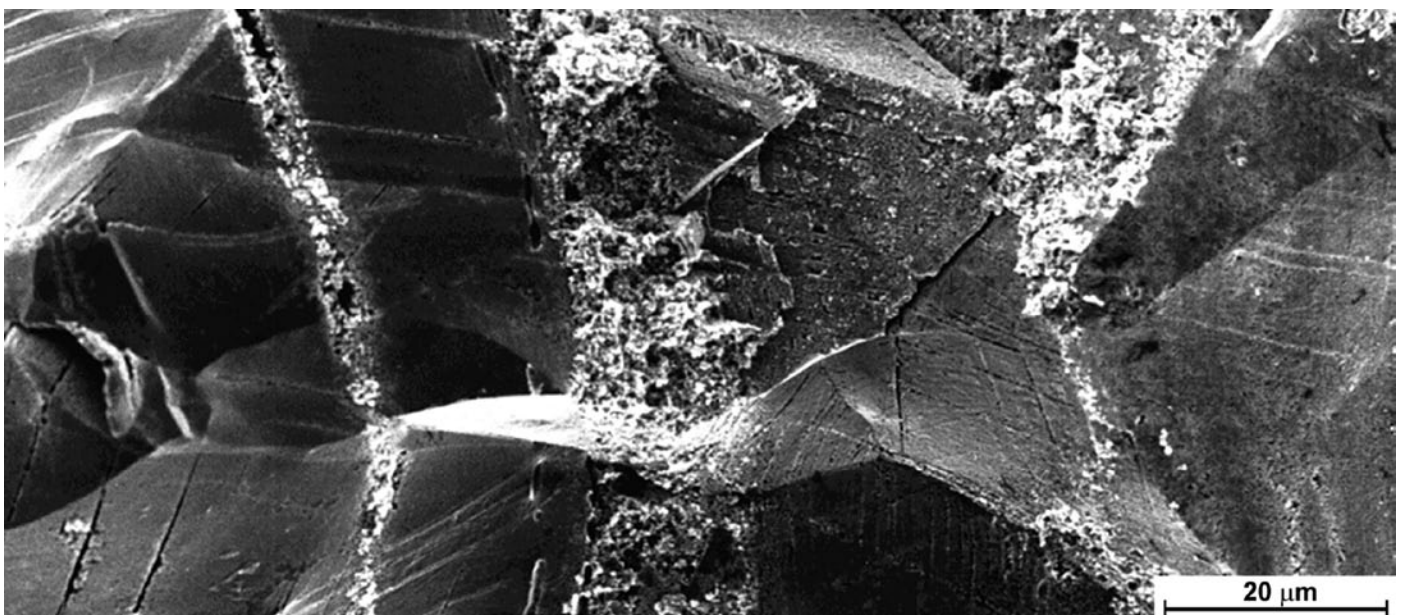
Synergistic embrittlement combines corrosion-induced and microstructurally induced embrittlement. For example, corrosion along slip lines, deformation twin boundaries, and segregation bands can result in cracks. These cracks can then initiate fracture along microstructurally embrittled grain boundaries—which may fracture anyway, though less easily—under the action of external loads. In turn, the grain boundary fractures expose more slip lines, deformation twins, and segregation bands to the environment and increase the opportunities for corrosion.

Figure 3: Synergistic embrittlement example: Microstructurally induced intergranular fracture and corrosion-induced damage and cracking along segregation bands in the Egyptian vase [1].

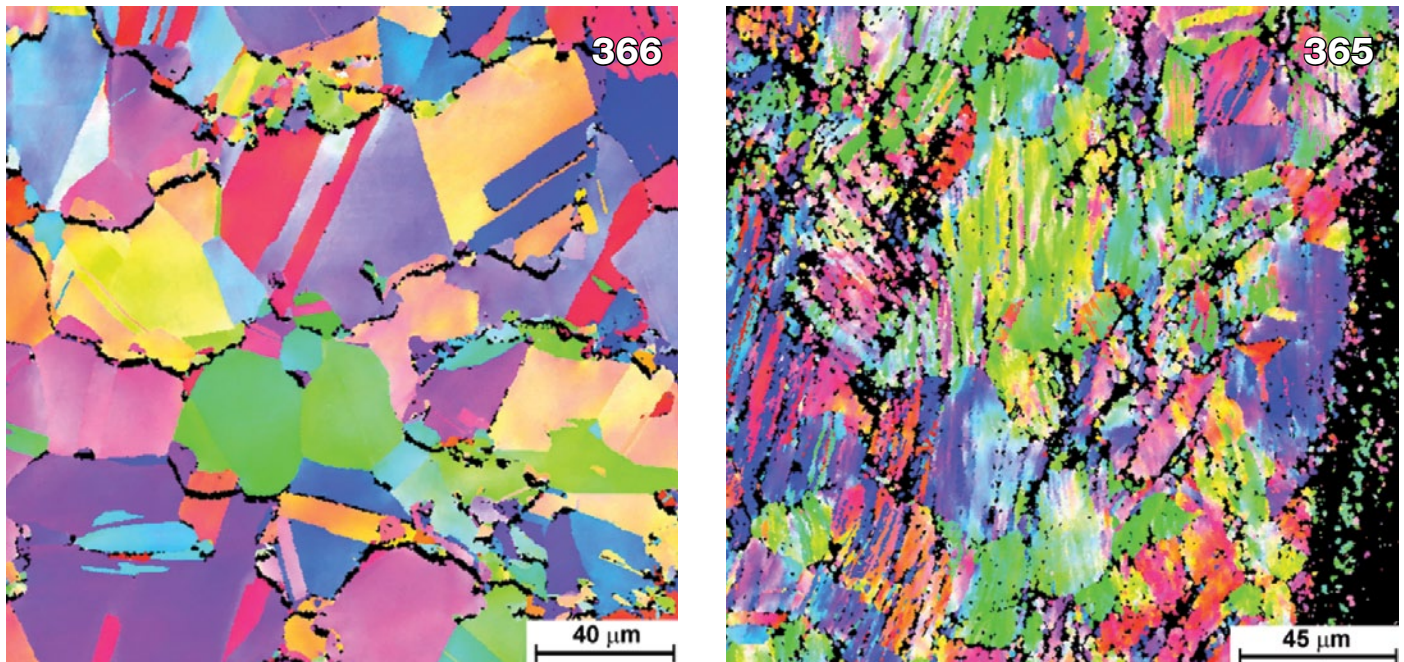
SEM metallographic and fractographic examples of all three types of embrittlement are given in Figures 1-3. Retained cold-work is generally responsible for corrosion-induced embrittlement. This can be seen from the EBSD Inverse Pole figure (IPF) color-coded maps in Figure 4, which show annealed and cold-worked samples from the Gundestrup Cauldron. The annealed sample is uncorroded even though there is

extensive discontinuous precipitation of copper along the grain boundaries. This is notable because the eminent metallurgist Cyril Stanley Smith took the view that grain boundaries along which discontinuous precipitation had occurred seemed to be highly susceptible to corrosion [4]. Also, limited evidence for the Byzantine paten [2, 3] suggested that corrosion occurred along grain boundaries with discontinuous precipitation. On the other hand, the Gundestrup Cauldron results are consistent with the experience of Peter Northover [5] who observed intergranular corrosion and cracking in ancient Bactrian silver despite copper contents less than 1 percent, which is almost certainly too low for discontinuous precipitation to occur [6].

Figure 4: EBSD IPF color-coded maps for Gundestrup Cauldron sample 366 (annealed) and sample 365 (cold-worked). The sample 366 image shows extensive discontinuous precipitation of copper along the grain boundaries. Black regions in the sample 365 image are due to corrosion damage and cracking [1].

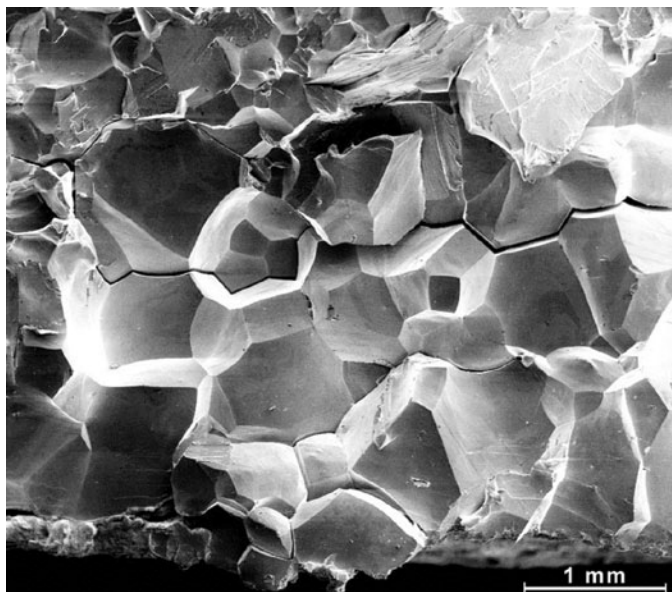
Figure 5 shows a detail of the fracture, which was caused by the pile-shoe falling onto a concrete floor during storage. This obviously intergranular fracture was attributed to local decarburisation during manufacture (a local carbon content of only 33 ppm) and subsequent embrittlement by high-temperature phosphorus segregation to the ferrite grain boundaries. The decarburisation would have occurred owing to locally oxidizing conditions in the smithing hearth, and the virtual absence of carbon would then permit phosphorus segregation to the ferrite grain boundaries [7]. It was also found that the pile-shoe was covered by a surface corrosion layer of akaganeite (an iron oxide) which would have formed after the pile-shoe was recovered [8].

Figure 5: Brittle intergranular fracture of an iron pile-shoe from a Roman bridge [1].

Remedial measures for iron pile-shoes. Many more pile-shoes were recovered besides the accidentally fractured one. Investigation of this pile-shoe indicated two aspects for conserving the others. Firstly, these must be expected to have surface corrosion layers containing akaganeite. Because akaganeite is hygroscopic,

corrosion will continue unless actively prevented by drying out the corrosion layers and either storing the pile-shoes in a low-humidity environment [8] or applying a protective (organic) coating. Secondly, some of these pile-shoes could also have local carbon contents that are extremely low. Thus if any are to be removed from storage, and whether or not they are still attached to piles, they should be handled and transported with care to avoid breakages. **MT**
