Investigations of a Type 316L Steam Dryer Plate Material Suffering from IGSCC After a Few Years in BWR Conditions.

Detailed microstructural characterization has been performed on a sample made of Type 316L stainless steel, removed from a boiling water reactor (BWR) steam dryer inner roof plate, which had suffered from intergranular stress corrosion cracking (IGSCC) after only a few years of operation. The aim of the characterisation was to increase the understanding of possible material related characteristics that could have affected the observed cracking.

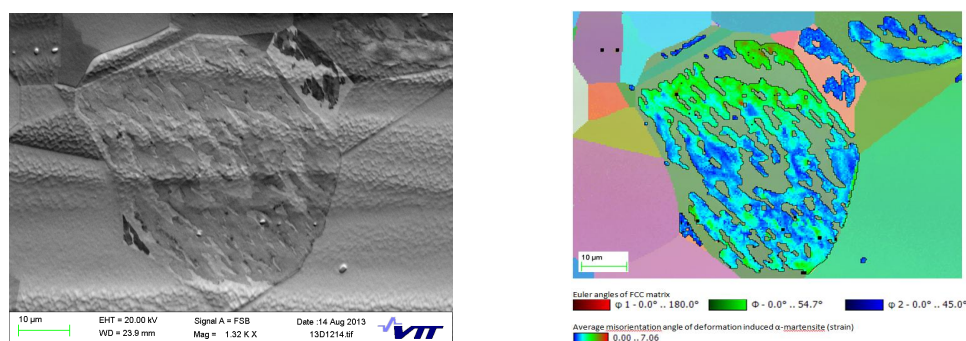
In the additional investigations focussing on detailed investigation of the material characteristics, a non-homogeneous microstructure shown in **Figure 1** was confirmed by EBSD and presence of alpha-martensite in the mid-thickness of the plate, as a consequence of deformation, was observed, **Figure 2**. Macro-segregation bands were observed with consequent fluctuations in the composition of especially Ni and Cr, **Figure 3**. Corresponding hardness difference over the bands was measured with a nano-hardness tester, **Figure 3**. Also very high surface hardness, obviously from surface grinding during manufacturing, was measured on both sides of the 6 mm thick plate. The macro-segregation is a result from continuous casting, which does not include upset forging as a manufacturing step. The reasons for the non-homogeneous microstructure through the plate thickness shown in **Figure 1** maybe caused by the aforementioned factors as well as the final rolling passes.

The non-homogeneous material and the high surface hardness are both material characteristics which have increased this material's susceptibility to IGSCC. High residual stresses from welding, which were also very likely in this case (based on received information), have increased the IGSCC susceptibility of the plate. The thickness of the deformed layer with high hardness was so thin, that it would not be detected using conventional techniques, e.g. Rockwell C hardness, used for quality assurance during manufacturing. To mitigate the risk for IGSCC due diligence must be taken at all steps of manufacturing and assembly. Ensuring safe and economic nuclear power plant operation for 60 years and above, it is of utmost importance that nuclear materials fulfil stringent requirements.

Figure 1 An EBSD map from the cross-section of the sample, showing an inhomogeneous grain orientation through the thickness of the plate. This is most likely caused by manufacturing parameters, e.g. deformation and temperatures in a non-homogenous material during rolling.
