## Unraveling the Mystery: Using Microscopy in a Metallurgical Failure Investigation

Steven A Bradley, Karl W Hagglund, Lily So, Amanda L Stolarski and Benjamin L Tiemens

UOP LLC, a Honeywell Company, Des Plaines, IL, USA

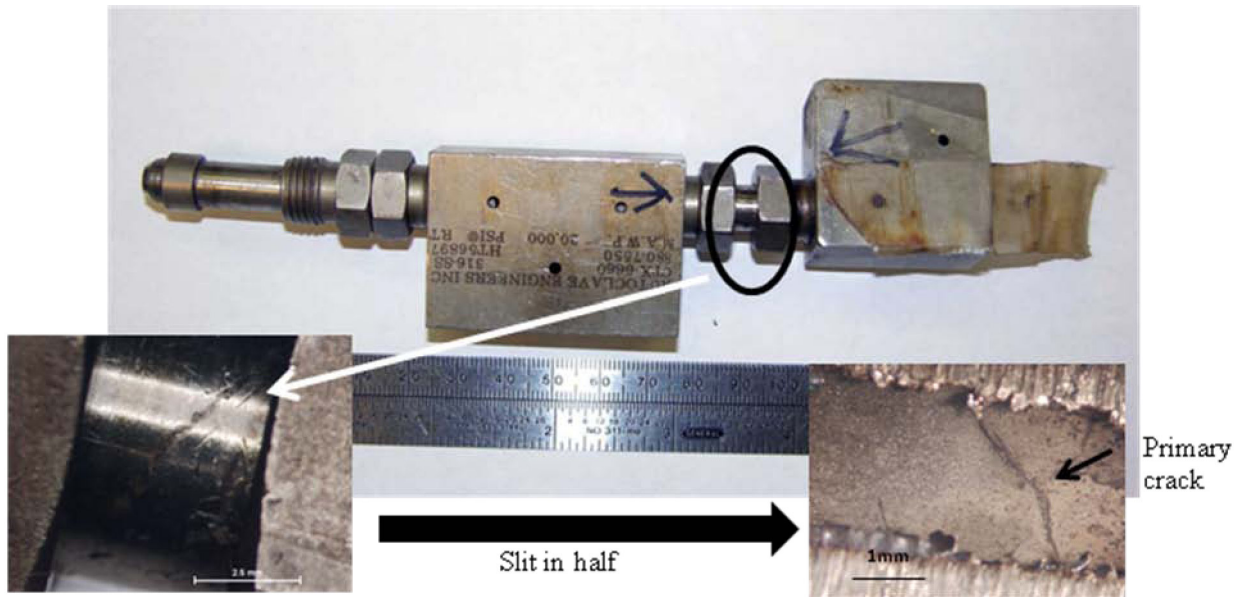
A possible crack was noted on the outside diameter (OD) of the fitting and the tube section was slit to reveal the extent of the cracking on the inside diameter (ID) (Figure 1). The sliced tube section was cut again length wise so that half could be used for metallographic analysis at the presumed initiation site and the other half could be used for SEM fractography.

**Figure 1.** Observed crack on OD and sectioned for viewing on ID; inlet is on right.

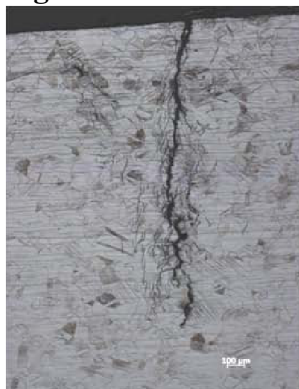
A branched, transgranular crack initiating from the ID was observed that propagated almost completely through the wall of the tube, as shown in the metallographic cross-section of Figure 2. Branching was not extensive, suggestive of high stress Cl stress corrosion cracking. Microstructure was typical of cold working and no sensitization could be found.

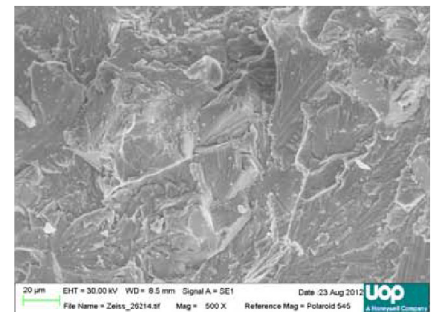
Most of the fracture surface consisted of transgranular shear (Figure 3) with only a small portion exhibiting a dimpled appearance typical of ductile overload. SEM/EDS chemical analysis at the crack initiation site identified the presence of both S and Cl; however, only S and no Cl was found a short distance (200 μm) from the ID. The ID of the tube also showed the presence of Cl and S but no Cl or S was detected at the crack tip. Cl was detected on other parts of the fitting with less noted for the outer block while the outer tube section had no detectable Cl or evidence of cracking.

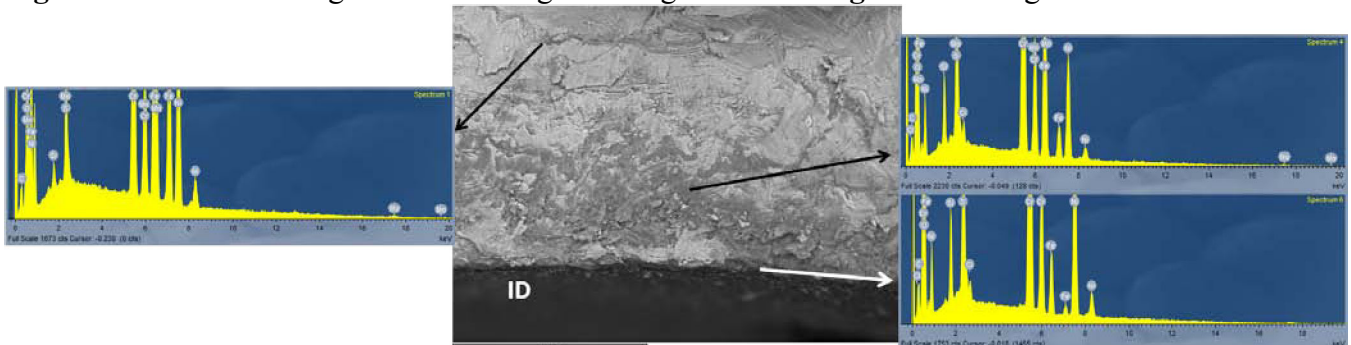
The ultimate cause of the failure was the result of Cl stress corrosion cracking. Because of the design and assembly of the fitting, the line was under high torsional stress. Although the Cl was at extremely low concentration, the Cl concentrated at the failed location because of vapor/liquid condensation along with the sulfide corrosion scale providing a concentration site. Change to a fitting connection producing less stress and suitable insulation to prevent vapor/liquid concentration was recommended.

**Figure 4.** At ID of fracture surface Cl is detected and has concentrated in the sulfide scale.
