Computer Tomography: A Useful Instrument for Failure Analyses

Michael Panzenböck, Marlies Borchert

Department of Physical Metallurgy and Materials Testing, Montanuniversität Leoben, Austria

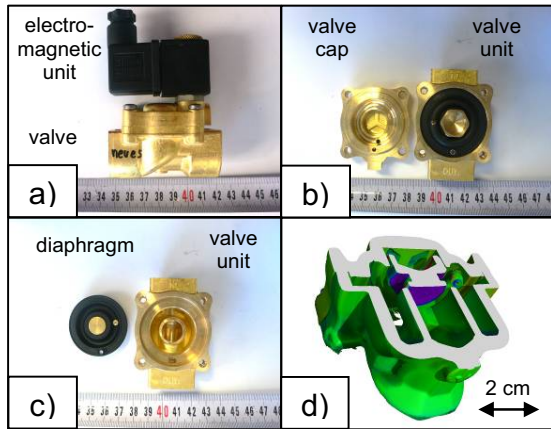
An electromagnetic valve mounted in water installations failed. Unfortunately, this causes flooding of many floors of a laboratory building. In addition to the damages on the building itself, in many cases the electronic equipment was destroyed too. A check of all installed valves proofed that most of them were leaky. These tests showed no failure of the electronic or magnetic device, which is mounted to the valve (Fig. 1). Therefore investigations had to be carried out to find the circumstances of failing.

Figure 1. a) Macroscopic overview of an electromagnetic valve; b, c) disassembled valve; d) CT cross section of a valve

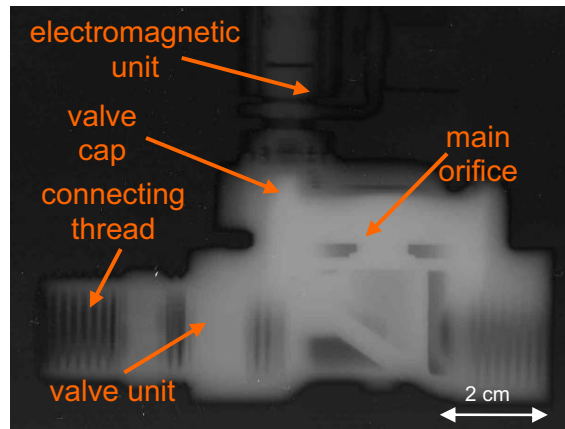
Figure 2. Two dimensional X-ray photograph of an electromagnetic valve. The main parts are marked with arrows.

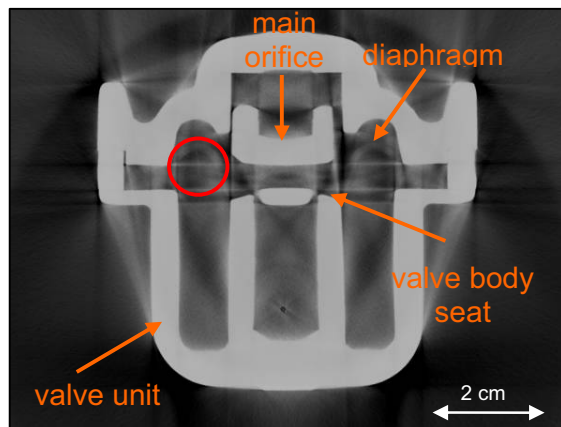
Figure 3. CT of an installed valve. The red circle marks a small metallic flitter. The diaphragm is also visible.

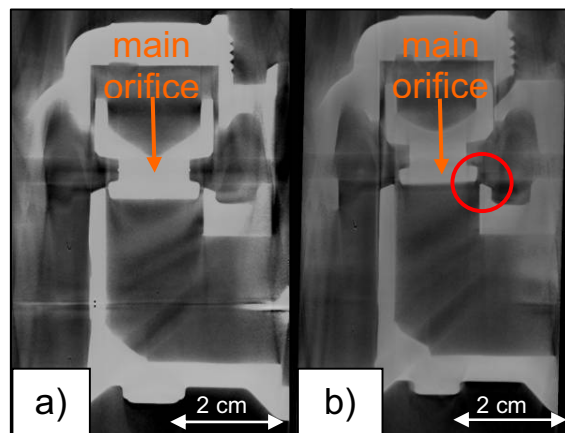
The main parts of such valves are depicted in Figs. 1a-1c, whereas Fig.1d shows its cross section. In Fig. 2 a typical two-dimensional X-ray photograph of the valve is shown, which was responsible for the disaster. In this figure only the contours of the valve are dimly visible. But there is no way to have a closer look into the inside in detail. On the contrary CT allows a view of the cross section in steps. One can say it is possible to take “a walk” through the valve. As can be seen from Fig. 3 this technique allows to distinguish between metal parts and components made of plastic. The diaphragm with its special form is clearly visible. Within the red marked region in Fig. 3 a very thin foreign particle can be identified. Further investigations showed, that this object can be related to a chromium flitter. Even more, comparison of the cross sections of a new valve (Fig. 4a) and a valve taken from the water installation (Fig. 4b) show clearly differences between the positions of the main orifice. For the new valve the main orifice blocks the flow of fluid and the diaphragm is in close contact with the sealing edge. In contrast to this, the main orifice in the failed valve (Fig. 4b) is not closed. Within the red marked circle a small particle between diaphragm and sealing edge is visible. Further investigations showed that all found particles can be attributed to the tubes of the water installation. These particles origin from cutting the tubes during manufacturing. So the pipework was not cleaned sufficient after installation.

Figure 4. Comparison of two valves: (Fig. 4a) new valve, (Fig. 4b) valve from the installation. Red circle marks a particle.

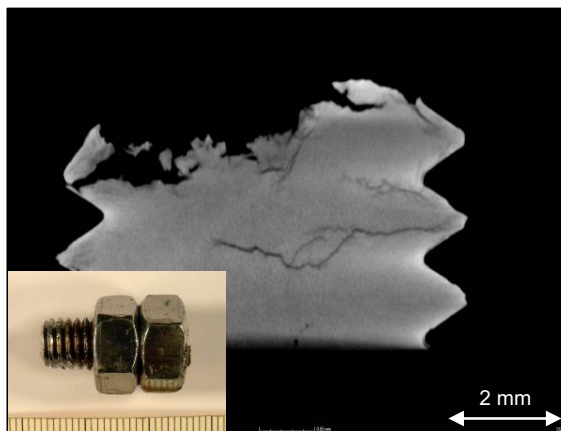
Another example for using CT is presented in the insert of Fig. 5. These small screws (M6) are used for fixing lamps in tunnels. Normally they are made of a high corrosion resistant steel like AISI 316L (X2CrNiMo17-12-2). From a CT cross section (Fig. 5) of the screw near the fracture surface many cracks can be identified. All these cracks are initiated within the grooves of the thread. Scanning electron microscope (SEM) investigations show clearly (Fig. 6) the presence of stress corrosion cracking (SCC). These conclusions can be drawn due to the presence of many branched cracks (Fig. 5) and the factory roofed structure of the fracture surface. Chemical investigations reveal that the material of the screw belongs to the family of corrosion resistant steels, but only of the AISI 304 (X5CrNi18-10) quality. On the fracture surface and other regions, high concentrations of chlorides were identified too.

Figure 5. CT of a small part taken from a failed screw (see insert). Many cracks are initiated in the grooves of the thread.

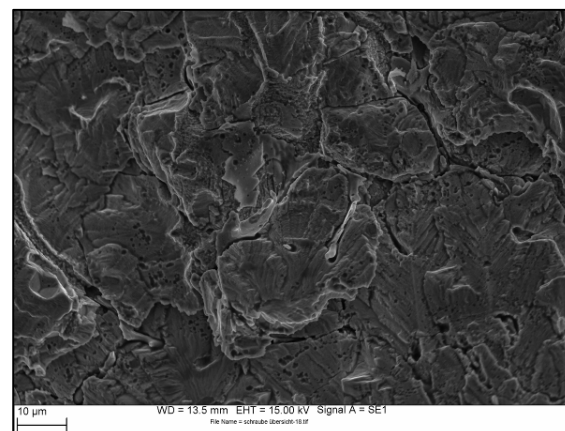
Figure 6. SEM micrograph of the fracture surface of the screw (see Fig. 5). Secondary cracks and factory roofs are visible.
