## Use of FIB to Identify Opens in Metal - Metal Bonds

Nathan Wang, Jason Silva, and George Perreault

Maxim Integrated, San Jose CA, USA

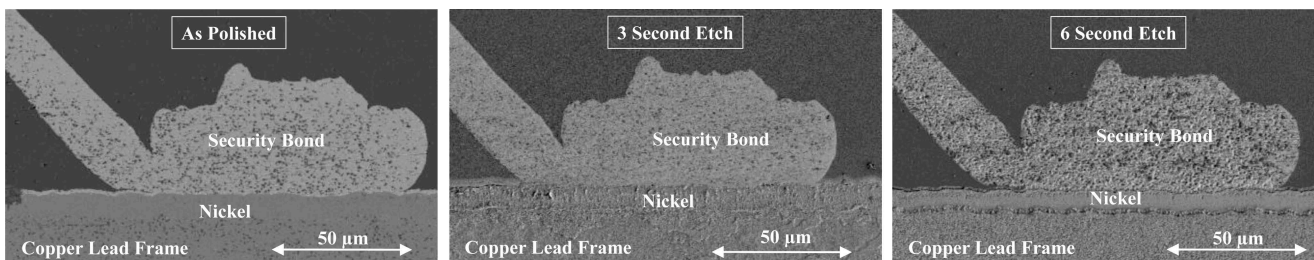
An issue with broken security bonds was observed. As part of the investigation, unstressed bonds were examined to look for possible assembly issues. A metal etch (Potassium Iodide based Columbus Chemical Industries Palladium Etch) was used to decorate the interfaces, Figure 1. The chemical was applied with a cotton swab and then dropped in a beaker of DI water after the etch was completed. After only 3 seconds, damage to the nickel plating layer was observed. After six seconds, the copper lead frame and gold wire bond were also affected.

Figure 1: SEM images of a cross sectioned gold security bond. a) As polished. b) After three second chemical etch. c) After a six second chemical etch.

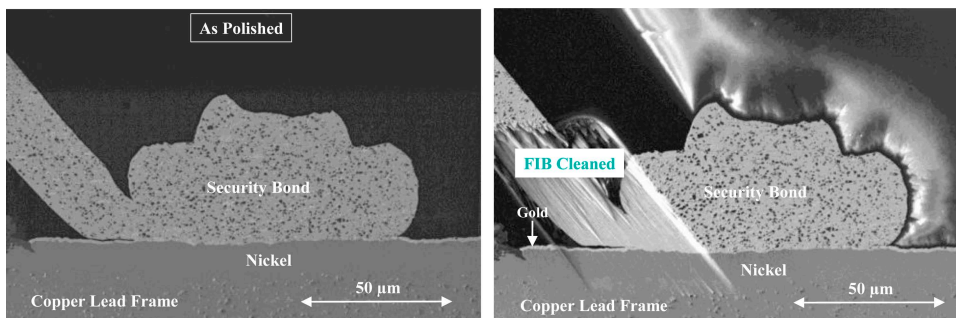
Results of the FIB cleaning of the security bonds are included in Figure 2. Unwanted material was removed, including the dark polishing grit buried in the soft gold, but none of the layers were chemically attacked, allowing follow up elemental analyses to look for possible contaminants.

Figure 2: SEM images of a cross sectioned gold security bond. a) As polished. b) After a FIB clean. The interface of interest has been cleared of debris without chemically changing any of the layers

As these results were not satisfactory, they were repeated with the use of a FIB. To clean the sample, the beam current was maximized and the sample was orientated so there was a  $5^\circ$ - $15^\circ$  angle between the sample surface and the ion beam. If a dual beam FIB is used, progress can be monitored with the electron beam. Depending on the area, cleaning takes between 1-10 minutes.

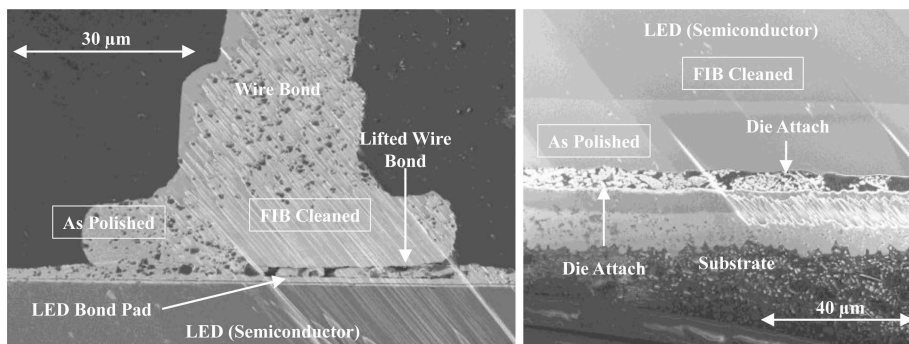
An open was identified on a two terminal device; one connection was wired bonded, the second was made through die attach. The device was mechanically cross sectioned, but due to metal smearing, no definitive conclusion could be reached. FIB cleaning was subsequently performed on both the wire bond and die attach interfaces. These results confirmed that the wire bond, and not the die attach, was the root cause of the failure, Figure 3.

Figure 3: Opens investigation of a two terminal device. After FIB cleaning, it was clear that the bond wire, not the die attach, was the root cause of the failure.

Metal to metal bonds will always be used in the semiconductor industry and some small number of them will fail. To reach the proper conclusion and to allow subsequent chemical analyses, FIB sample cleaning, and not metal etching, is recommended to remove sample preparation artifacts.
