Failure Investigation of WB-57 Aircraft Engine Cowling

¹ Structural Engineering Division, NASA Lyndon B. Johnson Space Center, Houston, TX 77058

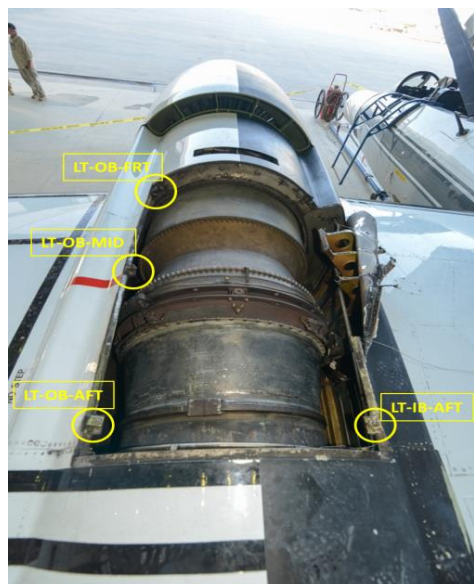
During the return from a 6 hour flight, at 30,000 feet, in the clean configuration, traveling at 175 knots indicated airspeed, in un-accelerated flight with the auto pilot engaged, in calm air, the 2-man crew heard a mechanical bang and felt a slight shudder followed by a few seconds of high frequency vibration. The crew did not notice any other abnormalities leading up to, or for the remaining 1 hour of flight and made an uneventful landing. Upon taxi into the chocks, the recovery ground crew noticed the high frequency long wire antenna had become disconnected from the vertical stabilizer and was trailing over the left inboard wing, and that the left engine upper center removable cowling panel was missing, with noticeable damage to the left engine inboard cowling fixed structure. The missing cowling panel was never recovered.

Each engine cowling panel is attached to the engine nacelle using six bushings made of 17-4 PH steel. The cylinder portions of four of the six bushings were found still attached to the aircraft (Fig 1). The other two bushings were lost with the panel. The other four bushings exhibited ratchet marks (multiple fatigue origins) which initiated in the sharp radius of the flange/cylinder fillet and were observed 300 degrees around the flange perimeter (Fig 2-3). Low stress, high cycle fatigue (HCF) was observed on the fracture surfaces of all four bushings^[2] (Fig 4).

Fig 1. WB-57 Aircraft Left Engine w/Missing Cowling. Location of four remaining bushings circled in yellow.

To improve the cowling panel joint design and enable return to flight, new cowling bushings with thicker flanges and a larger machined flange/cylinder fillet radius were installed on all cowling panels. In addition, a spacer was added to the joint to achieve the proper stack tolerance. Finally, a time change requirement for all cowling bushings was instituted.

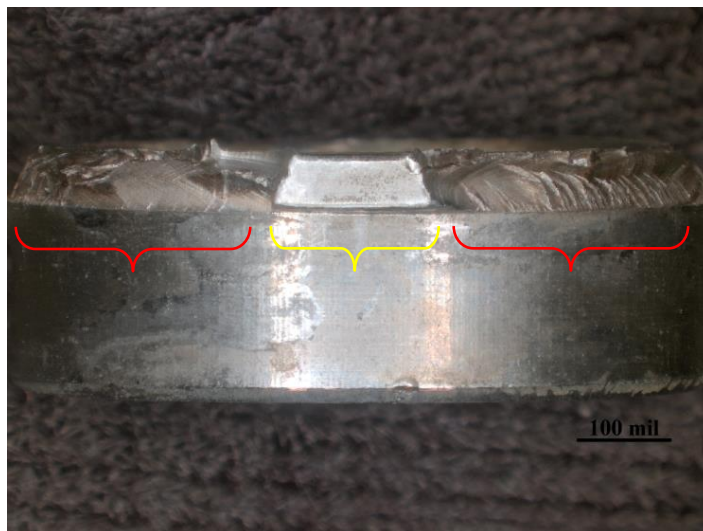
Fig 2. Photo of Failed Engine Cowling Bushing. Fatigue fracture zone in red, unfractured zone in yellow.

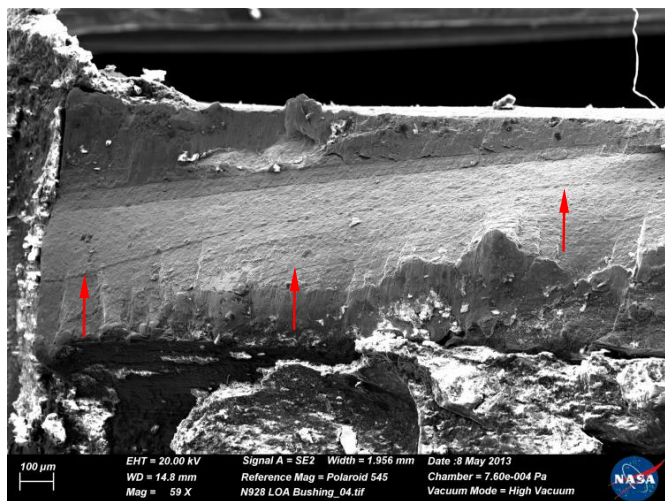
Fig 3. SEM of Failed Engine Cowling Bushing (ratchet marks at red arrows)

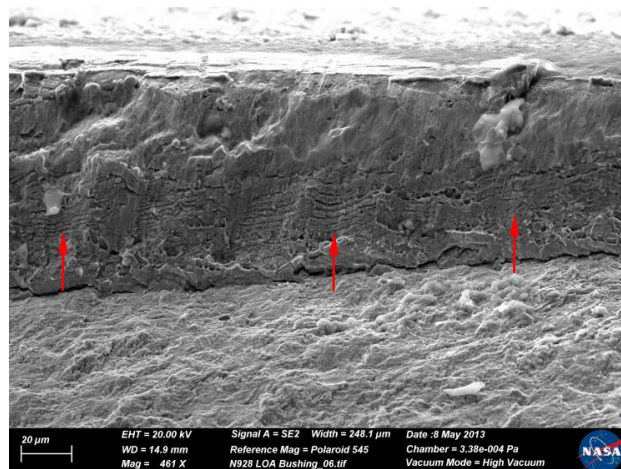
Fig 4. SEM Image of HCF Striations (red arrows)
