## The Combination of STEM Tomography and STEM/EDS Analysis of NiSi Formation Related Defects in Semiconductor Wafer-foundries

<sup>1</sup> GLOBALFOUNDRIES, 400 Stone Break Rd Extension, Malta, NY, USA

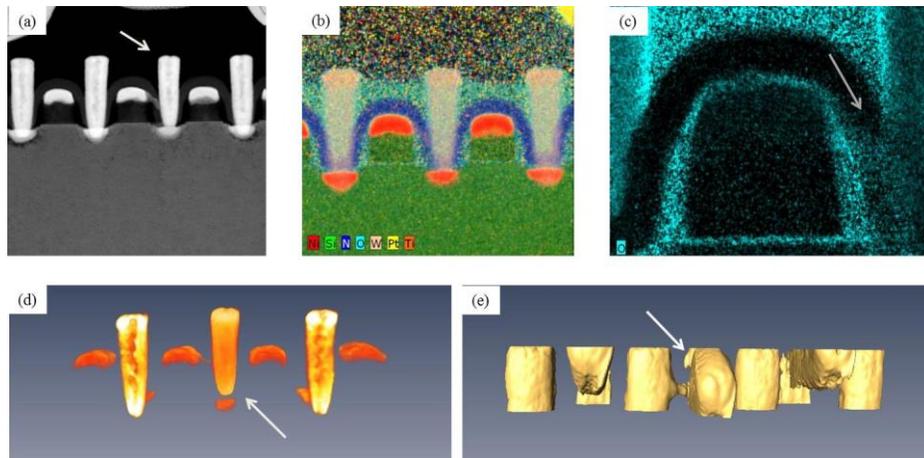
Fig.1 shows the results of a nickel silicide bridge defect from PC to W contact in a single bit failure of a SRAM cell. The cross-section STEM image (a) and EDS elemental image (b) confirm the bridge is NiSi. It also appears that the neighboring W contact lands on the NiSi at the S/D region (arrowed). However, from the 3D voltex view in STEM tomography, the W contact does not land on the NiSi (d). The isosurface view in Fig. 1e shows that the NiSi formation under this W contact is also blocked. This can be explained by the presence of silicon oxide particle located at the S/D region at the W contact, shown in the oxygen map in figure (c). This particle blocks the NiSi formation at S/D region and caused the shorter W contact. STEM tomography helped reveal the blocked NiSi defect in addition to the nickel silicide bridge defect found in TEM.

**Figure 1.** (a) STEM image showing S/D contact to gate short; (b) EDS elemental maps; (c) Enlarged view of oxygen map, noticing the extra oxygen signal (arrowed); (d) STEM tomography voltex visualization, showing contact is not landed on NiSi (arrowed); (e) STEM tomography isosurface visualization, showing part of the NiSi formation is blocked.

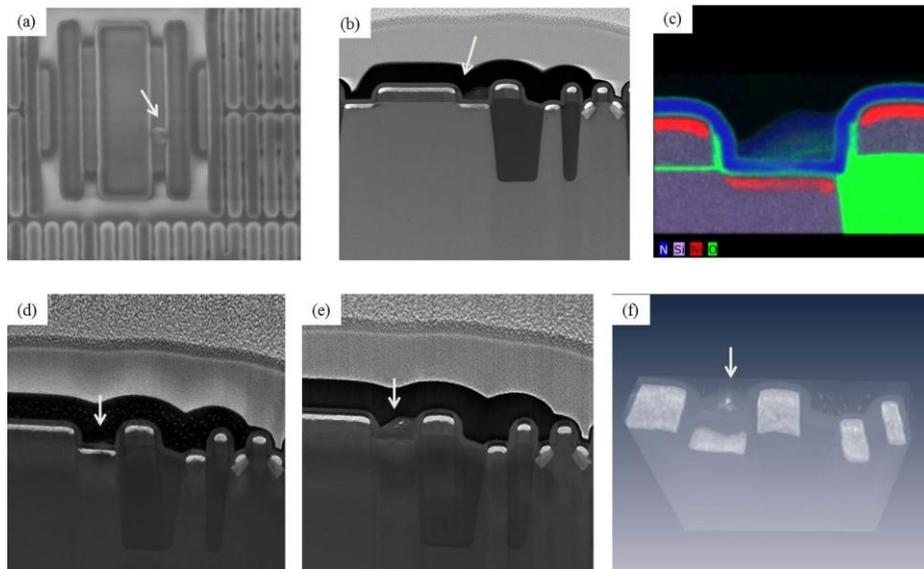
In Fig. 2a a particle is observed in the S/D region. Cross-section STEM and EDS analysis show, that the particle mainly contains O, N, and Si elements with some Ni signal detected in the particle core. However, NiSi at S/D region is still formed successfully below the particle (Figs. 2b,c). Since formation of NiSi requires clean Si surface it is difficult to understand how NiSi was formed. Figs.2d,e are two represented OrthoSlice views from 3D STEM tomography reconstruction volume, which clearly show that NiSi and the particle in Figs.2b,c are located in different planes within TEM sample, i.e. image in Fig. 2b suffers from the “projection effect”. This explains why perfect NiSi film was formed. The particle is composed of some tiny NiSi present on top of the Si oxide particle, covered with nitride layer (Fig. 2e). Directly under the particle, no “NiSi” formation is observed as expected. The entire morphology of the particle and NiSi formation can be clearly seen in the 3D voltex image in Fig.2f. The presented results illustrate unique capabilities of STEM tomography to understand the failure mechanisms in semiconductor devices and provide guidance for enhancement of device yield and performance.

**Figure 2.** (a) Top-down SEM image of defect location (arrowed); (b) cross-section STEM image and (c) EDS elemental map of the defect location; (d) Reconstructed OrthoSlice before the particle; (e) Reconstructed OrthoSlice at the center of the particle; (f) STEM tomography voltex visualization of the particle.
