Insight on High Temperature Hydrogen Attack Initiation and Morphology on Case Studies - 3D FIB-SEM and TEM Analyses for Fine Microstructural Characterization of Attacked Low Carbon Steels

Camille Flament^{1*}, Olivier Gillia¹, Thomas David¹, Romain Soulas¹, Laure Guetaz¹, Charles Le Nevé², Raphaël Goti²

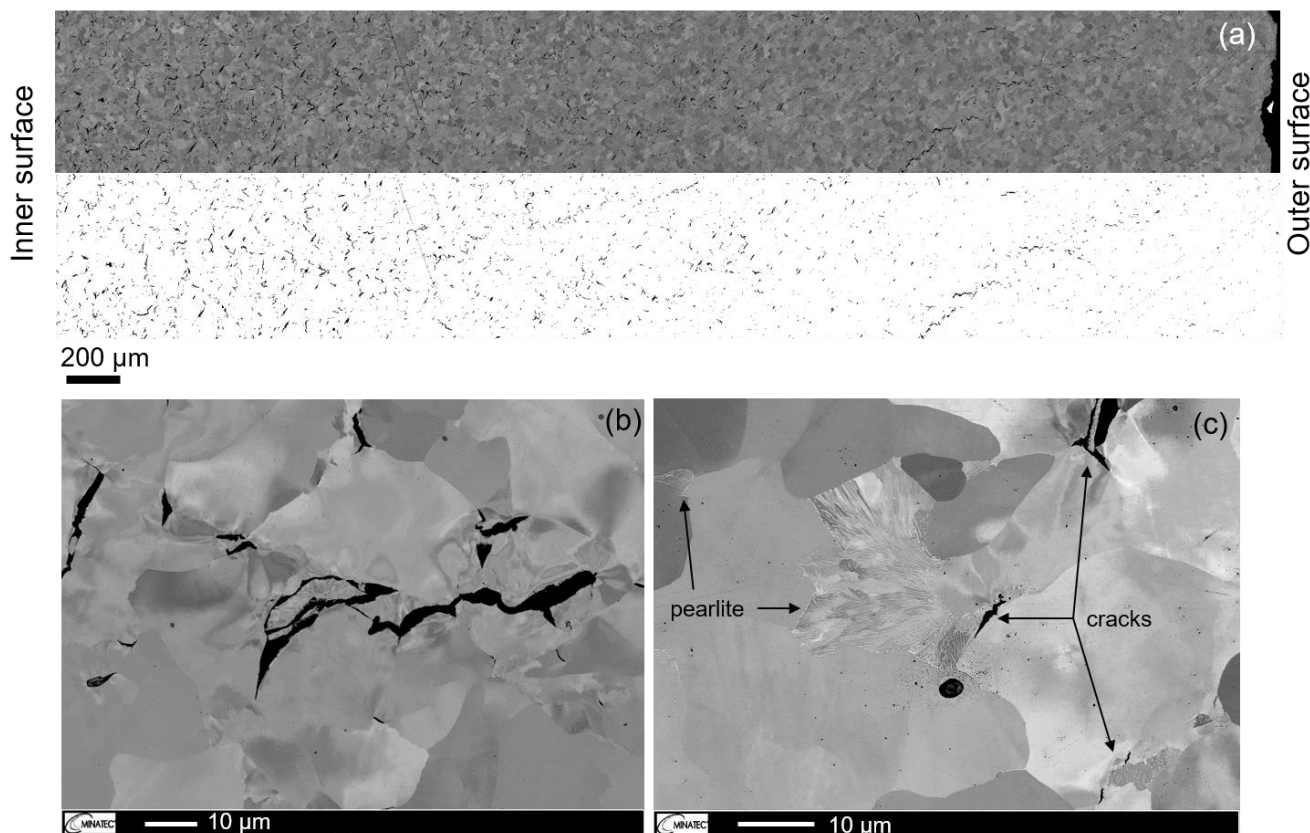
A careful attention has been paid to the location of initiation and the morphology evolution of defects (bubbles/voids, cracks) on the different case studies of this work. On a much-attacked C-steel vessel coming from a CO-methanation tube, observations at micron scale by optical microscopy and SEM reveal a particular attack profile with orthoradial intergranular cracks near the inner surface submitted to hydrogen atmosphere and radial near the outer surface. Pearlite grains, which are constituted of packets of cementite carbides plates distributed in a same ferrite grain, are preferentially attacked since their amount decreases approaching inner surface (Figure 1). This induces a surface decarburization and a weakening of the steel from the inner surface. On a much less attacked vessel coming from a hydrofinishing reactor, SEM observations from inner surface show that voids decorate some pearlite grains. They are located at the interface between cementite and ferrite as well as at grain boundaries. No crack has been noted for this stage of attack in this microstructure. 3D FIB-SEM technique has allowed to visualize in three dimensions the link between voids, carbon phases and inclusions distributed along particular planes which can cross several ferrite and pearlite grains (Figure 2). When a plane rich in inclusions intercepts a grain of pearlite or a grain boundary, voids are detected. Associated to TEM

Figure 1. Characterization of much-attacked steel microstructure. (a) SEM observations from the inner (left) to the outer (right) surface of a piece of attacked tube as well as the image analysis by Image J showing cracks in black. (c,d) SEM observations of intergranular cracks at different magnifications showing their relation with pearlite grains.

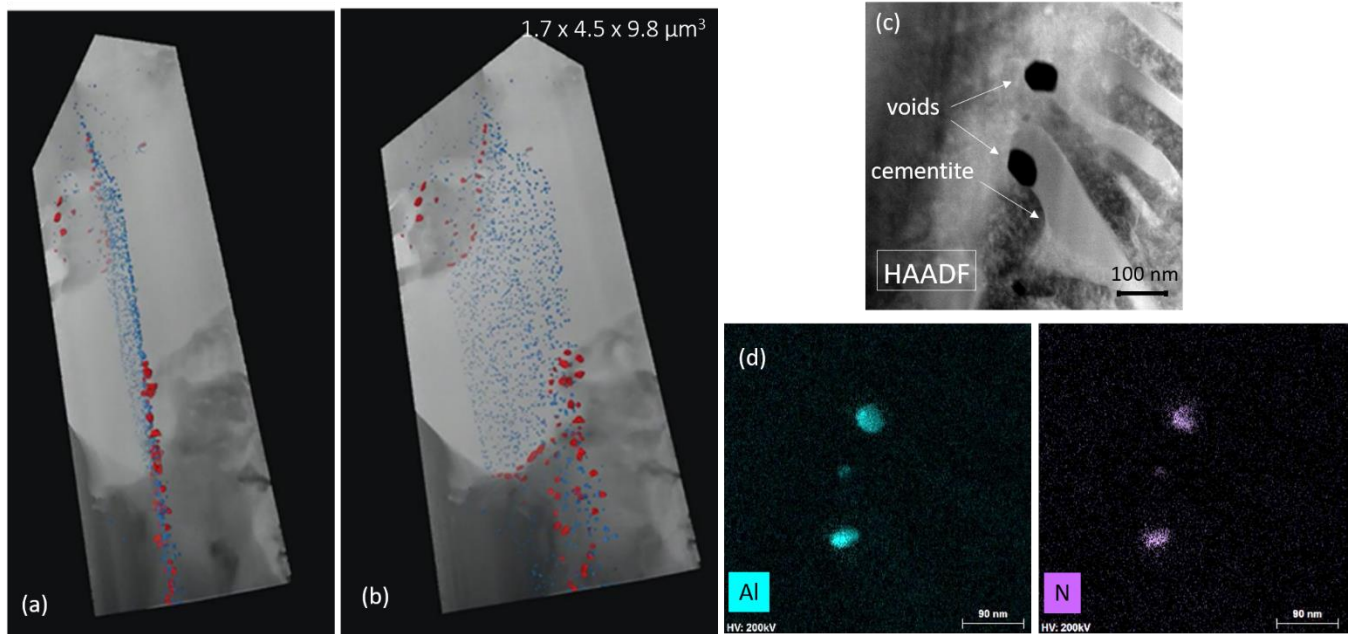
observations, it has been shown that the small inclusions observed both close to voids and carbon phases are mainly nanometric AlN precipitates. They could be a catalyst of voids nucleation. It shows that the advanced characterization techniques used in this study are very powerful for understanding the early hydrogen attack stage and as far as our knowledge, only very few articles [4] describe such combination of fine characterizations in order to highlight the trigger of HTHA.

Figure 2. Characterization of less-attacked steel microstructure. (a,b) 3D view of an alignment of small inclusions (blue objects) in ferrite (light grey) linked to voids nucleation (red objects) when the inclusion plane interferes with the carbon phase - cementite (dark grey) (volume dimension : $1.7 \times 4.5 \times 9.8 \mu\text{m}^3$). (c) STEM-HAADF (high angle annular dark field) image showing voids at carbides interface with the matrix. (d) Al and N EDX maps suggesting inclusions in voids can be AlN precipitates.
