Failure Analysis of International Low Impact Docking System Latch Hooks

J. Martinez, R. Patin, J. Figert

Structural Engineering Division, NASA Lyndon B. Johnson Space Center Houston, TX 77058 USA

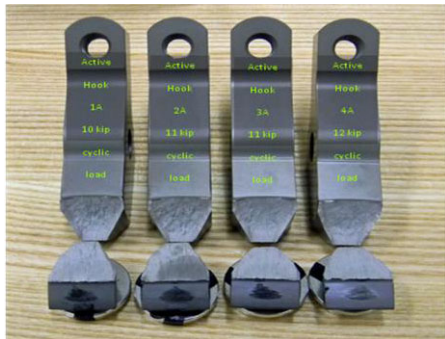
Constant amplitude fatigue testing to failure on four sets of active/passive iLIDS latch hooks was performed at load magnitudes of 10, 11, and 12 kips. Failure analysis of the hook fatigue failures identified multi-site fatigue initiation that was effectively centered about the hook mid-plane (consistent with the 3D model results). The fatigue crack initiation distribution implies that the fatigue damage accumulation effectively results in a very low aspect ratio surface crack (which can be simulated as thru-thickness crack). Fatigue damage progression resulted in numerous close proximity fatigue crack initiation sites. It was not possible to determine if fatigue crack coalescence occurs during cyclic loading or as result of the fast fracture response. The presence of multiple fatigue crack initiation sites on different planes will result in the formation of ratchet marks as the cracks coalesce. Once the stable fatigue crack becomes unstable and the fast fracture advances across the remaining ligament and the plane stress condition at a free-surface will result in failure along a 45 deg. shear plane (slant fracture) and the resulting inclined edge is called a shear lip. The hook thickness on the plane of fatigue crack initiation is 0.787". The distance between the shear lips on this plane was on the order of 0.48" and it was effectively centered about the mid-plane of the section. The numerous ratchet marks between the shear lips on the fracture initiation plane are indicative of multiple fatigue initiation sites within this region. The distribution of the fatigue damage about the centerline of the hook is consistent with the analytical results that demonstrate peak stress/strain response at the mid-plane that decreases in the direction of the hook outer surfaces. Scanning electron microscope images of the failed sections detected fatigue crack striations in close proximity to the free surface of the hook radius. These findings were documented at three locations on the fracture surface : 1) adjacent to the left shear lip, 2) adjacent to the right shear lip, and 3) near the centerline of the section. The features of the titanium fracture surface did not allow for a determination of a critical crack size via identification of the region where the fatigue crack propagation became unstable.

Fig 3. Post test photographs of the active hook test articles.

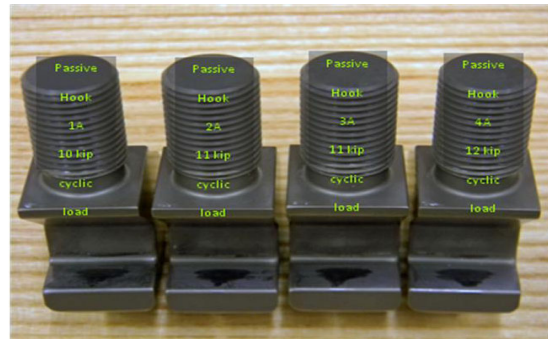
Fig 4. Post test photographs of the passive hook test articles.

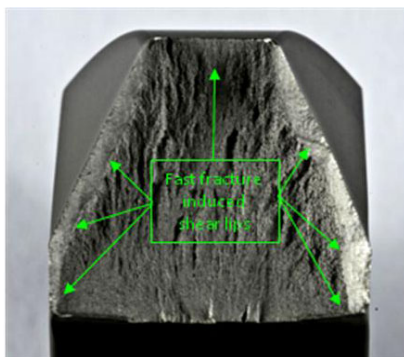
Fig 5. Active hook (10 kip fatigue loading) fracture photograph.

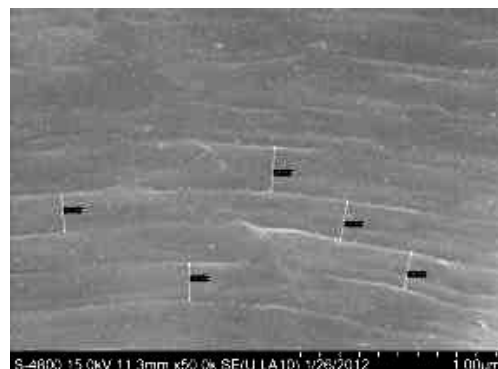
Fig 6. SEM image of fatigue striations adjacent to the shear lip-fatigue transition region.
