Failure Investigation of A 4340 Steel Forge Knock-Out

M. He*

*Scot Forge Company, 8001 Winn Road, Spring Grove, IL 60081-0008

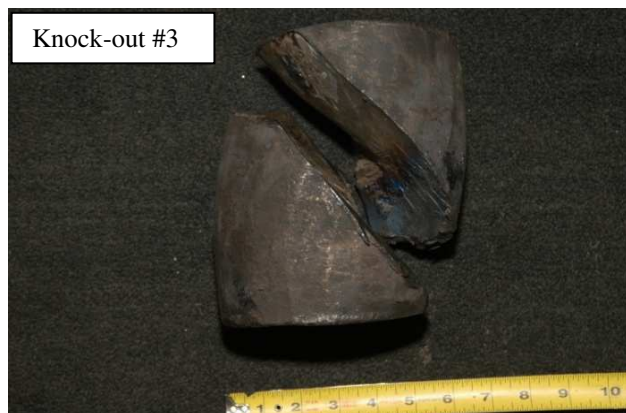
Fig. 1

A 6" diameter 4340 forge knock-out (termed knock-out #3) fractured into two halves during ID snapping of a nickel-based ring forging preform (Fig. 1). The knock-out below the fractured knock-out (termed knock-out #2), also made of 4340 steel, was buckled (non-uniform deformation) and cracked on the top face surface but did not split into multiple pieces (Fig. 2). This incident prompted an metallurgical investigation to determine if there are any abnormalities with the knock-out base material.

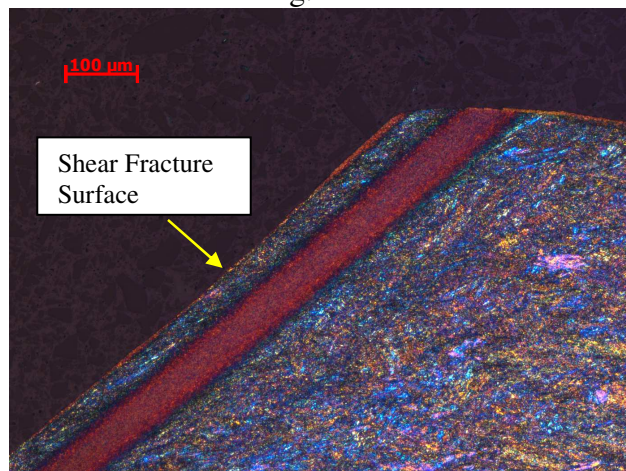
Fig. 3

Knock-out #3 fractured in compressive shear (Mode II fracture). A metallographic examination showed that its initiation site was heavily smeared by the metal flow during fracture that little useful evidence can be obtained (Fig. 3). Multiple adiabatic shear bands found near the fracture surface indicated the violent nature of this event (Fig. 4). Other than the cold worked region from the deformation occurred during the failure, the base microstructure is consistent with a 4340 steel in the quenched and tempered condition.

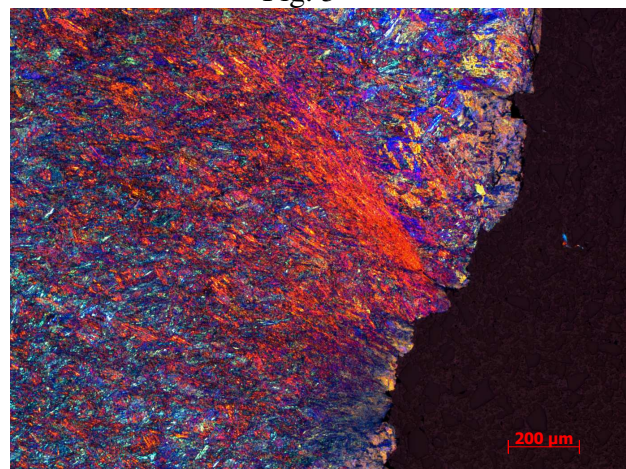
Fig. 5

Knock-out #2's crack on its top face surface was opened with an origin identified at the face/OD corner. Its cross section revealed evidence of cold work which was not unexpected given the event history (Fig. 5). Interestingly, along its tapered top surface, adiabatic shear bands were found, suggesting it also deformed rather rapidly (Fig. 6). Results of an axial tensile test survey along various locations on this knockout were consistent with the 363 HBW surface hardness obtained.
