Identifying ESC Failures in Polymers using Fractography

Dale B. Edwards, P.E.¹

¹ Engineering Systems Inc. (ESI), Aurora, IL, USA

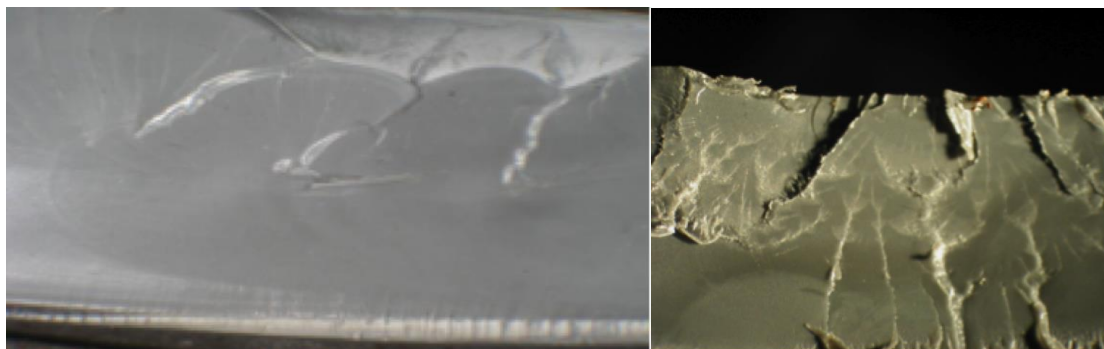
ESC failures resulting from aggressive ESC agents are easy to identify. They have glassy, extremely smooth fracture surfaces and a very low critical stress for the chemical/material combination, as shown in Figure 1, a fracture surface from a CPVC tank exposed to a plasticizer and an ABS part that failed due to exposure to silicone oil. Cracks driven predominantly by stress are also fairly easy to identify with significant micro-ductility on the fracture surface and/or the presence of discontinuous crack growth bands. Figure 2a is an example of a crack in a CPVC pipe that appears to be more stress-driven, exhibiting micro-ductility on the surface. Figure 2b is an example of a mechanically driven crack that occurred due to freezing of water in an assembly of CPVC pipe in the laboratory. This section of pipe was removed and then re-pressurized at high stress (4200 psi) for 1 week before removing it and opening up the fracture surface. This additional time under high stress (4200 psi) caused the rib marking on the fracture surface. The crack had occurred in the piping adjacent to the burst area of the pipe. [2]

Figure 1. Failures due to an aggressive ESC agent for CPVC (left) and ABS (right).

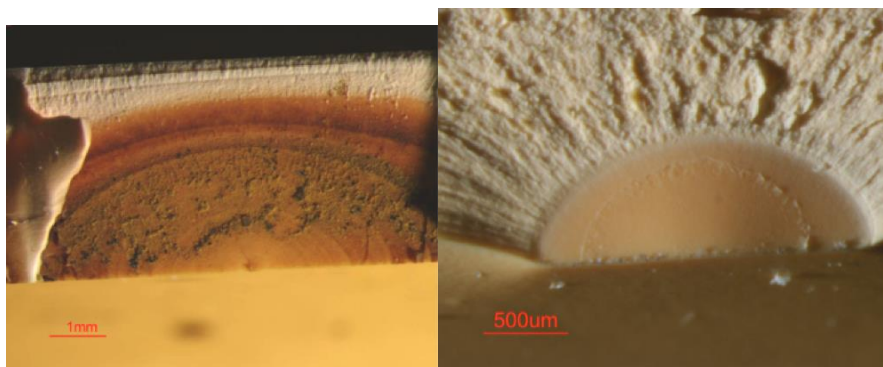
Figure 2a. CPVC failure due to slow crack growth and/or less aggressive ESC agent (left photograph). **2b.** Mechanically driven freeze crack from laboratory showing rib marking from secondary loading after freeze event (right photograph).
