Failure Analysis of Brass Components

Chirag G. Shah

Exova Inc, 194 International Blvd, Glendale Heights, IL 60139

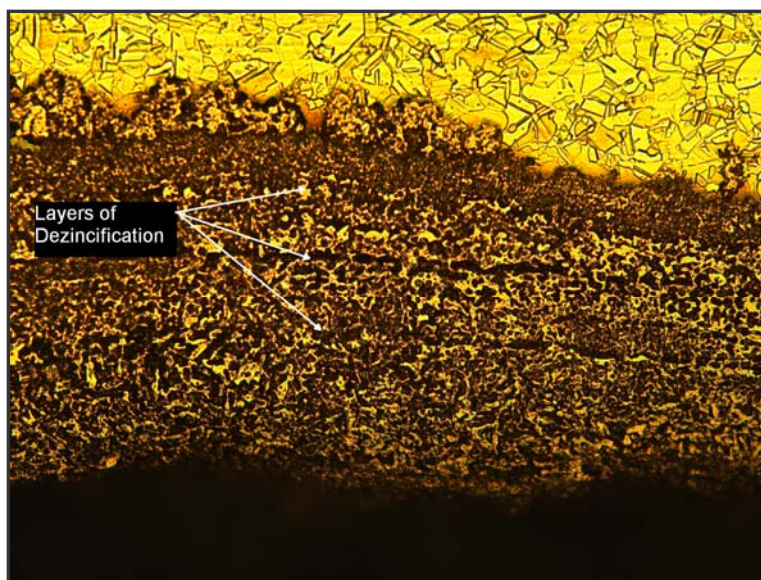
Figure 1: This optical micrograph shows a Dezincified area of brass contact indicating a layered microstructure consistent with dezincification occurring over time.

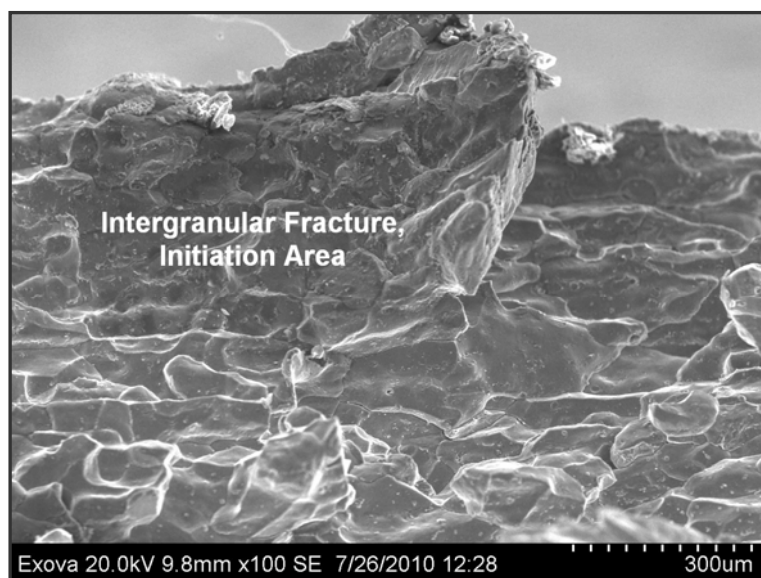
Figure 2: This secondary electron SEM image shows the intergranular fracture associated with the stress corrosion cracked brass fitting.
