High Contact Resistance in Spring Loaded Micro-Switches

K.R. Wasag*, P.E.,

* Scientific Control Laboratories, Inc., 3158 W. Kolin Ave., Chicago, IL 60623

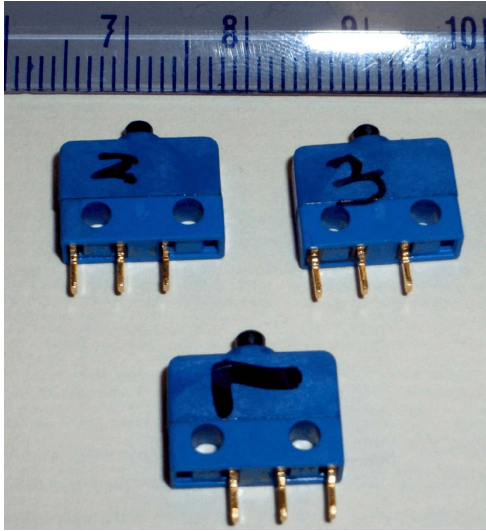
Fig. 1 - Overview of submitted samples.

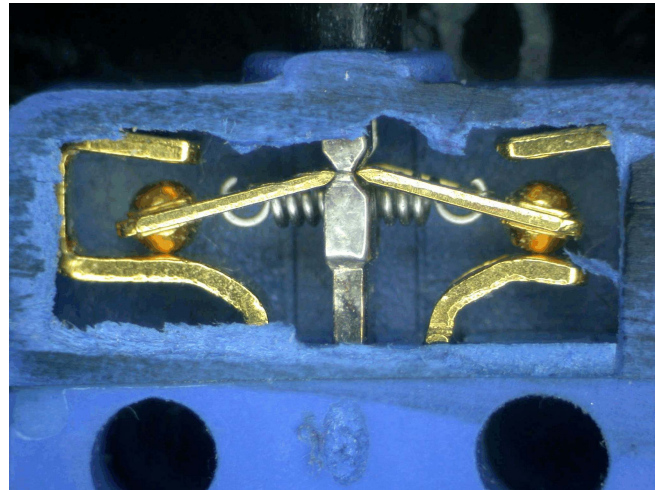
Fig. 2 - Internal view of a switch which exhibits high contact resistance.

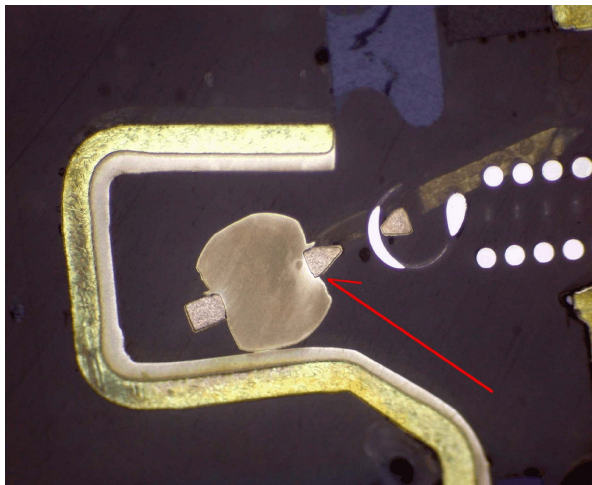
Fig. 3 - Good contact showing square attachment.

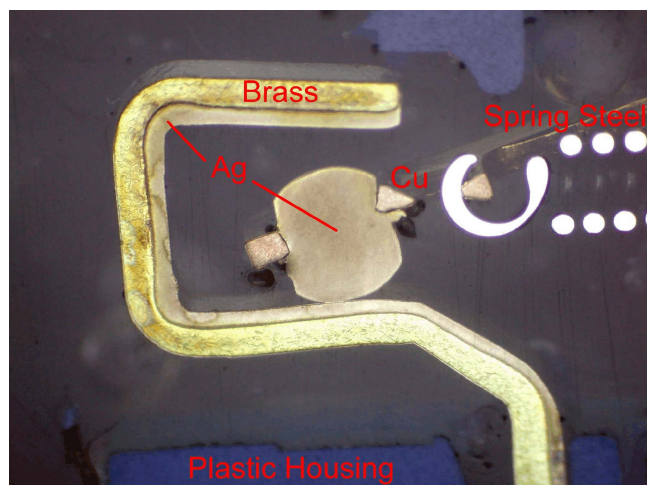
One face of the housing was gently removed with a razor blade, exposing the interior of the switch. Initial examination at low magnification did not reveal any evident contamination on the plated surfaces. The part was then mounted in clear media, metallographically polished, and etched with 50-50 nitric-acetic acid. Examination was initially made at 10 ~ 30X, and photographs were taken. It was immediately apparent that the arms which the gold plated spheres attach to were contacting at an abnormal angle. Comparison to known "good" examples showed that the sphere-arm contact point should be flat and head on (see attached photographs). Higher power examination at 100X revealed gaps at the interface (due to the angle of contact) and a smaller than normal contact area, hence higher resistance. This was observed on both the left and right spheres.

Fig. 4 - Bad contact. Note angle of attachment.

As this was an obvious physical defect, the gold plater was exonerated of the problem. Adjustments to the manufacturing process alleviated the issue. On a side note, it was highly likely that plating processing solutions were trapped and then dried within the gaps formed by the abnormal attachment, further increasing the contact resistance. This was a secondary effect, however, and would not come into play if the attachment were normal.

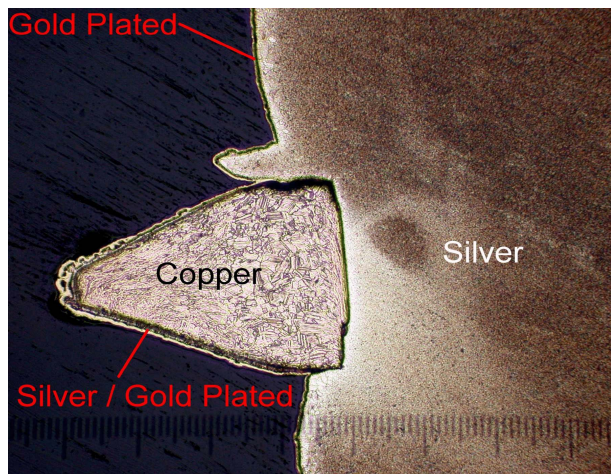
Fig. 5 - Normal attachment on a good contact.

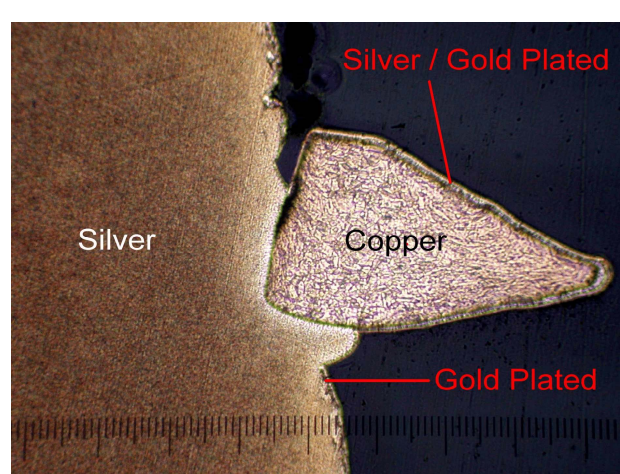
Fig. 6 - Angled attachment on a bad contact. Note gap as well.
