Metallographic Preparation of Space Shuttle Reaction Control System Thruster Electron Beam Welds for Electron Backscatter Diffraction

J. Martinez, W. Castner, J. Figert, J. Ventura, D. Gonzalez

Materials Evaluation Laboratory, Structural Engineering Division
National Aeronautics and Space Administration – Johnson Space Center
2101 NASA Parkway, Houston, TX 77058

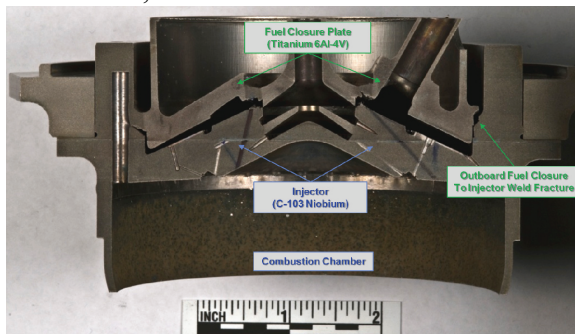
Fig 1. RCS Thruster Injector Cross-Section

A Space Shuttle Reaction Control System (RCS) thruster failed during a firing test at the NASA White Sands Test Facility (WSTF), Las Cruces, New Mexico. The firing test was being conducted to investigate a previous electrical malfunction. A number of cracks were found associated with the fuel closure plate/injector assembly (Fig 1). The firing test failure generated a flight constraint to the launch of STS-133. A team comprised of several NASA centers and other research institutes was assembled to investigate and determine the root cause of the failure. The JSC Materials Evaluation Laboratory was asked to compare and characterize the outboard circumferential electron beam (EB) weld between the fuel closure plate (Titanium 6Al-4V) and the injector (Niobium C-103 alloy) of four different RCS thrusters, including the failed RCS thruster.

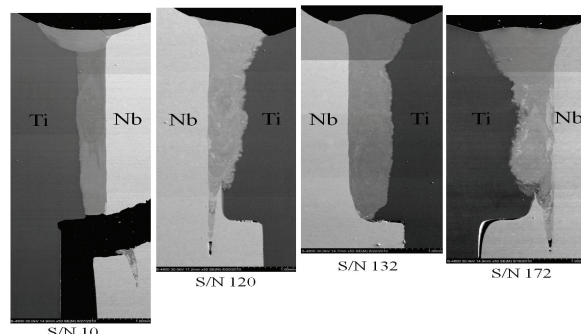
Fig 2. SEM BSE Comparison of 4 Injectors Outboard Fuel Closure Welds

Once polished, each sample was micrographed using bright field, differential interference contrast optical microscopy, and scanning electron microscopy (SEM) using a backscatter electron (BSE) detector. No typical weld anomalies were observed in any of the cross sections. However, areas of large atomic contrast were clearly visible in the weld nugget, particularly along fusion line interfaces between the titanium and the niobium. This prompted the need to better understand the chemistry and microstructure of the weld (Fig 2). Energy Dispersive X-Ray Spectroscopy (EDS) was used to confirm the chemical composition of the variations in contrast in these areas.
