Denickelification and Dezincification of Copper Alloys in Water Environments

Jun-Fu Liu, Mel J. Esmacher and David Kotwica

GE Power & Water, Water & Process Technologies, 9669 Grogans Mill Road, The Woodlands, TX 77380

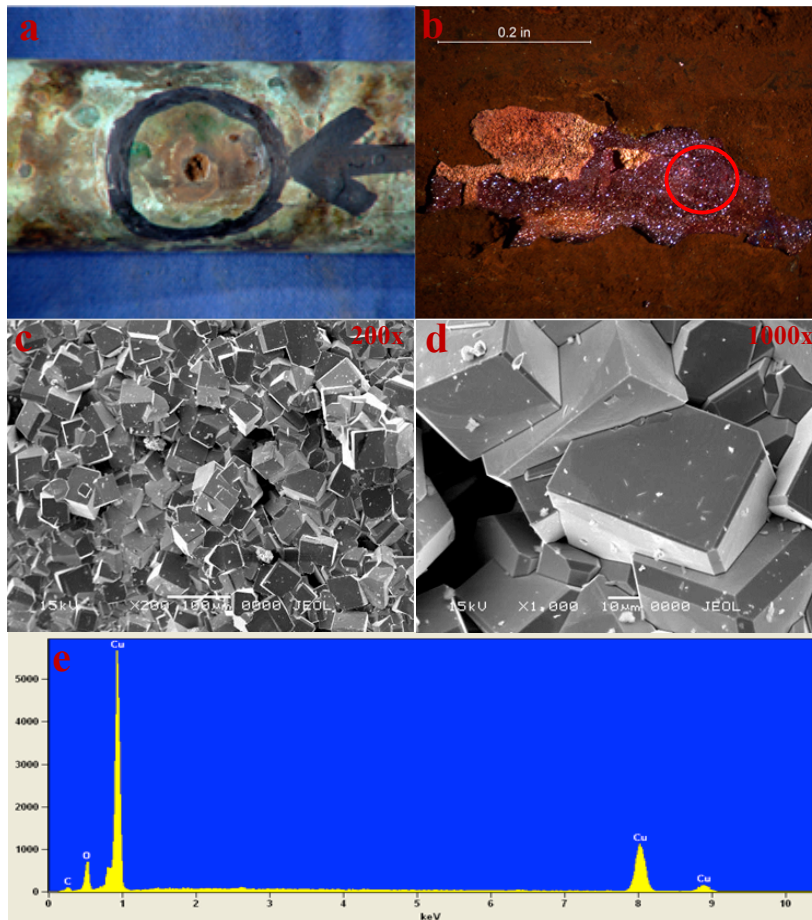
Case 1 (Figure 1a) is a failed copper-nickel tube section (10% Ni, 1% Fe, 0.55% Mg, balance Cu) from a heat exchanger. City make-up water circulating on the tube side was heated by a hot gas stream on the shell side of the exchanger. The time in service was 20 years. Purple deposits are observed at some locations on the internal surface (Figure 1b). SEM images in Figure 1(c, d) and EDS analysis in Figure 1e show that the purple deposits consist of Cu micro-crystals.

The de-alloying process is consistent with the mechanism of simultaneous dissolution of Ni (or Zn) and Cu, followed by re-deposition of Cu.

Later Cu^{2+} ions were reduced to metallic Cu due to a higher tendency of Cu^{2+} than Ni^{2+} or Zn^{2+} ions to plate out of solution.

Figure 1. Photographs of (a) Ni-Cu tube and (b) purple deposit on the inside surface, and SEM images (c, d) of Cu micro-crystals of the purple deposit, and (e) EDS result.

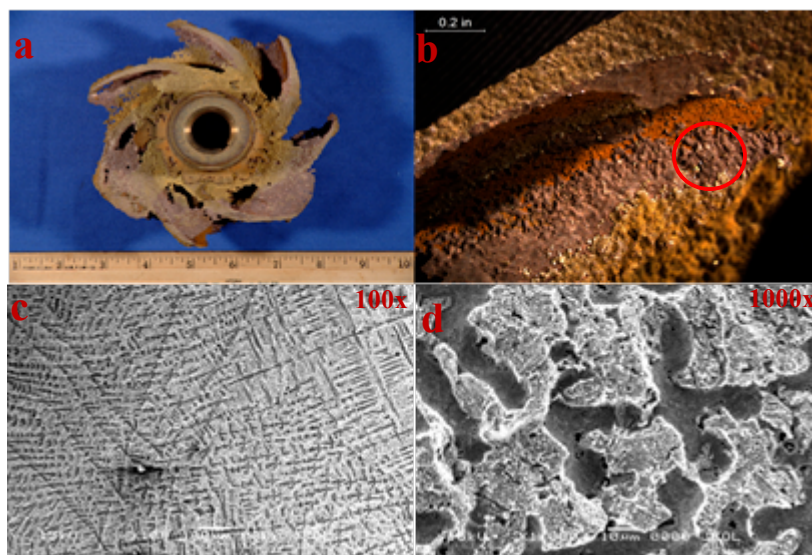
Case 2 (Figure 2a) is a silicon bronze pump impeller (7.3% Zn, 4.3% Si, balance Cu) from a booster pump. The time in service in potable water was 2 years. In addition to erosion corrosion (Figure 2a) due to excessive flow velocity and cavitation, surface dezincification of the bronze alloy resulted in localized red deposit area (Figure 2b). The SEM images in Figure 2(c, d) show that the area has a micro-porous surface texture. It is 99% Cu from the EDS analysis result.

Figure 2. Photographs of (a) a silicon bronze pump impeller and (b) red deposit on the inside surface, and SEM images (c, d) of red Cu deposit area.
