Investigation of Steel Lug Nut Failures with Brittle Fracture Characteristics

D.F. Susan, N.R. Sorensen, J.R. Michael, A.C. Kilgo, and G.L. Clark II

Sandia National Laboratories, Albuquerque, New Mexico

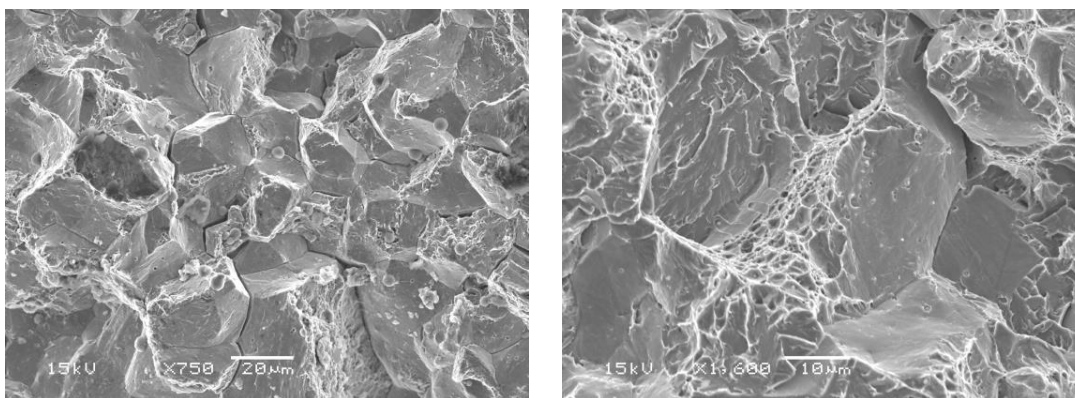
Scanning electron microscopy showed intergranular (IG) brittle fracture or mixed transgranular (cleavage)/IG fracture (Fig. 1). Intergranular fracture indicates embrittlement of normally ductile steel.[2] The cap nuts contain a tempered martensite microstructure and fracture occurs along prior austenite grain boundaries. Hydrogen embrittlement is known to be exacerbated in higher strength steels. Figure 2 displays Rockwell C hardness and tensile test results of cap nuts. The failed cap nuts reside in a higher strength regime, 37-40 HRC, putting them at greater risk for H embrittlement.[2,3] All failures were traced to newer lots of material with higher strength from a new supplier. Older lots with hardness in the 33 - 35 HRC range exhibited more elongation and ductile fracture morphology.

Figure 1. SEM photomicrographs showing brittle intergranular fracture (left) or mixed intergranular, quasi-cleavage, and microvoid coalescence (right).

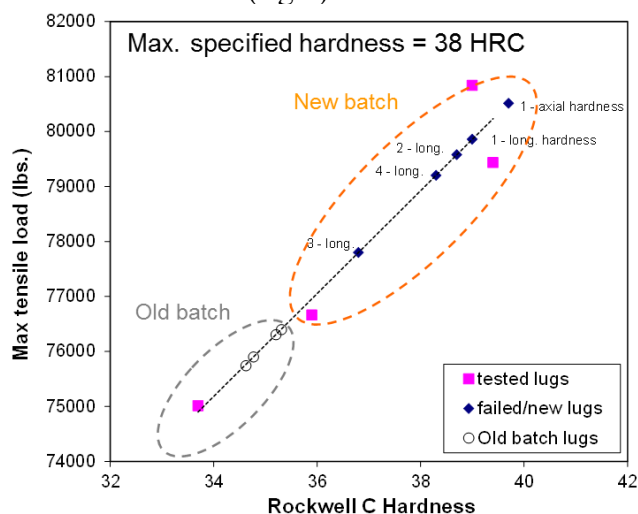
Figure 2. Maximum tensile load vs. Rockwell C hardness for old lot and new lot cap nuts. In-service failures occurred only in new lots of cap nuts with higher strength and hardness.
