Failure Analysis of Polyethylene Products Using Microscopy

Ann Johnson, Praveenkumar Boopalachandran, Eddy Garcia-Meitin¹ and Siddharth Ram Athreya²

¹ The Dow Chemical Company, Analytical Sciences Microscopy, Lake Jackson, USA.

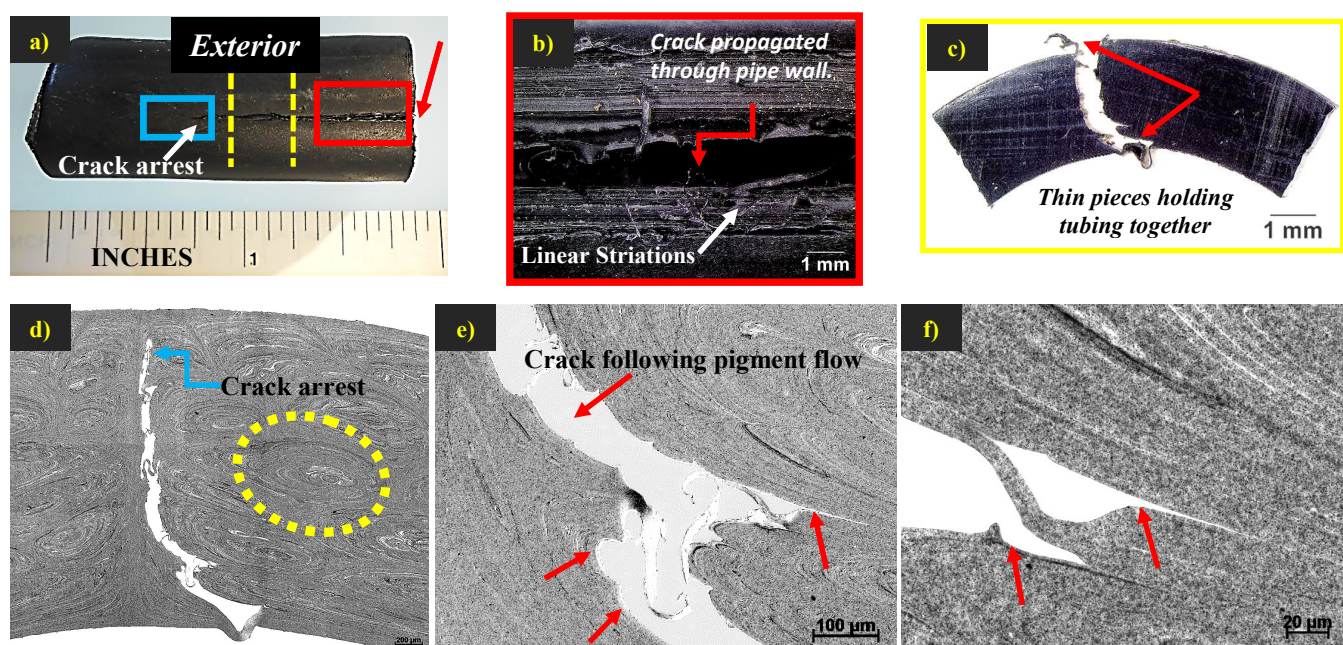
In the first example, a black tubing (A) attached to a connector fitting failed service. Light microscopy was used to survey the tubing and determine that a crack occurred at the fitting (Figures 1a-b). A razor blade was used to isolate the failed joint by cutting 2 mm thick slices perpendicular to the longitudinal tubing crack near the crack arrest. Low magnification optical analysis of razor cut cross sections provided evidence that crack initiation occurred internally near the interior tubing surface. This finding was evident by the remaining polymer ligaments holding the tubing walls together (Figure 1c). To further investigate the crack arrest, a cryogenic microtome with a diamond knife was used to collect 5µm thick cross sections for transmitted light microscopy (Figures 1d-f). Cross sections were examined under transmitted bright-field illumination on a compound microscope. Examination of the crack clearly showed that swirl lines associated with poor carbon black pigment dispersion had initiated internal cracks which propagated along pigment rich interfacial boundaries (Figure 1f). This work showed that poor carbon black pigment dispersion associated with “salt and pepper” dry blending of pigment produced poor pigment dispersion resulting in weak interfacial boundaries that led to connector failures. Melt blending of pigments prior to fabrication can improve dispersion and mitigate inhomogeneity that can influence product performance.

Figure 1. Black tubing (A). a) Tubing with linear crack which formed at fitting, b) exterior top-down view of exterior surface with open crack, c) 2mm thick cross section ligaments on interior and exterior surfaces, d) 5 μ m thick cross sections of crack and arrest, e) magnified view showing crack path following pigment interfacial boundaries along pipe interior, f) higher magnification of image in e.

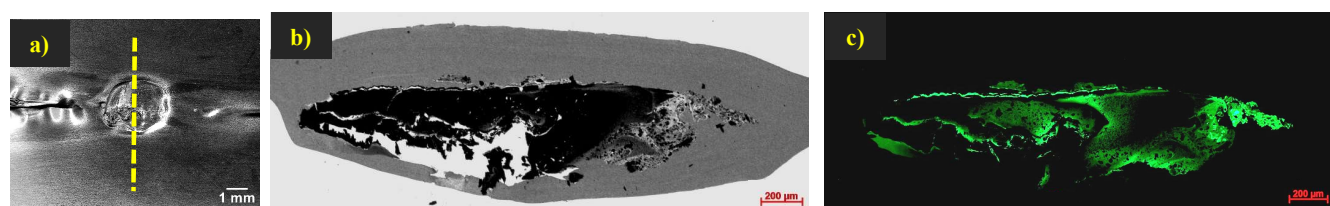
In a second example, a black tubing (B) developed a visible surface defect resembling a gel or inclusion upon production (Figure 2a). Gels are defects that can develop from unmelt polymer, pigments, cross-linking, or foreign contamination during production, handling or fabrication [3]. Others in the industry may also refer to them as inclusions due to the variety of ways that defects form [4]. Analysis of 5µm thick cross sections under transmitted bright field (Figure 2b) and epifluorescence illumination showed a highly brittle material that fluoresced under ultraviolet light (Figure 2c). Further investigation using energy dispersive x-ray (EDX) and infrared micro spectroscopy determined that the gel was organic and

consistent with oxidized polyethylene. The source of the gel was traced to dirty extrusion equipment which contaminated the tubing during fabrication.

Figure 2. Black tubing (B). a) Top down image of a gel identified from the edge of a blister defect, and b) transmitted bright-field image of 5 μ m thick cross section taken through the gel, c) epi-fluorescence image of gel showing an intense fluorescence emission consistent with polymer oxidation.
